TO: Mercedes-Benz Dealer Principals, General Managers, Sales Managers, Service Managers, Parts Managers	FROM: Anthony Washington, Department Manager, Regulatory Mgmt & Campaigns Vans
RE: <b>Recall Campaign 2018110007</b> <b>Replace Front Passenger-side Airbag MY15 Freightliner and Mercedes-Benz Sprinters</b>	DATE: August 16, 2019

<b>Campaign No. :</b>	<b>Campaign Desc. :</b>	<b>Takata Recall Notification – Passenger-side Airbag</b>
<b>2018110007</b>	<b>NCV3TAKAGA</b>	
<p>This is to notify you of the upcoming <b>Recall Campaign</b> to replace the Passenger-side Airbag on approximately <b>26,829</b> MY15 Freightliner and Mercedes-Benz Sprinter vehicles. The recall campaign will be visible on the <a href="http://www.safercar.gov">www.safercar.gov</a> website and may generate questions from customers. All affected VINs will be flagged as “OPEN” in VMI by August 30, 2019.</p>		
<b>Background</b>		
<b>Issue</b>	<p>The passenger-side airbag is affected by this recall based on the defect decision of TK Holdings, Inc. (“Takata”). Under certain circumstances during a crash that necessitates frontal airbag deployment, the defect in the passenger-side airbag inflator housing may cause the inf

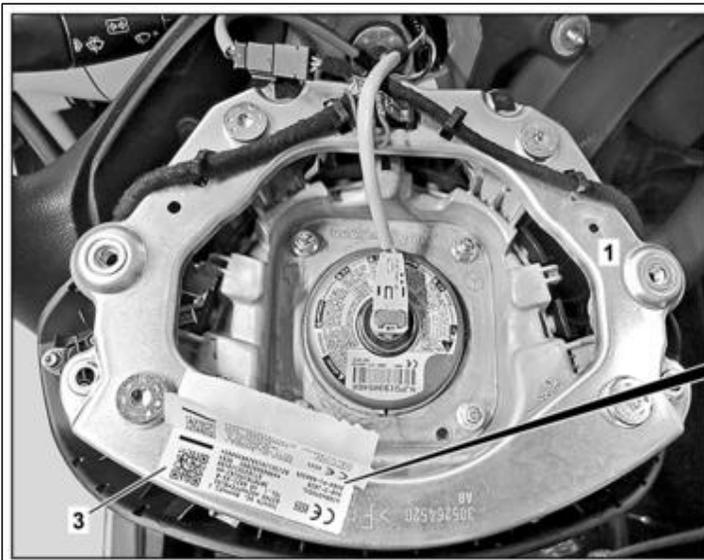
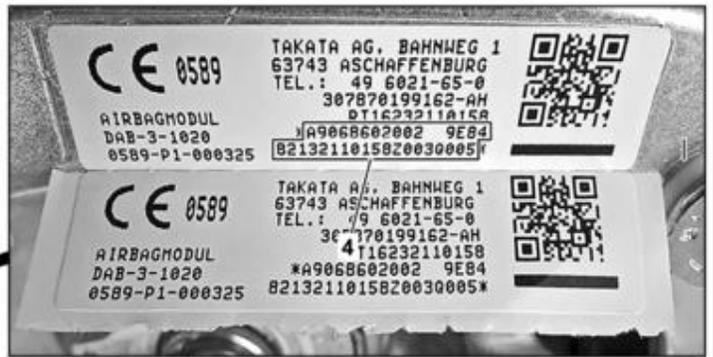
**Shown on driver airbag (1)**

1 Driver airbag

3 Adhesive label

4 Serial number

The serial number (4) consists of the following information:

- A-object number (e.g. A906860200005)
- Color number (e.g. 9051)
- Sequential number (e.g. 831716400752001)
- Q-status (e.g. Q001)

This information must be read off the adhesive label (3) and entered consecutively without spaces (e.g. A906860200005905183171640075001Q001) as the serial number (4).

1 Document the serial number (4) of the removed driver airbag (1) or of the removed front passenger airbag (2) using "Mercedes-Benz Part Scan".

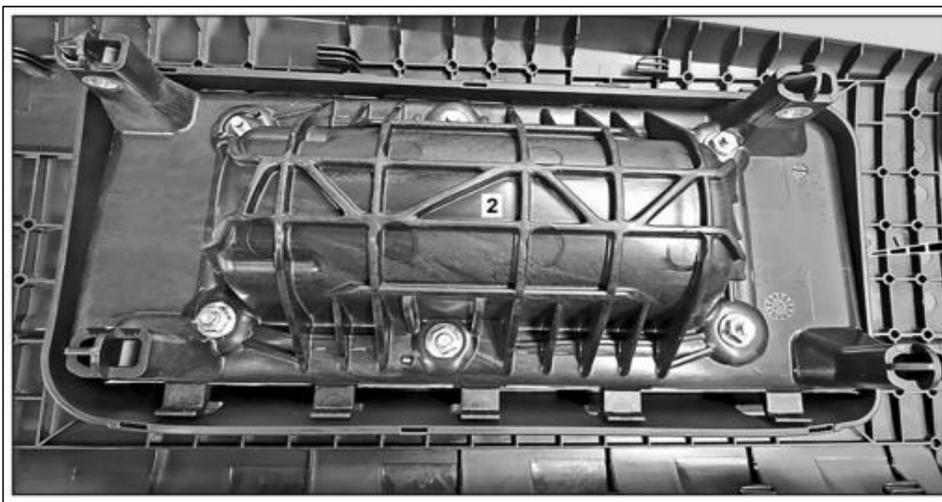
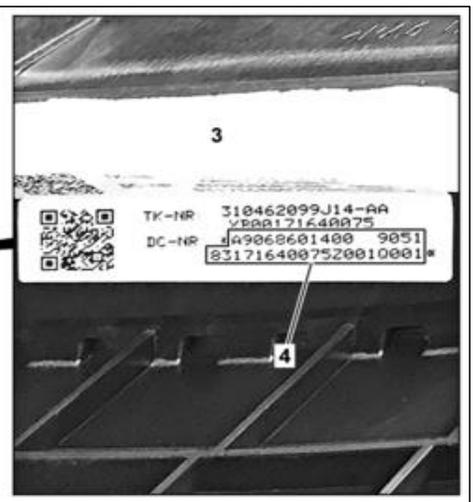
**Shown on front passenger airbag (2)**

2 Front passenger airbag

4 Serial number

3 Adhesive label

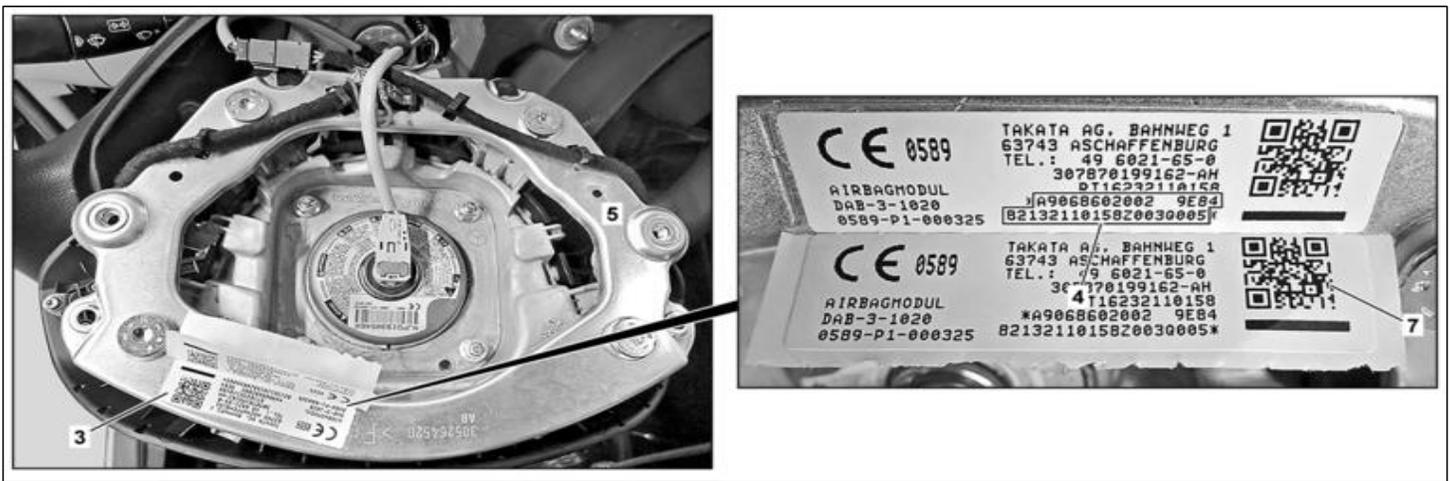
**Shown on new driver airbag (5)**

- 3 Adhesive label
- 4 Serial number

- 5 New driver airbag
- 7 QR code

Document the new driver airbag (5) or the new front passenger airbag (6) using "Mercedes-Benz Part Scan".

To do this, scan the serial number (4) on the adhesive label (3) with the QR code (7) on the new driver airbag (4) or the new front passenger airbag (6). If necessary, the serial number (4) of the new driver airbag (5) or of the new front passenger airbag (6) can also be documented manually using the keypad. To do this, read off the serial number (4) on the adhesive label (3) on the new driver airbag (5) or the new front passenger airbag (6) and enter it manually in the application using the keypad.

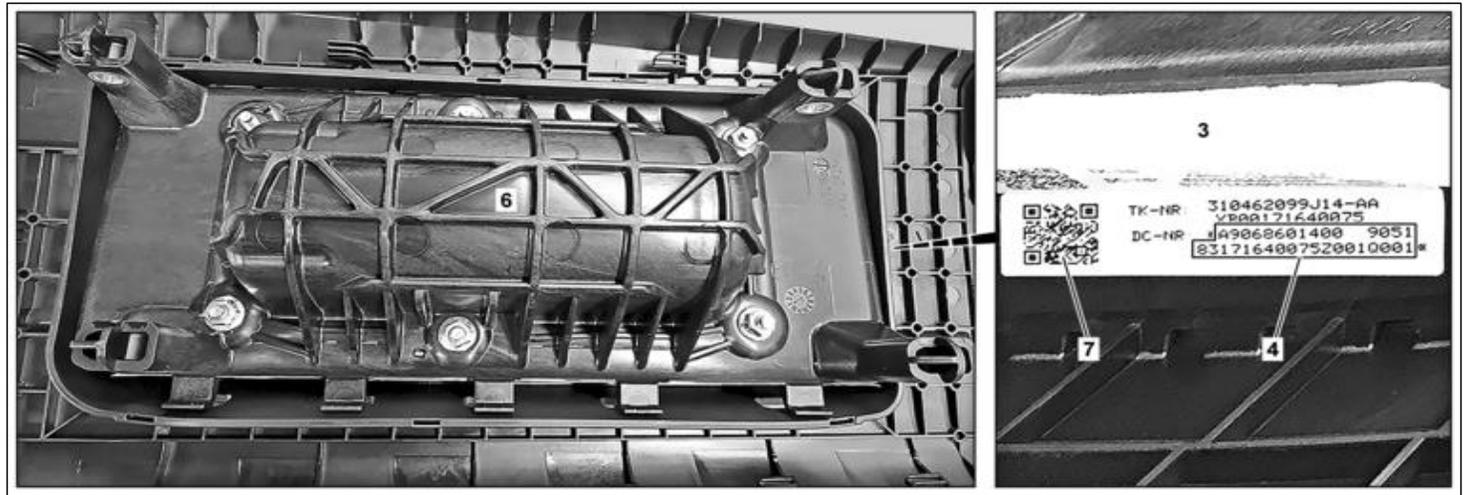
**Shown on new front passenger airbag (6)**

- 3 Adhesive label
- 4 Serial number

- 6 New front passenger airbag
- 7 QR code
