## TECHNICAL INSTRUCTIONS FOR SAFETY RECALL G0P/G0R/H0A FRONT PASSENGER AIRBAG INFLATOR MODULE CERTAIN 2010-2016 MY 4Runner

### UPDATE 1-11-2019

The subject vehicles are equipped with front passenger airbag inflators produced by Takata. According to Takata, the propellant in these inflators may degrade after prolonged exposure to high absolute humidity and fluctuating high temperatures. Degraded propellant can cause inflator rupture during airbag deployment. In the event of an inflator rupture, metal fragments could pass through the airbag cushion material, striking the vehicle occupants, and result in serious injury or death.

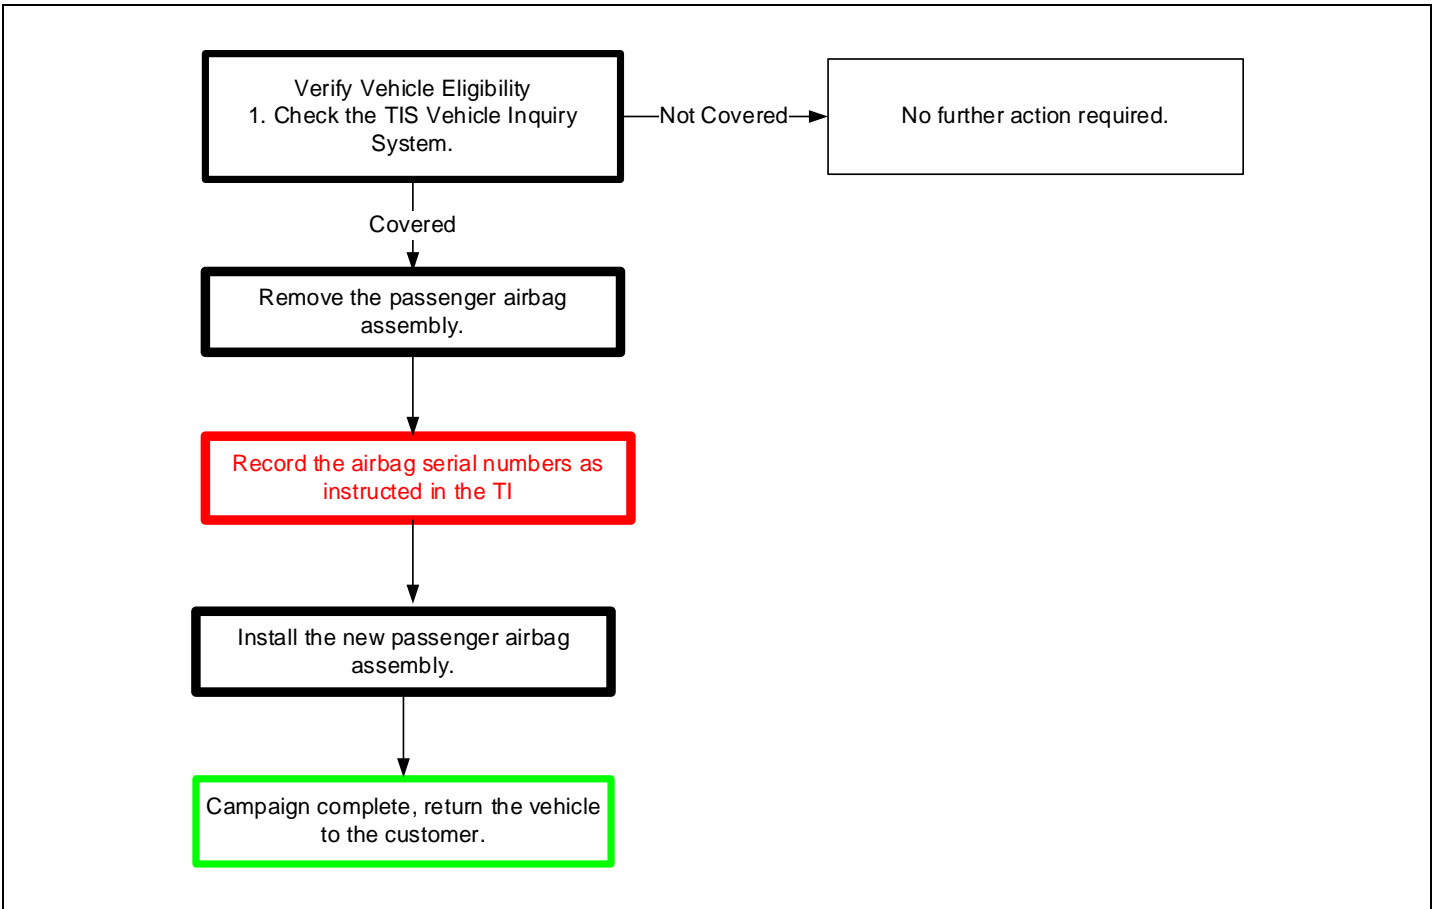
## I. OPERATION FLOW CHART

The flow chart is for reference only. **DO NOT** use it in place of the full technical instructions. Follow **ALL** steps as outlined in the full technical instructions to confirm the campaign is completed correctly.

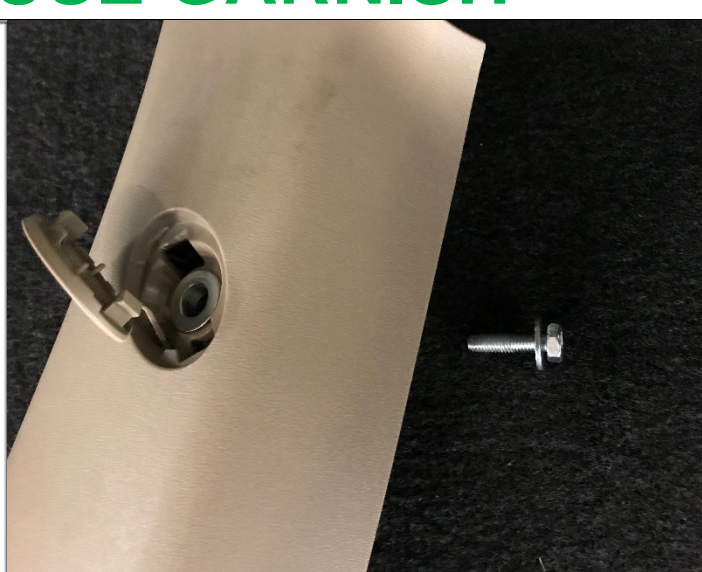
\*\*Only 2010 to Certain 2013 Model Year 4Runner vehicles require A-Pillar garnish replacement. If you have a 2013 – 2016 4Runner that contains an A- Pillar garnish that is bolted in at the top, the A-Pillar **DOES NOT** require replacement. See photos below for reference.

<b>REPLACE</b>	<b>RE-USE GARNISH</b>	
<p>Part manufactured before August 2013:</p>

<p style="color: red; text-align: center;">● FRONT PILLAR GARNISH LH</p>	<p>Part manufactured after August 2013:</p> <p>No. 1 FRONT PILLAR GARNISH COVER LH</p>   <p style="text-align: center;">FRONT PILLAR GARNISH LH</p>

**NOTE:** The left front A-Pillar garnish needs to be replaced on vehicles manufactured prior to August 2013. Only one garnish is required per vehicle depending upon color code. The kit contains the garnish and the non-reusable clip. (see parts information)

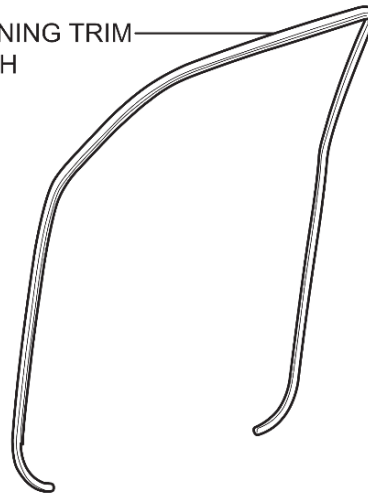
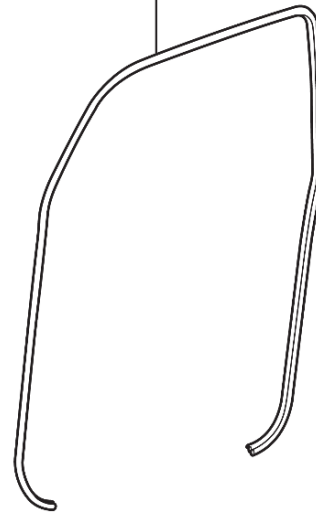
R1703160011

**CAUTION-PLASTIC RETAINING CLIPS ARE FRAGILE. REMOVE WITH CARE**

FRONT PILLAR  
GARNISH RH

FRONT DOOR OPENING TRIM  
WEATHERSTRIP RH

Part manufactured  
before August 2013:

● FRONT PILLAR  
GARNISH LH

Part manufactured  
after August 2013:

No. 1 FRONT PILLAR  
GARNISH COVER LH

FRONT PILLAR  
GARNISH LH

● Replacement part

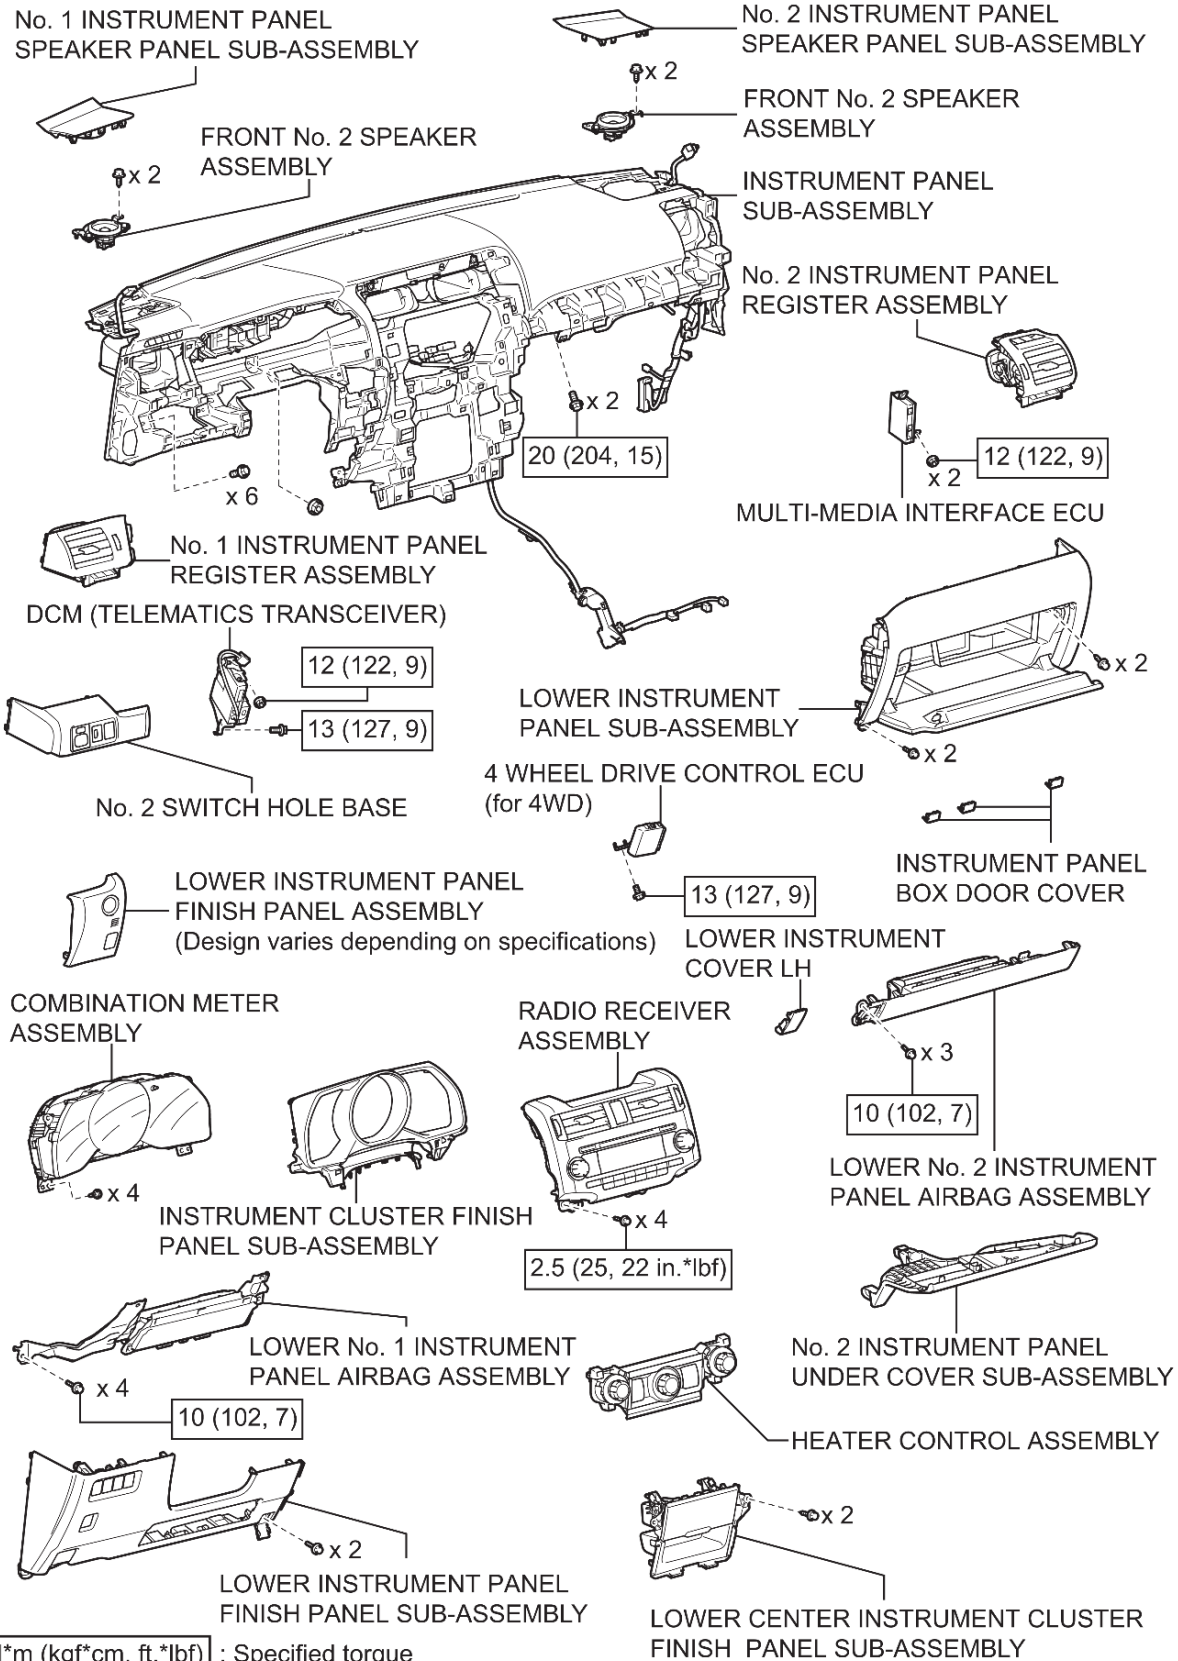
R1703160012

**CAUTION-PLASTIC RETAINING CLIPS ARE FRAGILE. REMOVE WITH CARE**

N\*m (kgf\*cm, ft.\*lbf) : Specified torque

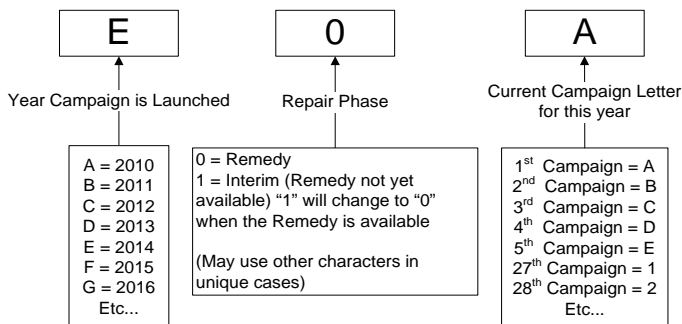
### A. CAMPAIGN DESIGNATION DECODER

Examples:

A0D = Launched in 2010, Remedy Phase, 4<sup>th</sup> Campaign Launched in 2010

B1E = Launched in 2011, Interim Phase, 5<sup>th</sup> Campaign Launched in 2011

C1C = Launched in 2012, Interim Phase, 3<sup>rd</sup> Campaign Launched in 2012
