**TECHNICAL INSTRUCTIONS**  
**FOR**  
**SAFETY RECALL GLG/GLH/HLA**  
**FRONT PASSENGER AIRBAG MODULE**  
**CERTAIN 2010-2017 MY GX 460**  
**UPDATED 1-15-2019**

The subject vehicles are equipped with front passenger airbag inflators produced by Takata. The propellant in these inflators may degrade after prolonged exposure to high absolute humidity and fluctuating high temperatures. Degraded propellant can cause inflator rupture during airbag deployment. In the event of an inflator rupture, metal fragments could pass through the airbag cushion material, striking the vehicle occupants, and result in serious injury or death.

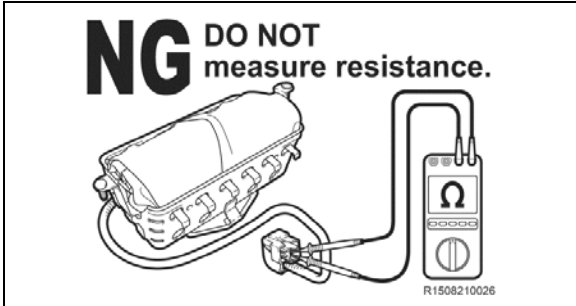
#### 2. DO NOT MEASURE RESISTANCE

- a) **NEVER** measure the resistance of an airbag, this may cause accidental activation.

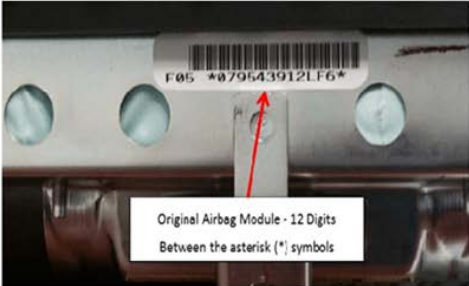
#### Airbag Serial Number Label Example

- The airbag serial number is **ALWAYS** the 12 **DIGITS** located between the asterisks.
- The 3 digits before the asterisk **ARE NOT** part of the serial number, and **SHOULD NOT** be entered or an inaccurate response may be returned.

Original Airbag Module - 12 Digits  
Between the asterisk (\*) symbols

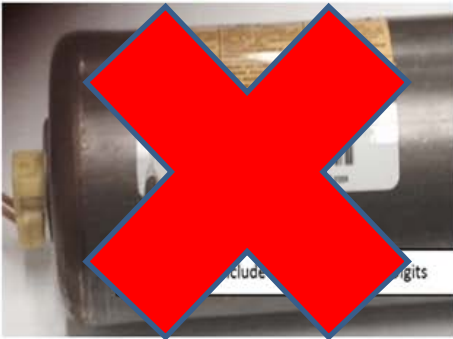
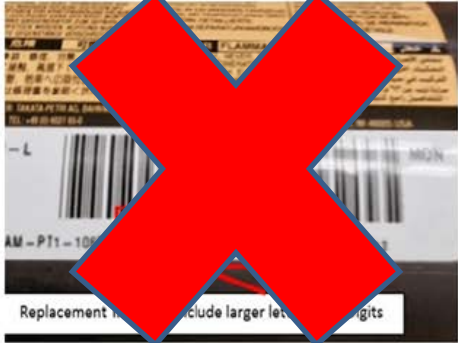
How to Identify the Inflator serial code on the Original and Replacement Inflator can?

The Inflator serial code is an **11 digit code** on the Inflator can. It can be found with a bar code on removing the Inflator can from the Airbag Assembly unit.

The first two characters of the **Original Inflator Serial code** will be from [AA, AB, AJ, FD or JD].

The first two characters of the **Replacement Inflator Serial code** will be either 'LT' or 'LR'.
