IMPORTANT UPDATE

TECHNICAL INSTRUCTIONS FOR SAFETY RECALL GLG/GLH/HLA FRONT PASSENGER AIRBAG INFLATOR REPLACEMENT CERTAIN 2010-2015 MY IS 250/350 CONVERTIBLE

UPDATED 1-9-2019

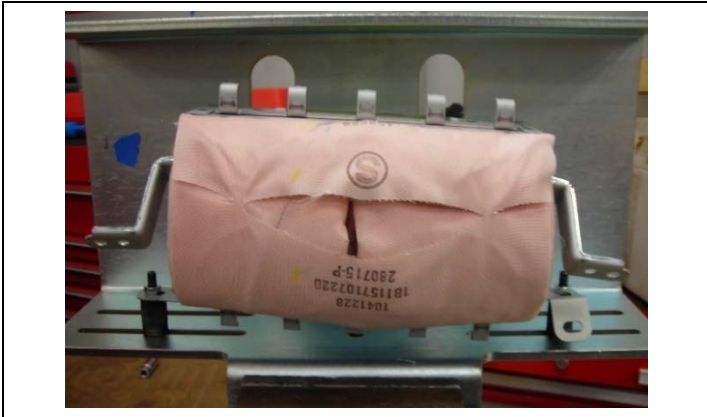
b) Mount the adaptors (579943-3R3) to the airbag as shown.

NOTE: The 6mm stud mounts to the airbag.

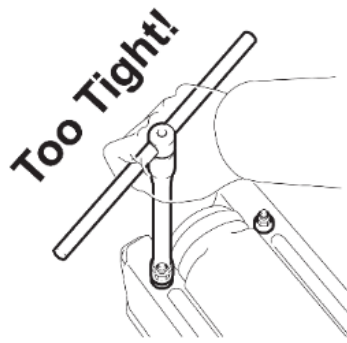
NG

Too Tight!

These tools cause overtightening !
