## TECHNICAL INSTRUCTIONS FOR SAFETY RECALL GLG/GLH/HLA

### FRONT PASSENGER AIRBAG INFLATOR REPLACEMENT CERTAIN 2006 – 2013 MY IS 250/350 and 2008 – 2014 MY IS F

#### UPDATE 1-15-2019

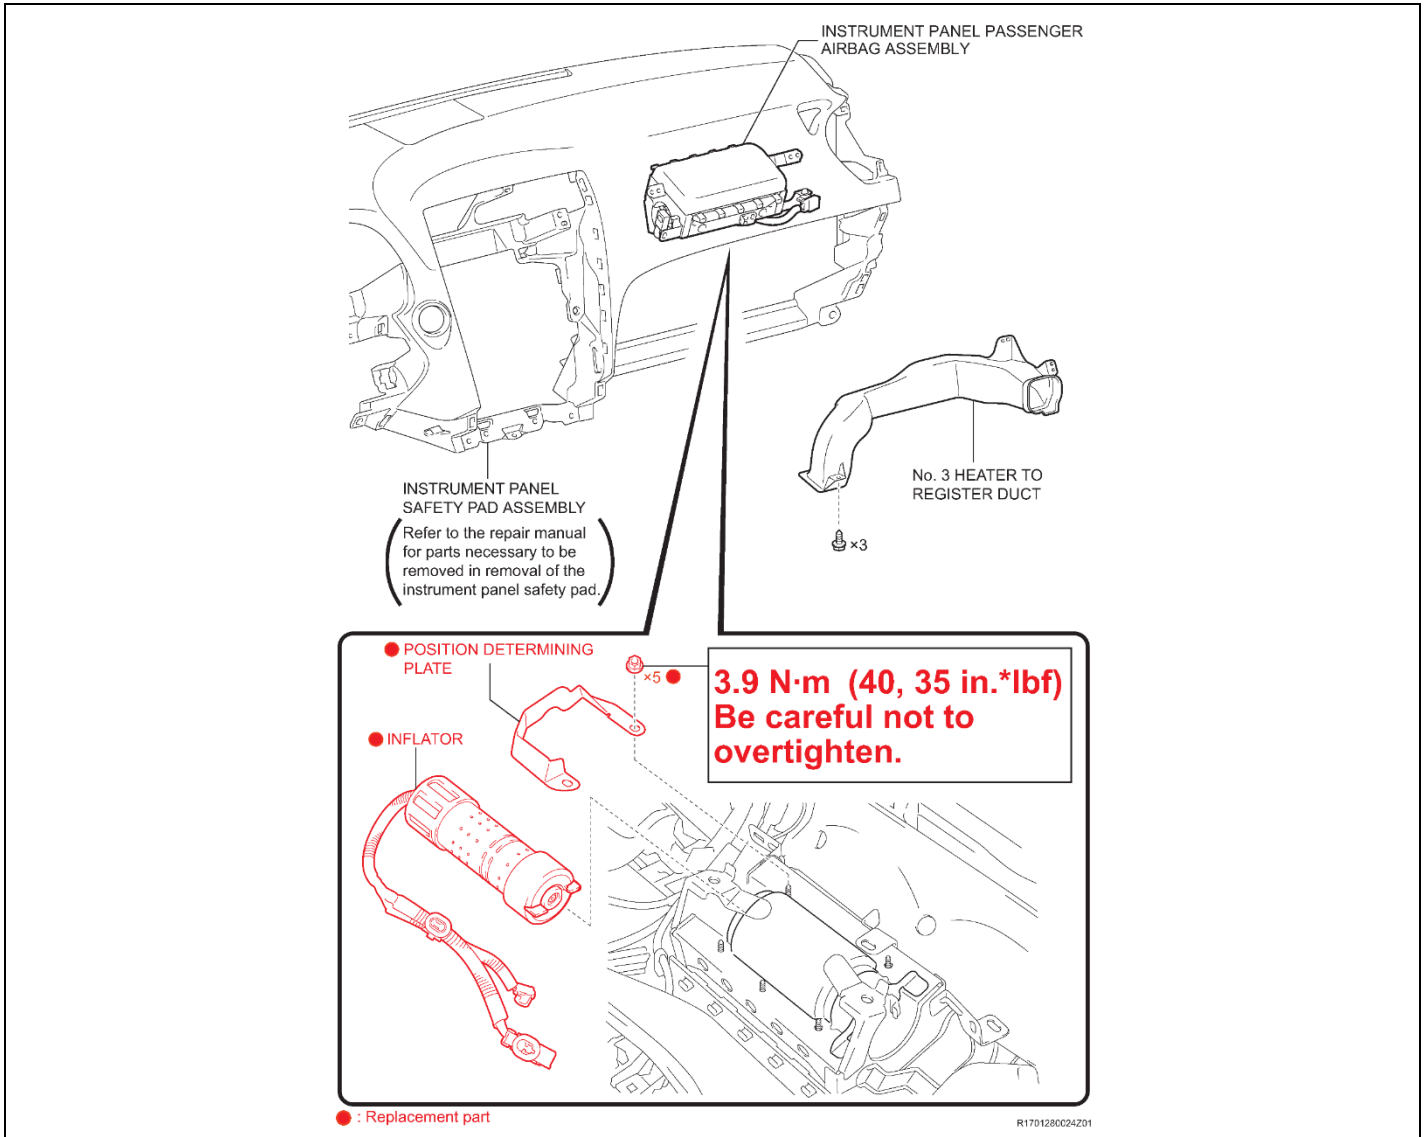
- a) Remove the 3 screws and the side defroster nozzle.
- b) Remove the 2 screws and the heater to register duct.
