**April 30, 2019**

## Safety Recall: 2017-19 Ridgeline Fuel Tank Unit Cracks or Leak Inspection

Supersedes 19-013, dated January 25, 2019, see REVISION SUMMARY.

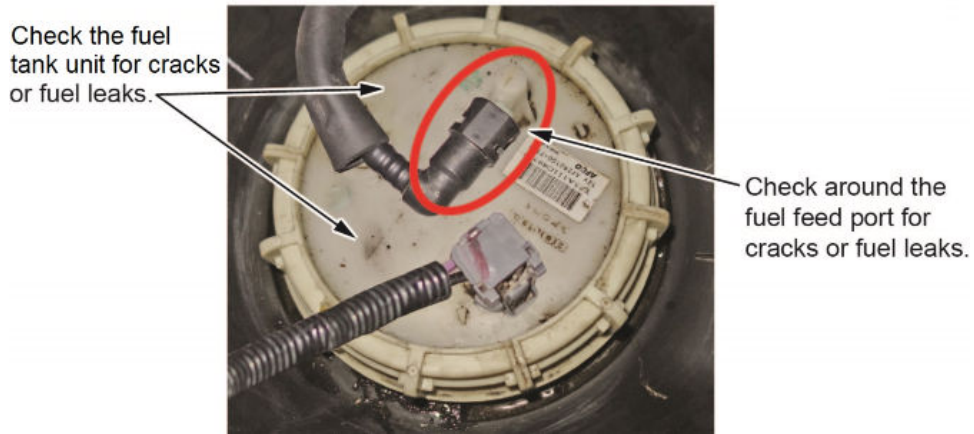
6. Relieve the fuel pressure; refer to the service information.
7. Remove the fuel line, and check for cracks at the fuel feed port.
  - If no leaks or cracks are found, install the fuel pump cover kit.
  - If the fuel tank unit is leaking and/or cracks are found, replace the fuel tank unit and install the fuel pump cover kit. Refer to the service information.

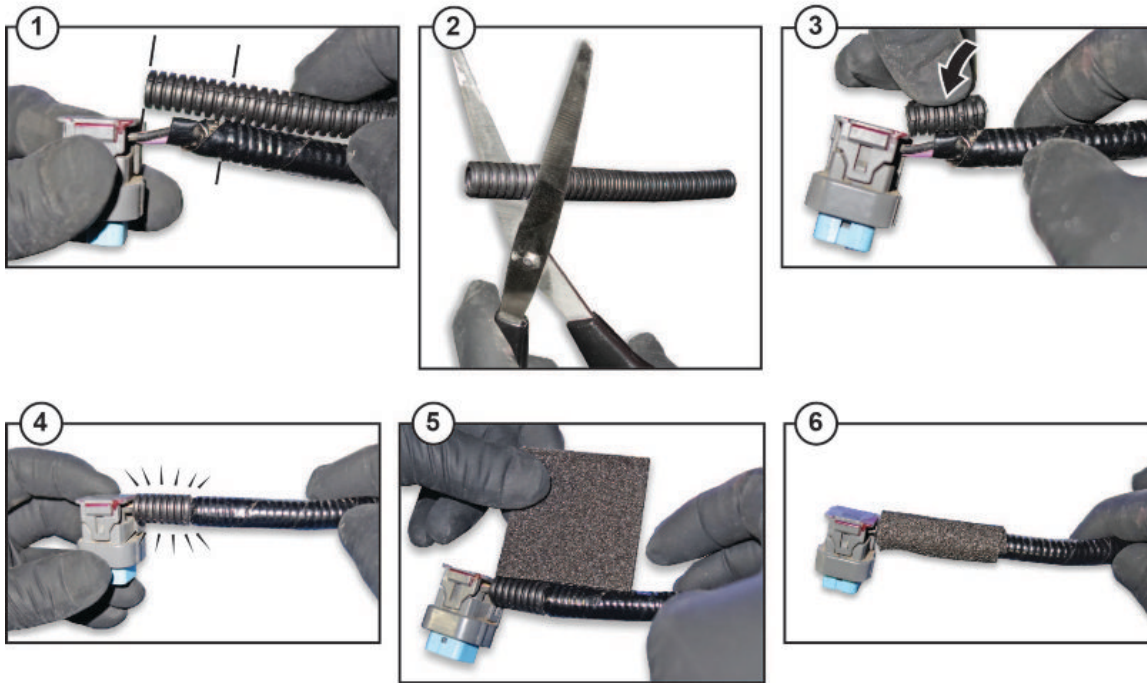
9. Place the corrugated tubing next to the connector and the corrugated tube on the wiring harness, and cut to fit as shown. Then, wrap a piece of EPT foam tape around the area as shown.

If the corrugated tubing is already against the connector, this step is not needed.

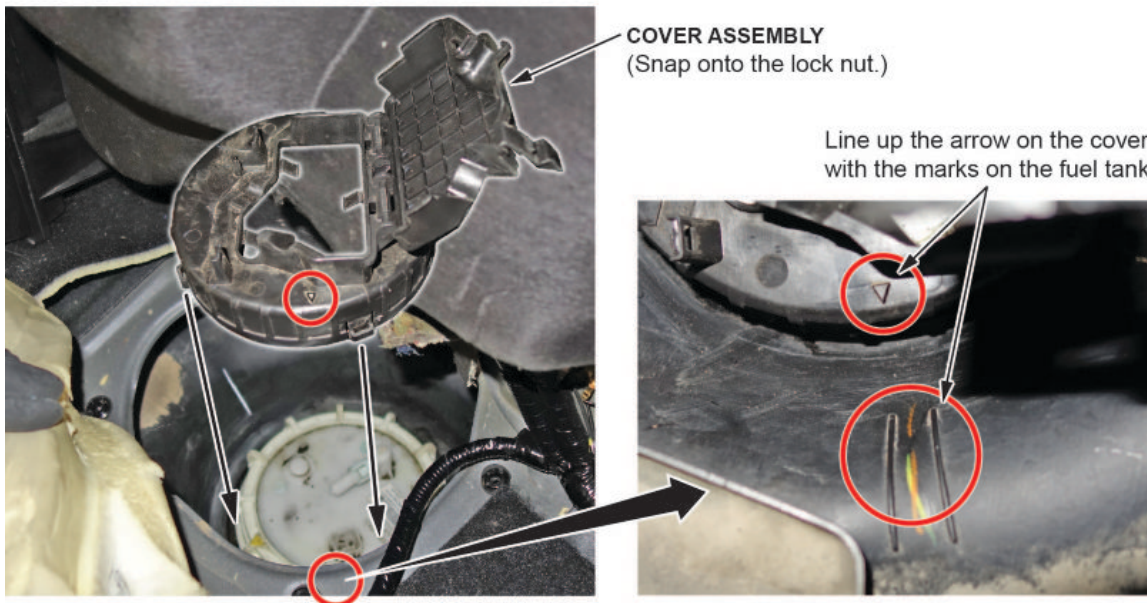
10. Install the cover assembly, and make sure the arrow on the cover lines up with the marks on the fuel tank and the cover assembly is fully snapped onto the lock nut.

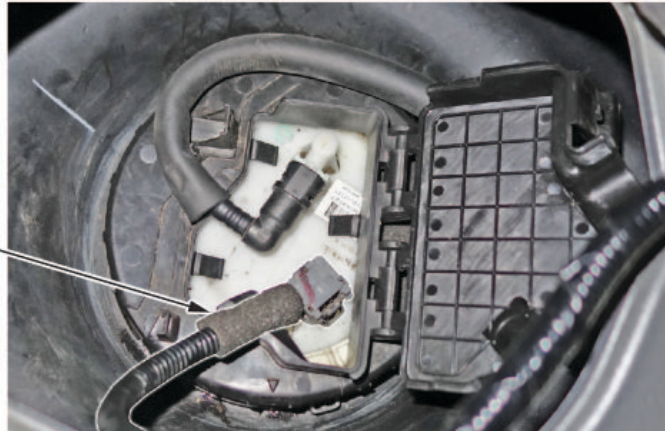
11. Connect the fuel line and the connector as shown.

Reconnect the connector and route across the cover as shown.

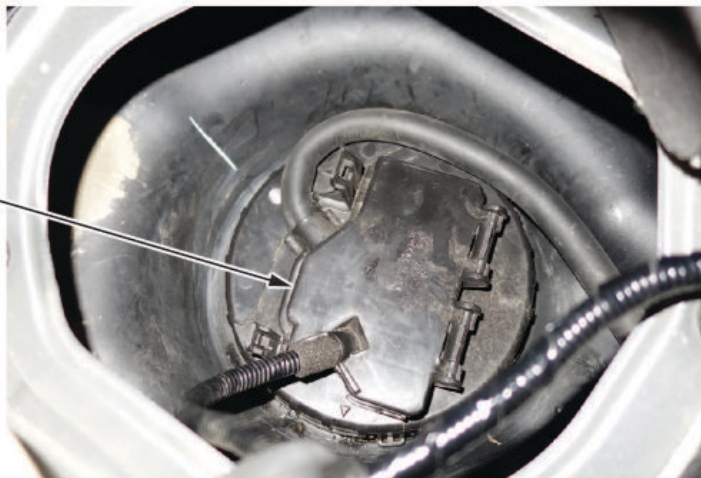
13. Close the lid on the cover assembly.

Close the cover lid.
