Keystone RV Company

SAFETY ADVISORY # 19-341

Montana 3855BR Slide Ram

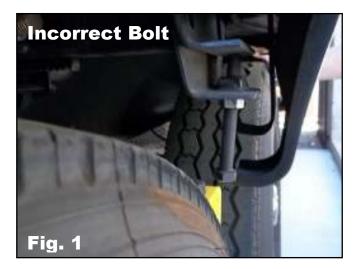
If there is less than 2 $\frac{3}{4}$ " of space between the bolt head and tire replace the bolt with the part number provided above. See Figure 1 for incorrect bolt and Figure 2 for correct bolt. Using a ratchet and $\frac{3}{4}$ " socket, remove the existing bolt. Start the new bolt by hand and finish with the ratchet, install the bolt firmly against the adjustment plate.

The remedy is to replace the incorrect length of adjustment bolt with a 2" bolt.

Inspect the tire for any physical damage and touch up /spray paint the bolt as needed.
