BULLETIN NUMBER:
CB19-N-001A

NONCOMPLIANCE RECALL

INCORRECT ODOMETER DISPLAY INSPECTION AND REPLACEMENT 19V-064 (Transport Canada 2019-052)

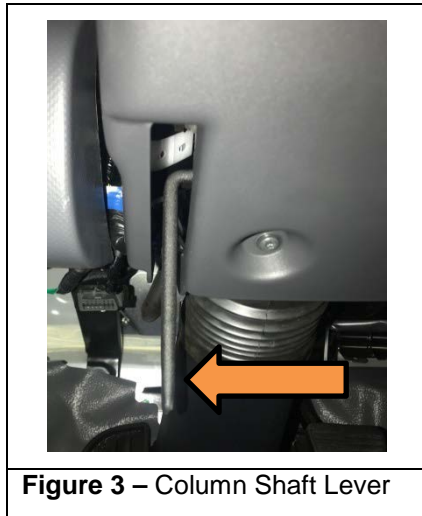
2. Block the vehicle wheels and apply the parking brake.
3. Disconnect the battery ground (-) cable.
4. Pull the column shaft lever to the front and adjust the column angle. Ensure the column shaft lever is locked in place. (See Figure 3.)

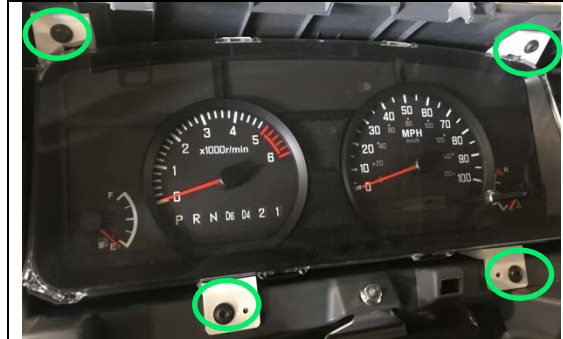
Figure 5 – Remove Torx® Bolts

a. Remove the four (4) Torx® bolts (T25) and set aside for reuse. (See Figure 5.)

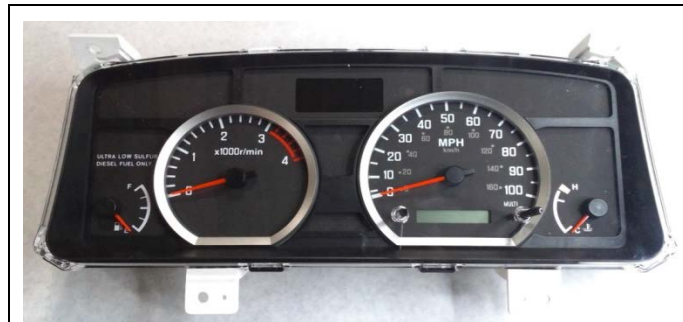
Figure 6 – New IP Cluster

7. Install the new IP cluster assembly. (See Figure 6.)

a. Connect the cab harness connectors.

b. Reinstall the four (4) Torx® bolts (T25).

NOTE: Be careful not to pinch the harness between the IP cluster assembly and the instrument panel.
