F/CMVSS Noncompliance Recall

N192212270 Incorrect Odometer Display

Release Date: February 2019

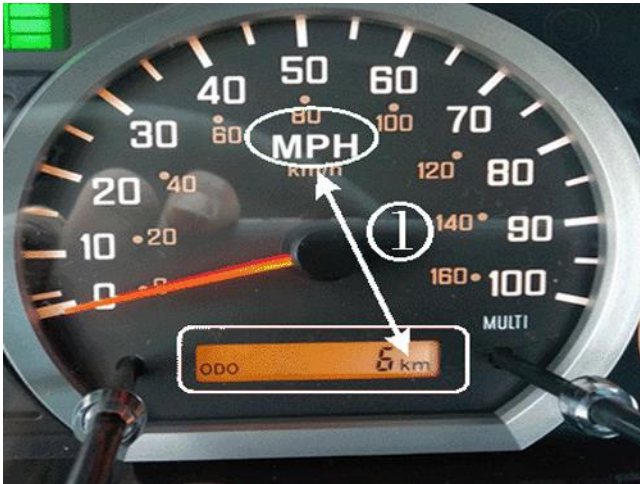
5227315

1. From the driver's side, press the odometer switch to display the odometer reading.
 - 1.1. If the odometer reading matches the instrument cluster (for example, "MI" on the display and "MPH" on the instrument cluster), instrument cluster assembly replacement is NOT required. No further action required.
 - 1.2. If the odometer reading does not match the instrument cluster (See Figure 1), the instrument cluster assembly MUST be replaced. Proceed to Step 2.
2. Block the vehicle wheels and apply the parking brake.
3. Disconnect the negative battery cable.

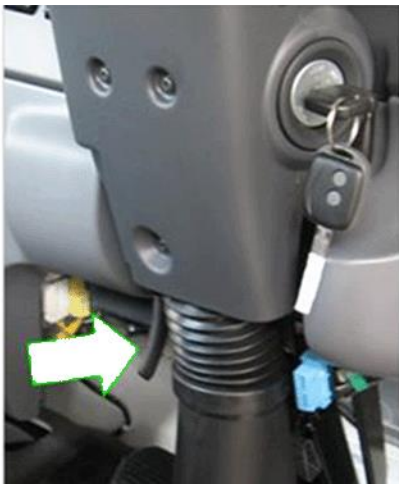
5227317

4. Pull the column shaft lever to the front and adjust the column angle. Ensure the column shaft lever is locked in place.

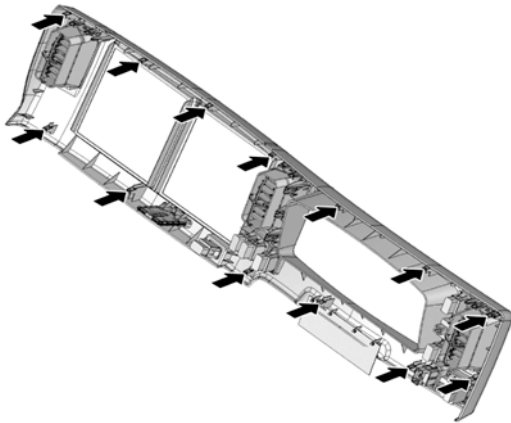
5227319

5. Remove the instrument cluster bezel.

Important: Be careful when removing as to not scratch the bezel or damage the connectors.

- 5.1. Remove the bezel at the 13 clip positions.

- 5.2. Disconnect the cab harness connectors.

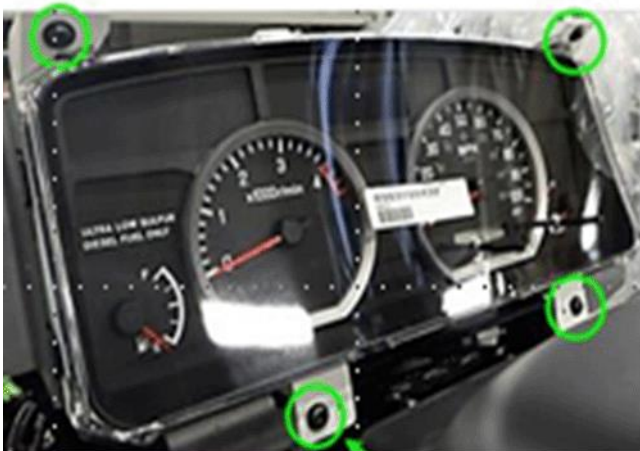
5227320

6. Remove the incorrect instrument cluster assembly and discard.

- 6.1. Remove the four (4) Torx® bolts (T25) and set aside for reuse.

- 6.2. Disconnect the cab harness connectors.

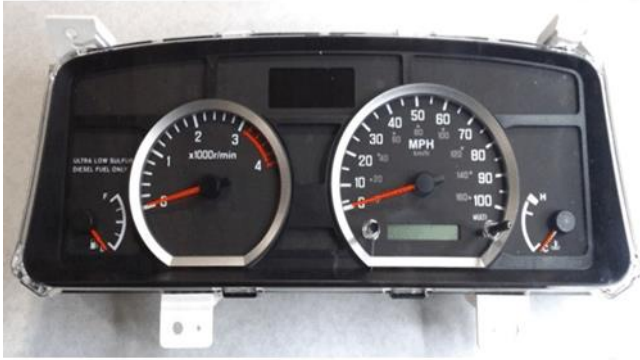
5227321

7. Install the new instrument cluster assembly.

Important: Be careful to not pinch the harness between the IP cluster assembly and the instrument.

- 7.1. Connect the cab harness connectors
- 7.2. Install the four (4) Torx® bolts (T25).

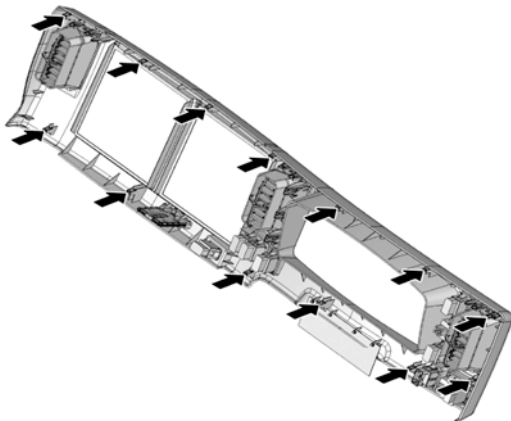
5227319

8. Install the instrument cluster bezel.

Important: Be careful when reinstalling to not scratch the bezel or damage the connectors.

- 8.1. Connect the cab harness connectors.
- 8.2. Push and install the IP cluster bezel at its thirteen (13) clip positions.
9. Connect the negative battery cable.
10. Press the odometer switch to display the odometer reading and confirm it matches to the new instrument cluster.
