# SAFETY RECALL V07 ADJUSTABLE BRAKE PEDAL REINFORCEMENT OF REPAIR PROCEDURE

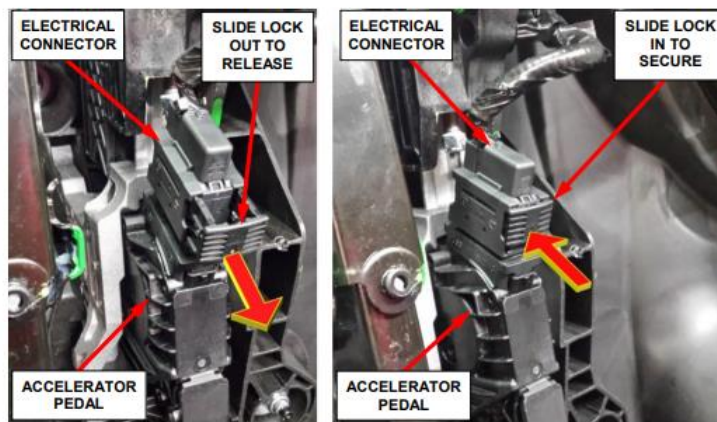
Figure 5 – Accelerator Pedal Electrical Connector Slide Lock Style

3. Disconnect the electrical connector from the accelerator pedal (Figures 5, 6).  
**NOTE: This is a slide style connector.**

Please pay special attention to step 3 on page 6 of the Dealer Instructions. If the electrical connector is not disconnected this could cause difficulty in getting the pedal to align properly for reassembly.

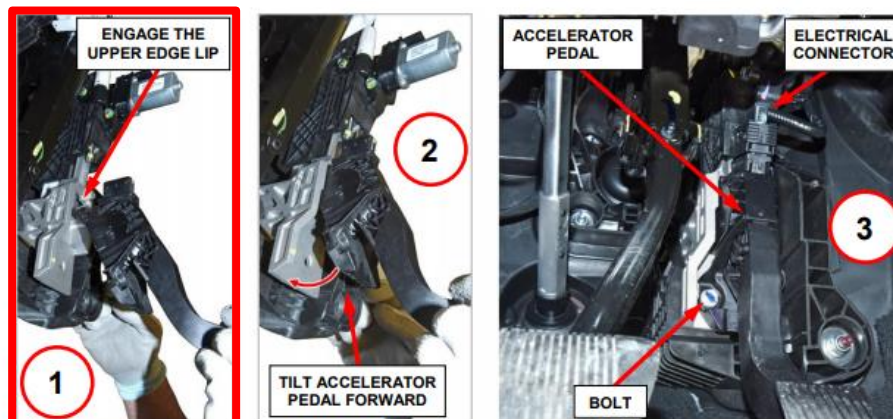
Figure 11 – Install Accelerator Pedal to Adjustable Pedal Assembly

12. Connect the accelerator pedal electrical connector (Figure 11).

When performing step 12 on page 9 of the Dealer Instructions it is important to ensure that per figure 11 the “Upper Edge Lip” is fully engaged. Failure to do so could result in the pedal not having the intended clearance between it and the floor mat.
