SAFETY BULLETIN

Communication #: T-18-01

Model Year(s): 2015-2019

SUBJECT: SEAT BASE FRAME INSPECTION / REPLACEMENT

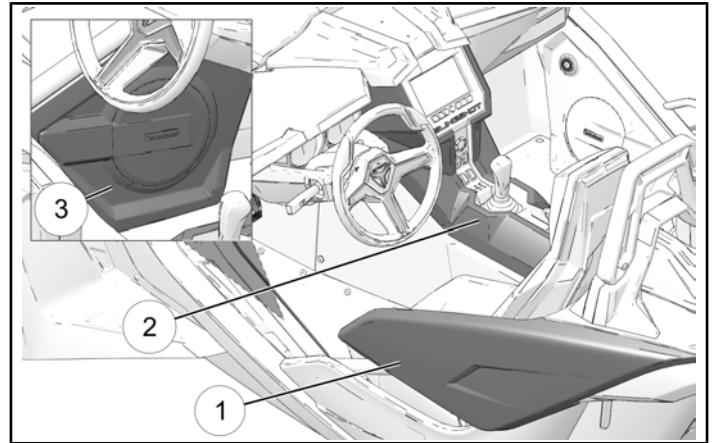
- Park vehicle on a flat and level surface. Keep transmission in gear. Set parking brake. Turn key to "OFF" position and remove from vehicle.
- Cover Wing Panel ① Center Console ②, and Speaker Surround ③ with a protective mat to prevent cosmetic damage to panels and painted surfaces.

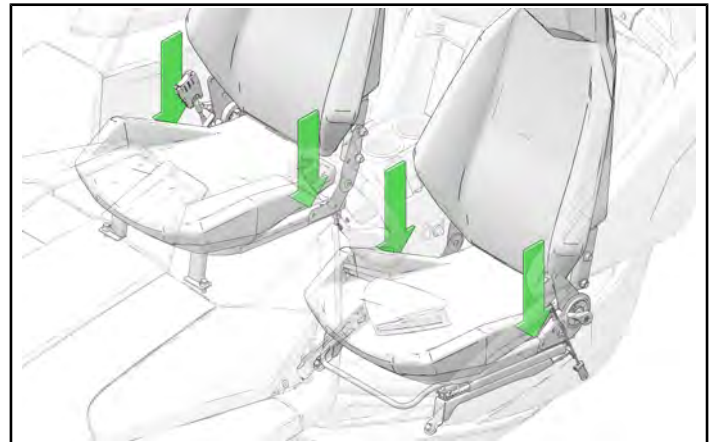
- Inspect for welds along both sides of the seat base as indicated by the arrows.

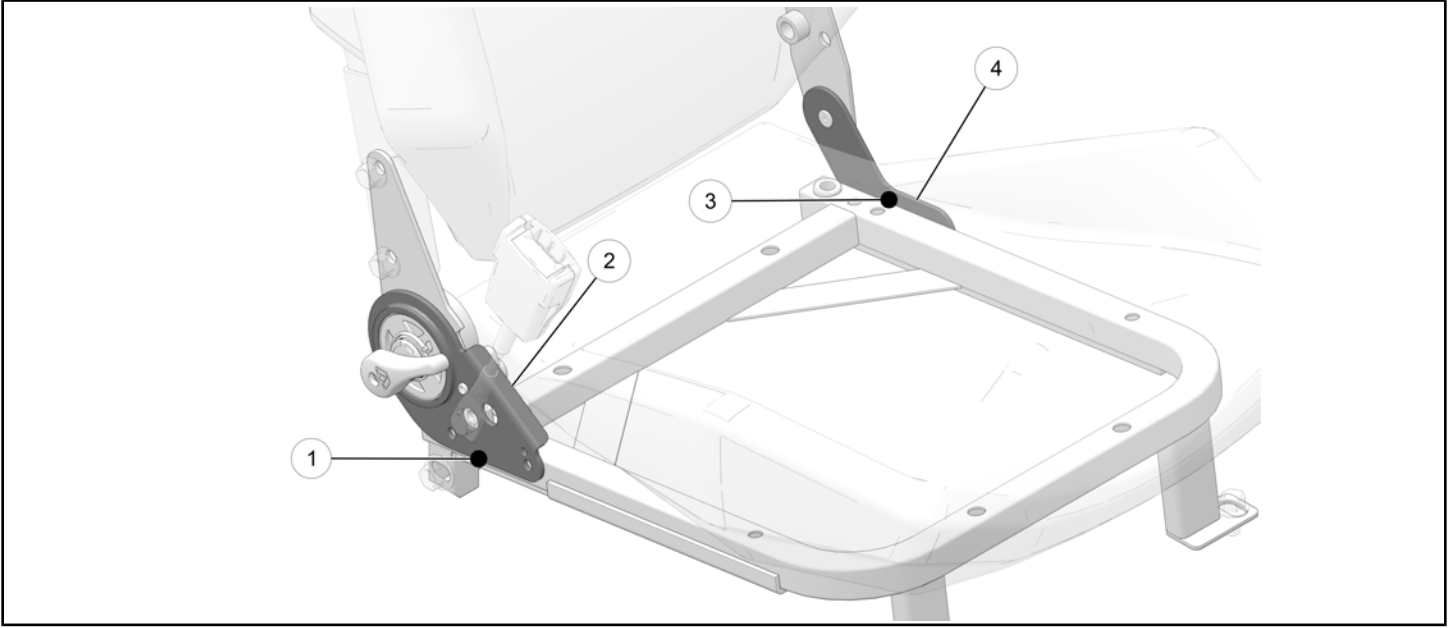
Passenger-Side Seat Base Frame Weld Inspection:

Each weld is unique, the length and size of the welds are not critical. If welds are present in the approximate locations specified, then the seat base frame passes inspection.

Visually inspect the passenger-side seat base frame using an inspection mirror and a flashlight at the locations shown below. See next page for examples of good and bad welds with locations matching the callout numbers ① - ④ below.

Welds must be present at all seat base frame locations. See next page for examples. If welds are missing, the seat MUST BE REPLACED.

- A** - Remove seat from vehicle. See page 19 for detailed seat removal instructions.
- B** - To gain access to welds, remove the seat base bottom cushion.

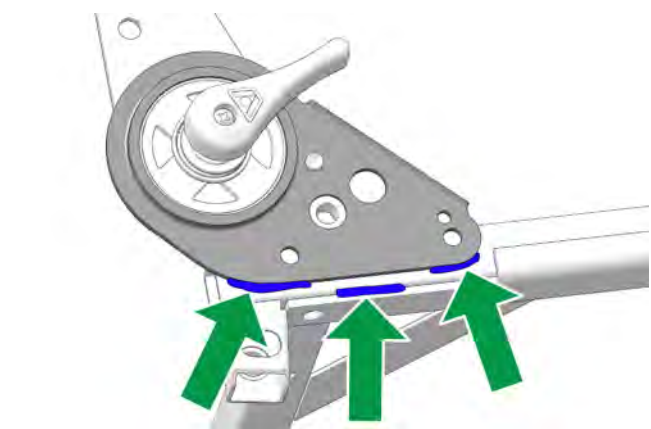
<p>Diagram 1 shows a close-up of a metal bracket attached to a frame. Three green arrows point to three distinct, continuous weld lines along the bottom edge of the bracket, indicating good welding.</p>

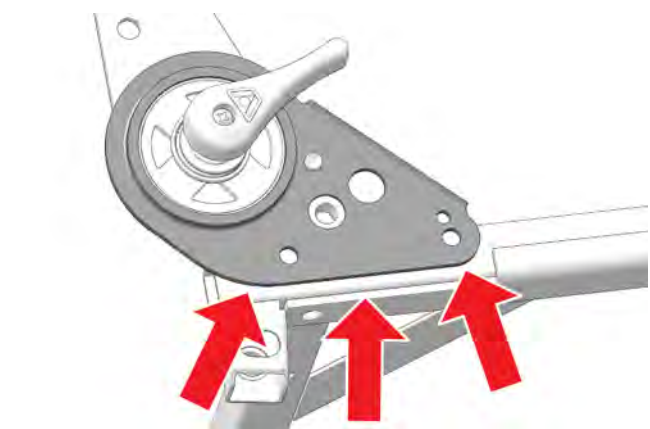
<p>Diagram 1 shows the same bracket and frame. Three red arrows point to gaps between the bracket and the frame, indicating missing welds.</p>
②

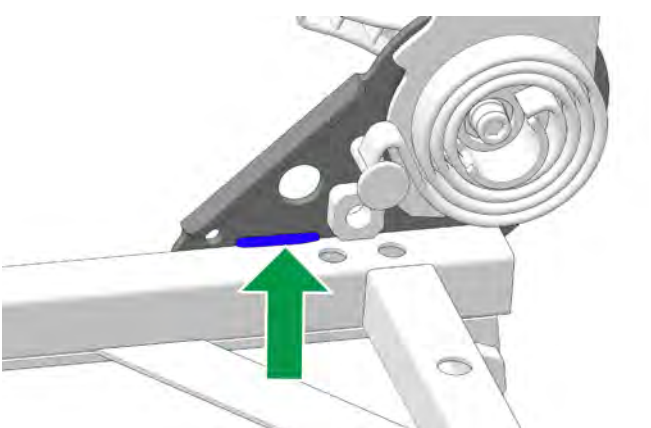
<p>Diagram 2 shows a different view of the bracket and frame. A single green arrow points to a continuous weld line, indicating a good weld.</p>

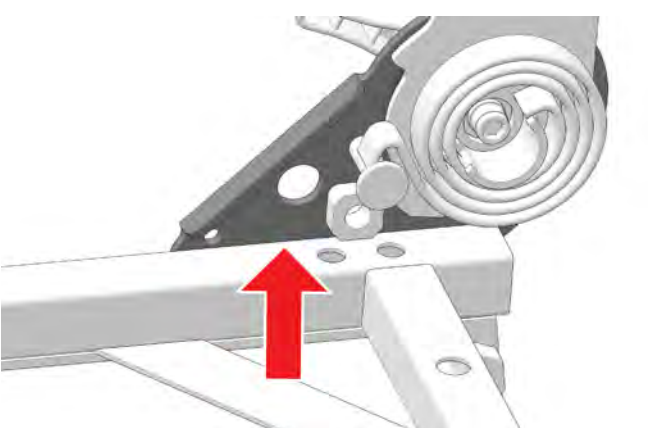
<p>Diagram 2 shows the same view. A single red arrow points to a gap between the bracket and the frame, indicating a missing weld.</p>
③

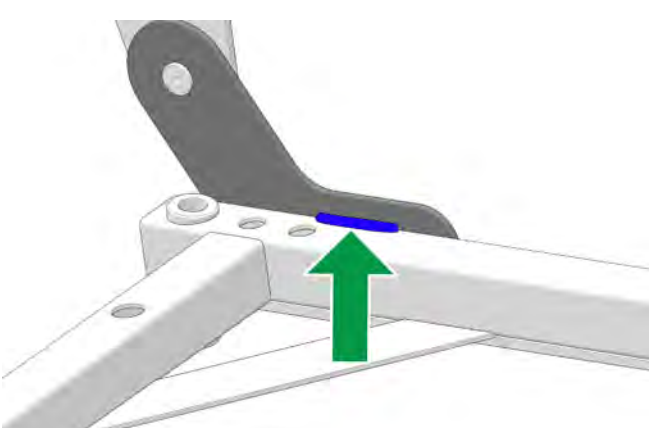
<p>Diagram 3 shows a close-up of the bracket's attachment point. A single green arrow points to a continuous weld line, indicating a good weld.</p>

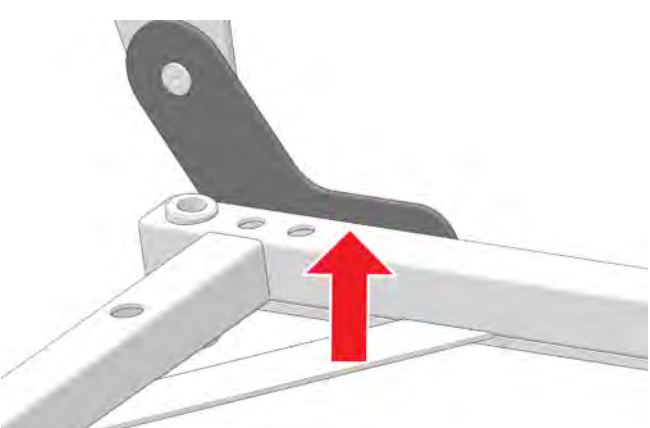
<p>Diagram 3 shows the same view. A single red arrow points to a gap between the bracket and the frame, indicating a missing weld.</p>

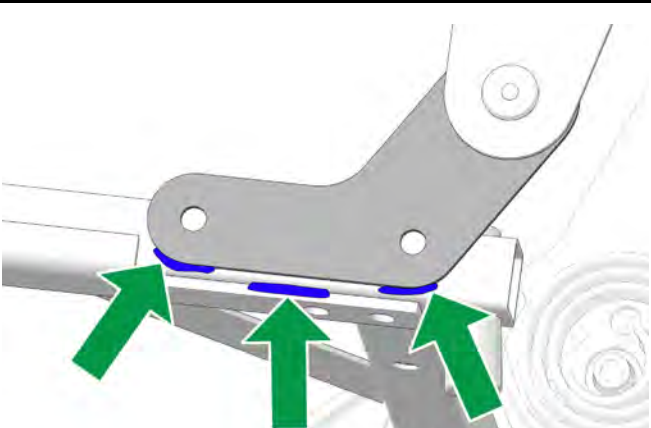
<p>Diagram 4 shows a close-up of the bracket's attachment point. Three green arrows point to three distinct, continuous weld lines, indicating good welding.</p>

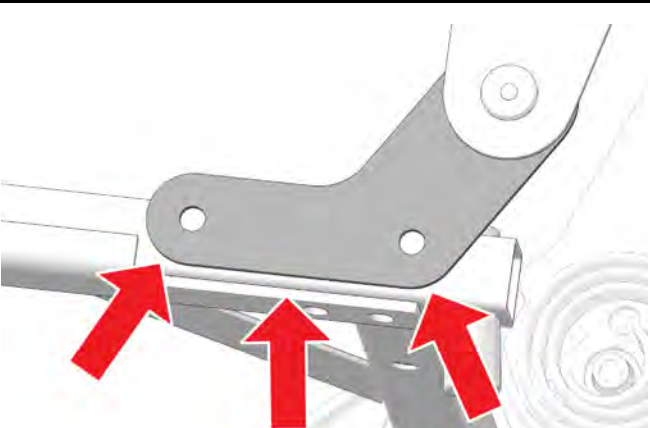
<p>Diagram 4 shows the same view. Three red arrows point to gaps between the bracket and the frame, indicating missing welds.</p>

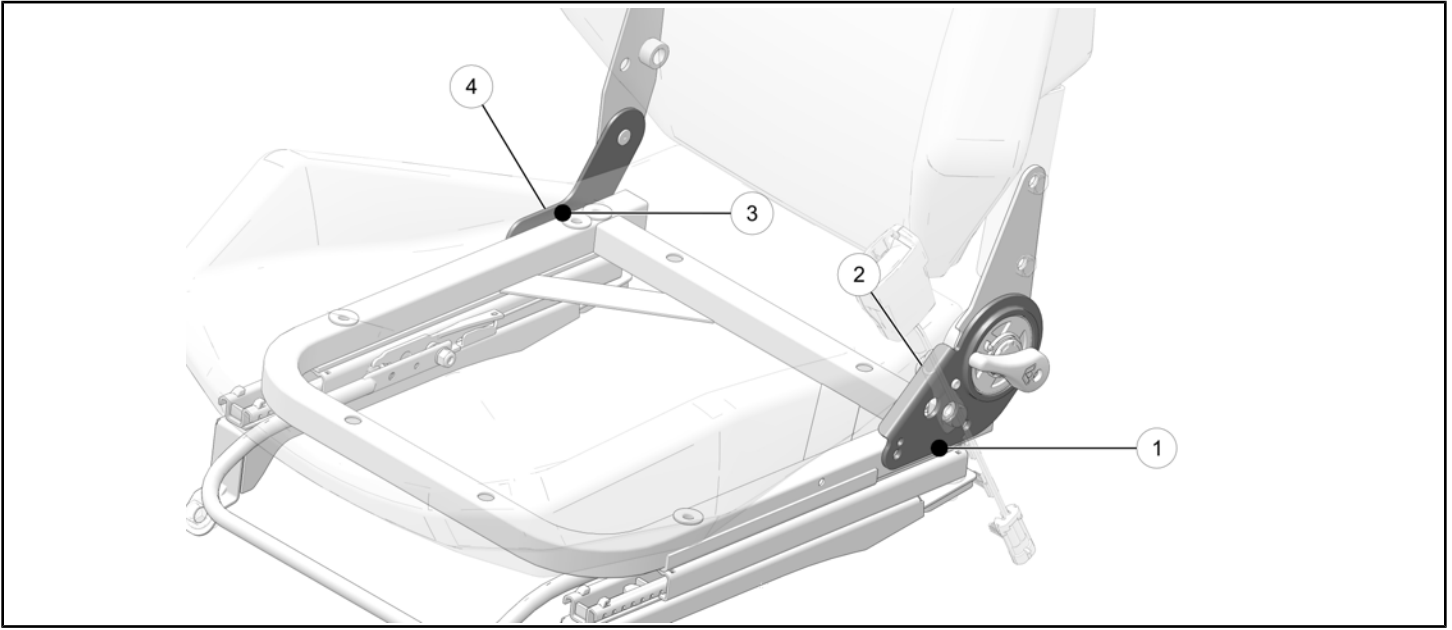
Driver-Side Seat Base Frame Weld Inspection:

Each weld is unique, the length and size of the welds are not critical. If welds are present in the approximate locations specified, then the seat base frame passes inspection.

Visually inspect the driver-side seat base frame using an inspection mirror and a flashlight at the locations shown below. See next page for examples of good and bad welds with locations matching the callout numbers ① - ④ below.

- If all welds are present on the driver-side seat base frame, perform the **Seat Slider Test** on page 11.

Welds must be present at all seat base frame locations. See next page for examples. If welds are missing, the seat MUST BE REPLACED.

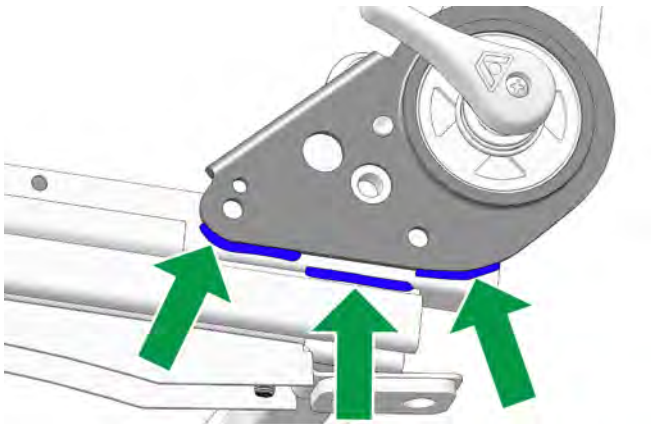
<p>Diagram 1 shows a close-up of a metal bracket assembly. Three green arrows point upwards to three distinct blue weld lines that are continuous and well-defined, indicating good welding quality.</p>

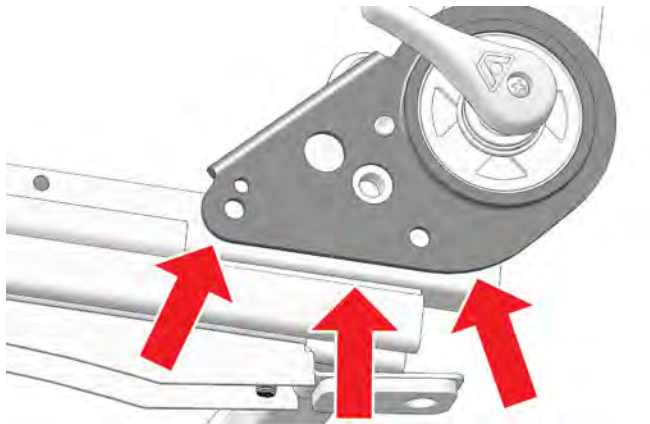
<p>Diagram 1 shows the same metal bracket assembly. Three red arrows point upwards to three locations where the welds are missing or incomplete, indicating poor welding quality.</p>
②

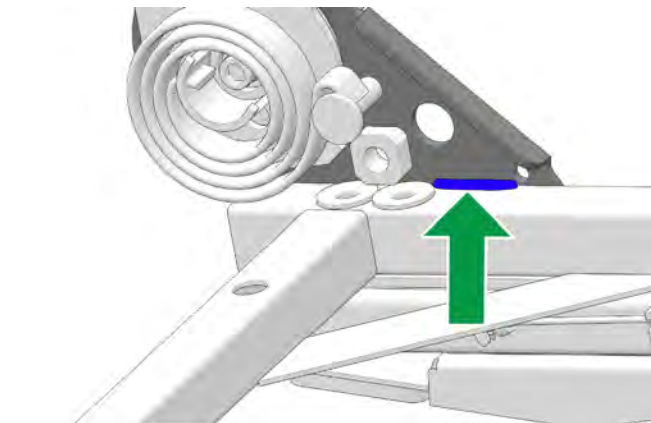
<p>Diagram 2 shows a close-up of a metal bracket assembly. A single green arrow points upwards to a single, continuous blue weld line, indicating a good weld.</p>

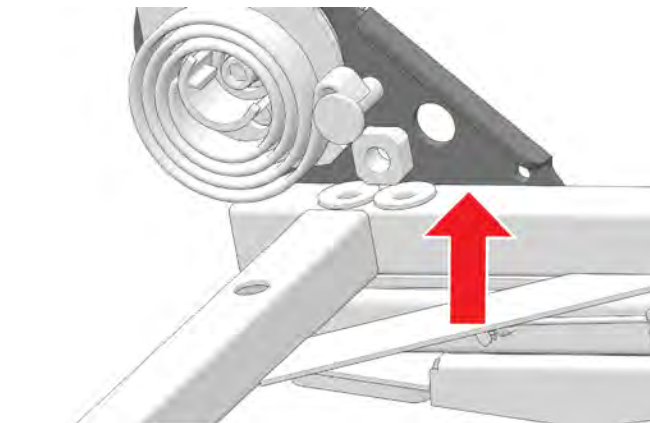
<p>Diagram 2 shows the same metal bracket assembly. A single red arrow points upwards to a location where the weld is missing, indicating a missing weld.</p>
③

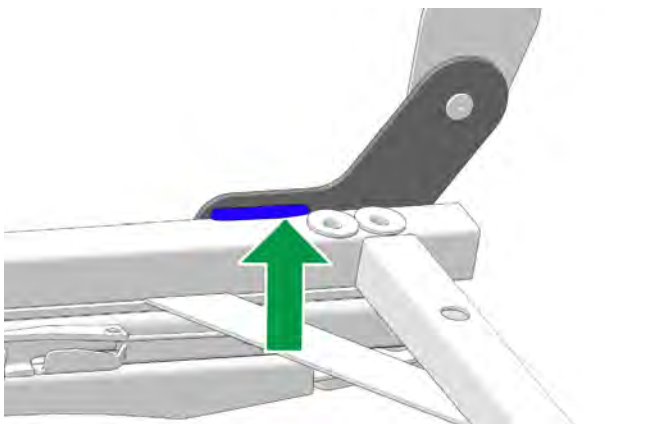
<p>Diagram 3 shows a close-up of a metal bracket assembly. A single green arrow points upwards to a single, continuous blue weld line, indicating a good weld.</p>

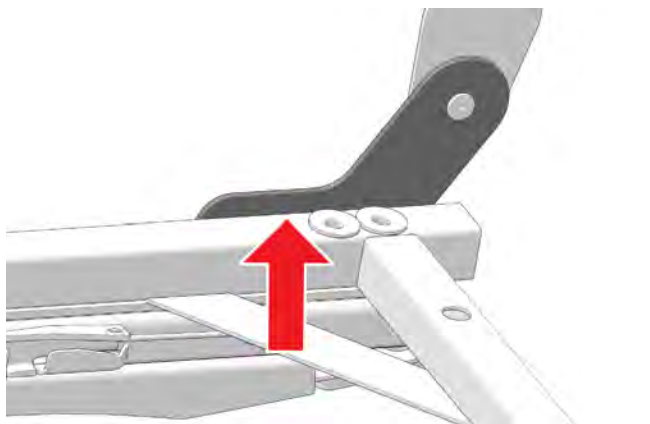
<p>Diagram 3 shows the same metal bracket assembly. A single red arrow points upwards to a location where the weld is missing, indicating a missing weld.</p>

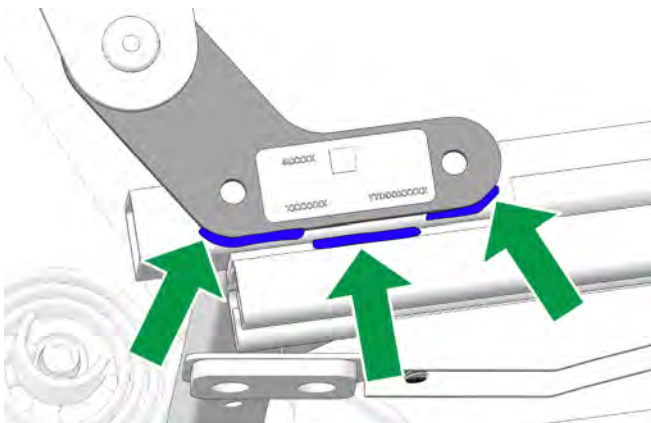
<p>Diagram 4 shows a close-up of a metal bracket assembly. Three green arrows point upwards to three distinct blue weld lines that are continuous and well-defined, indicating good welding quality.</p>

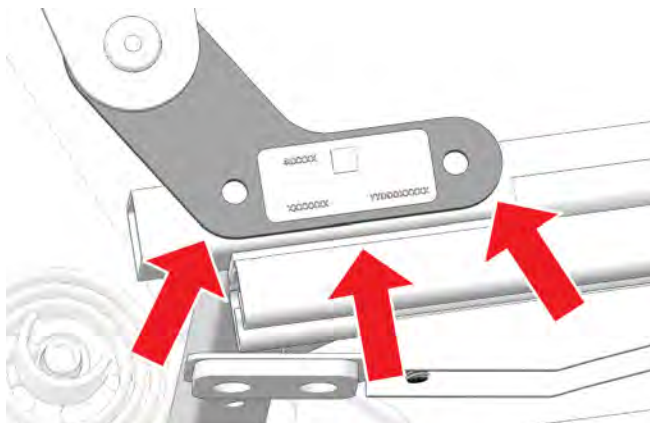
<p>Diagram 4 shows the same metal bracket assembly. Three red arrows point upwards to three locations where the welds are missing or incomplete, indicating poor welding quality.</p>

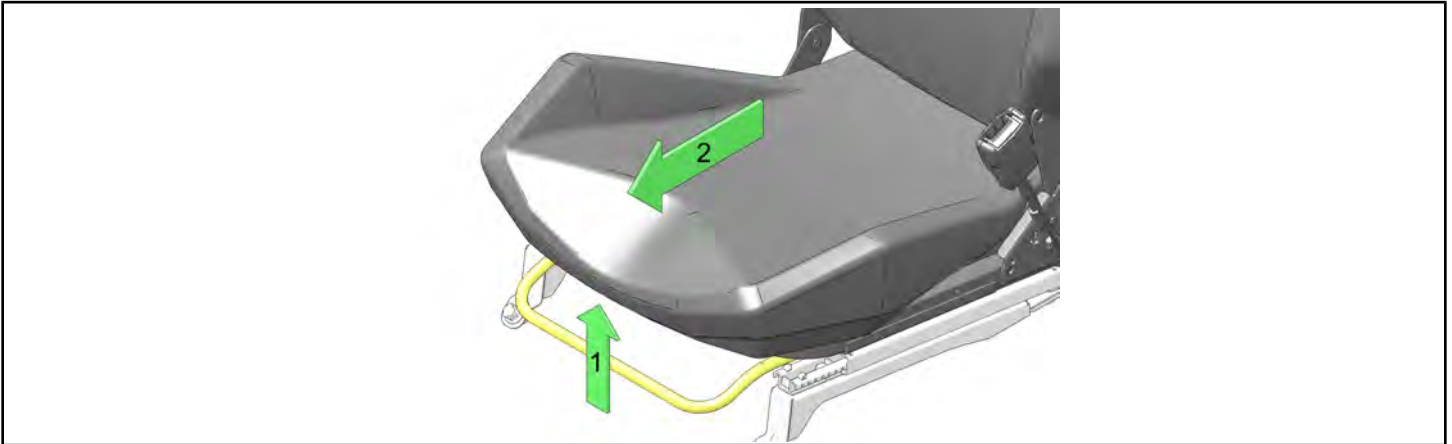
T-18-01-A SEAT SLIDER TEST

1. While sitting in the seat, grab slider bar in the middle of the seat base, and pull up to release slider latches.
2. Pull seat to the fully forward travel position using your legs until the seat slider stops.

3. Push the seat back slightly, and gently release the slider bar ensuring that it falls all the way down and properly latches into the first slider position.
4. Place one foot on the dead pedal and the other on the brake pedal. Place both hands on the steering wheel. Using your hands and feet, push the seat backward, testing to ensure the seat stays locked in place.
5. Repeat above procedure at the three additional positions below to ensure engagement along the entire seat slider travel range:
 - 1/4 travel position
 - 1/2 travel position
 - 3/4 travel position

If the seat unlatches or moves more than one tooth rearward in ANY of the four positions, the test is considered a FAIL and a new seat base MUST be installed:

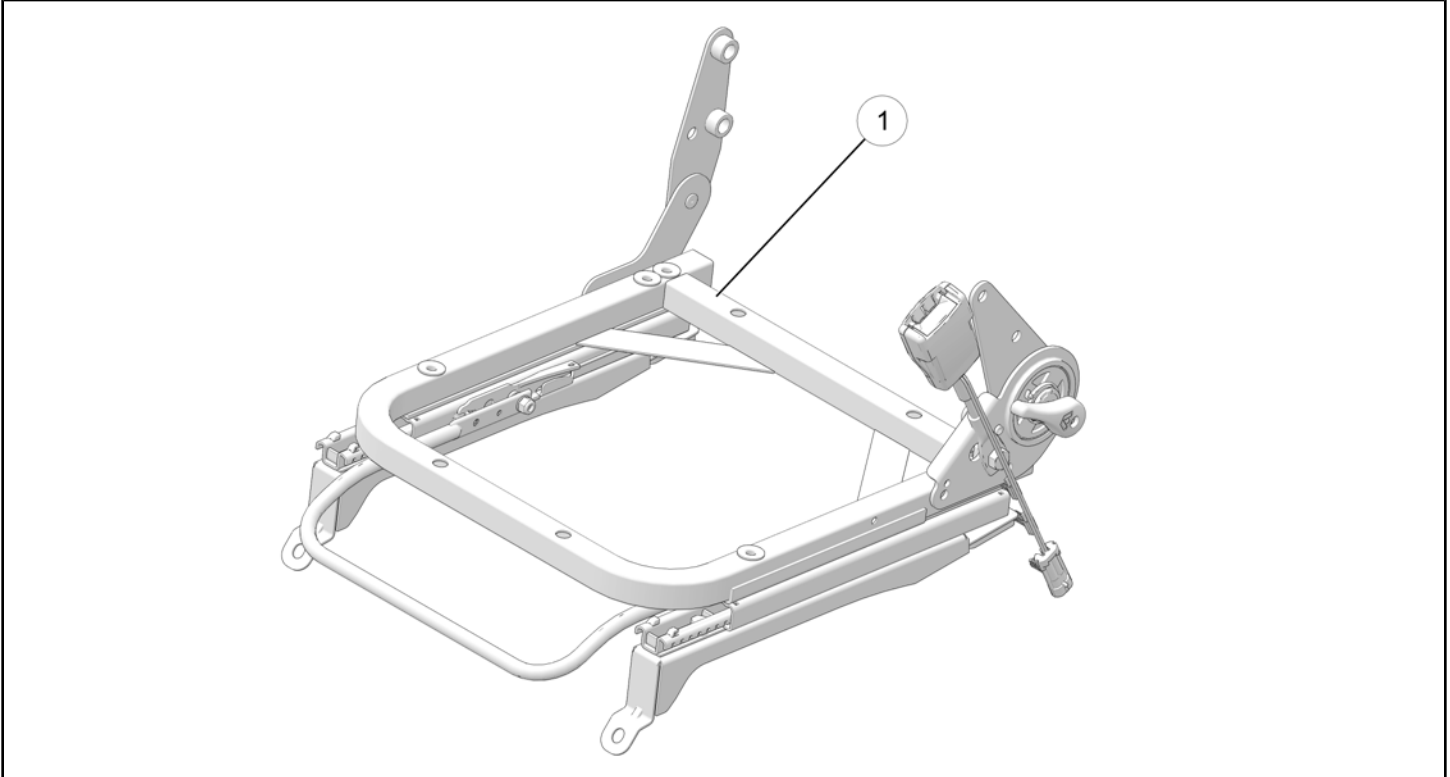
KIT CONTENTS (P/N 2207822)

ITEM	DESCRIPTION	PART NUMBER	QTY
①	Frame, Seat Bottom, Driver	2207822	1
	Instructions, Kit (not shown)	9929216	1

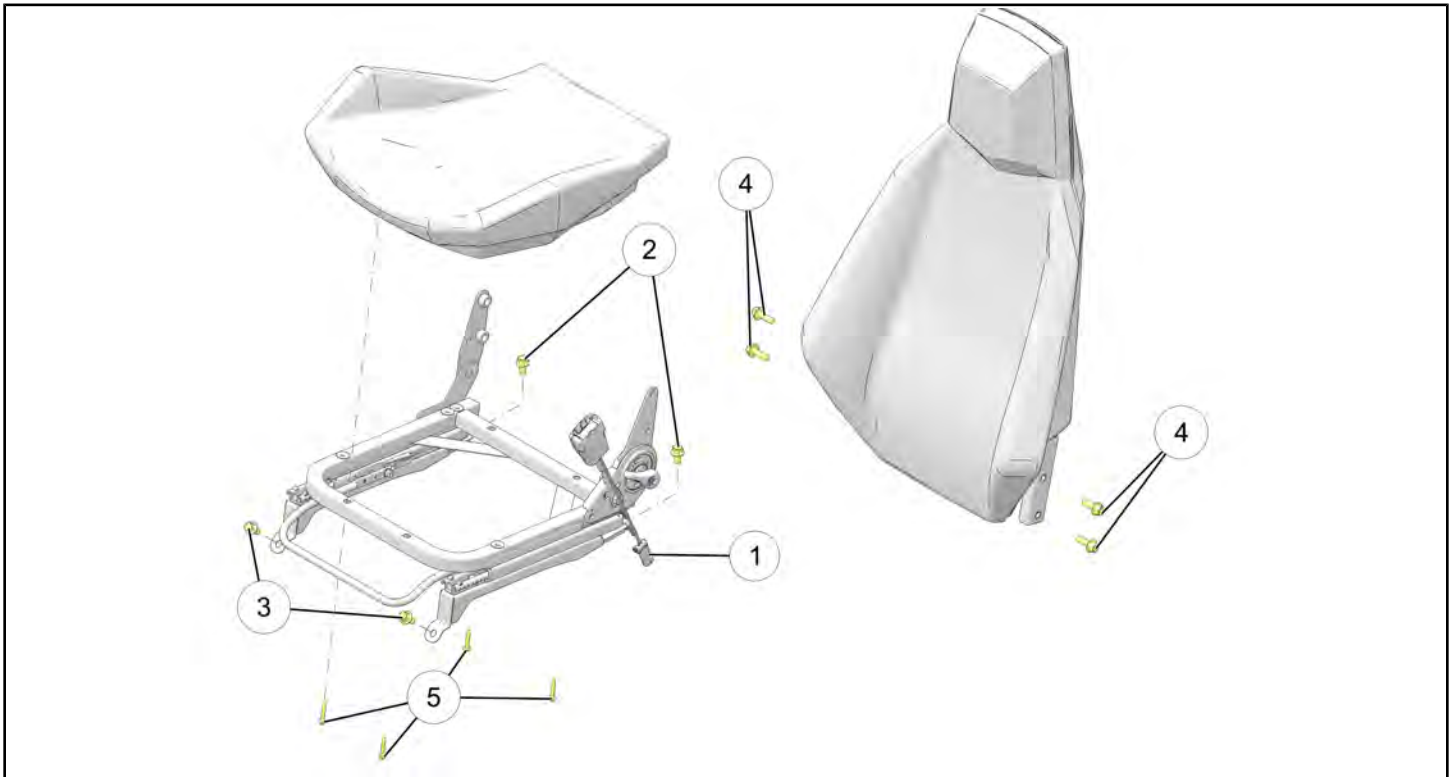
DRIVER-SIDE SEAT BASE FRAME REMOVAL

ITEM	DESCRIPTION	LOCATION	FASTENER DETAILS
①	Seatbelt Switch Connector	Connector mounted on the back of the rear seat frame rail	—
②	Seat Base Fasteners, Rear	Rear of seat base	15 mm Hex / 20 mm Length (QTY 2)
③	Seat Base Fasteners, Front	Front of seat base	15 mm Hex / 20 mm Length (QTY 2)
④	Seat Back to Seat Base Fasteners	Both sides of the seat back securing the seat back to the seat base	15 mm Hex / 30 mm Length (QTY 4)
⑤	Seat Bottom Cushion Fasteners	Bottom of seat base	8 mm or T-30 Torx (QTY 4)

1. Slide seat to the forward-most position and tilt seat forward toward the steering wheel.
2. Disconnect the seatbelt switch electrical plug ① located along the back of seat rail.
 - 2015 and 2016 vehicles include a second electrical connector mounted to the rear seatbase frame rail's bottom surface. Separate electrical connector from the seat base by forcing the connector fir tree pin out of the hole in the frame with a trim removal tool.

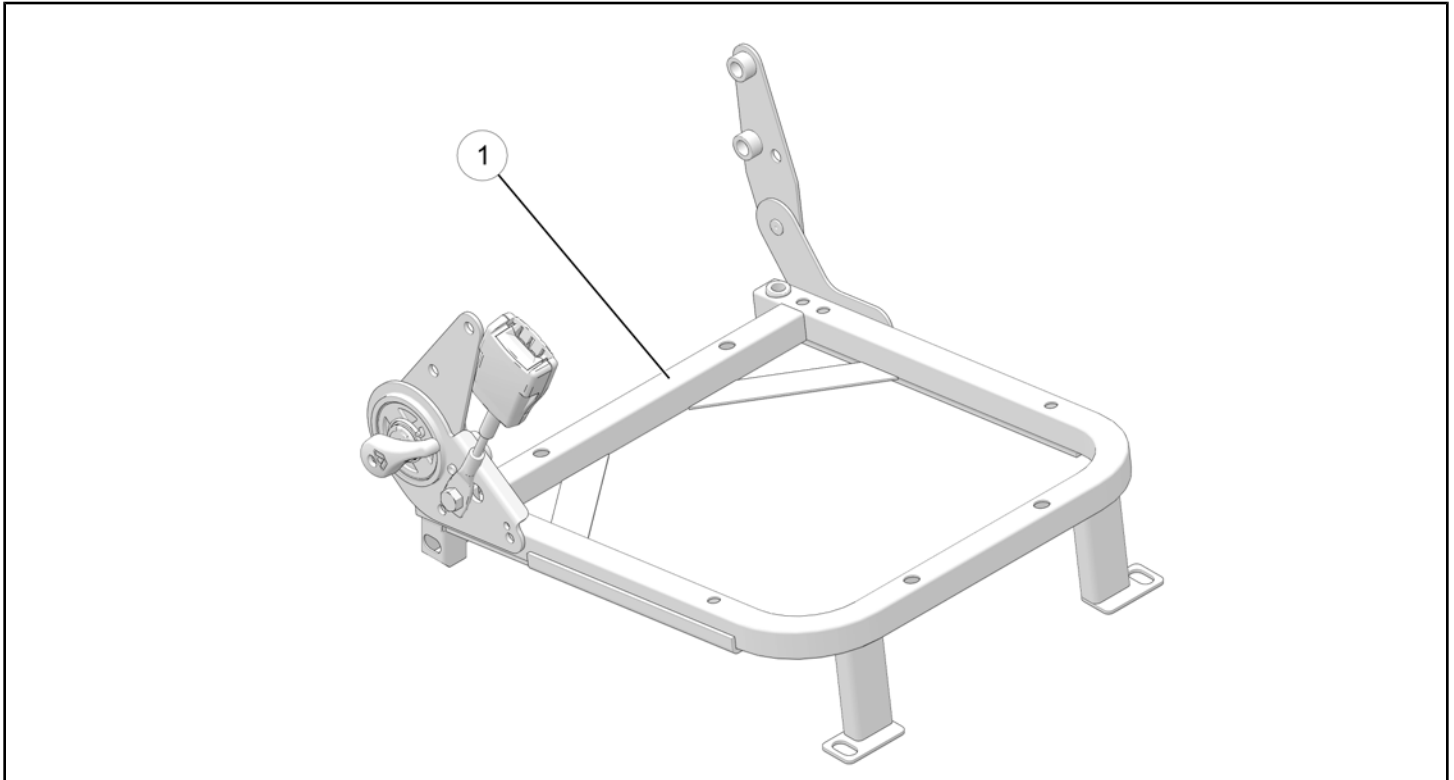
KIT CONTENTS (P/N 2207823)

ITEM	DESCRIPTION	PART NUMBER	QTY
①	Frame, Seat Bottom, Passenger	2207823	1
	Zip Tie (not shown)	7081496	1
	Instructions, Kit (not shown)	9929216	1

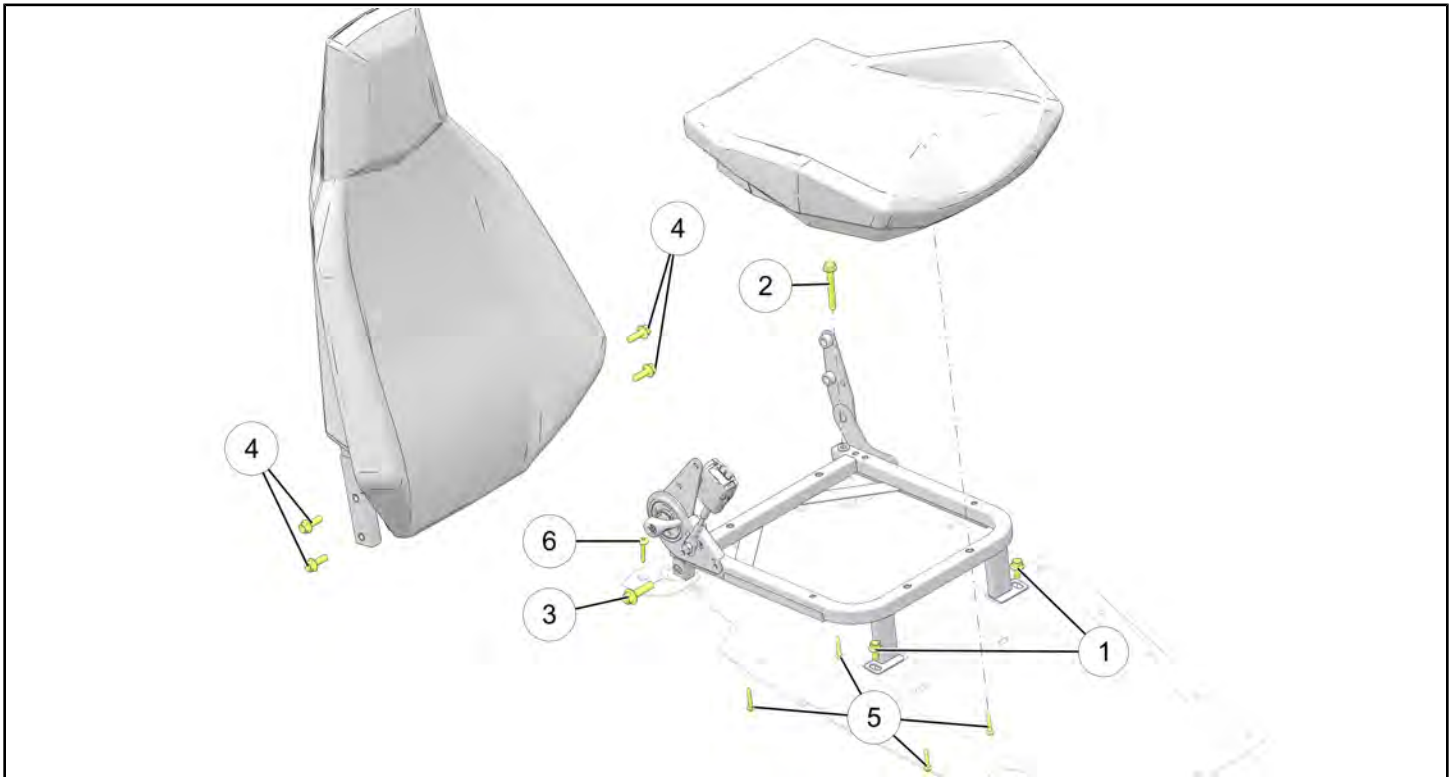
ITEM	DESCRIPTION	LOCATION	FASTENER DETAILS
①	Seat Fasteners, Front	Front of seat base	15 mm Hex / 20 mm Length (QTY 2)
②	Seat Base Fastener, Rear Vertical	Rear of seat base	15 mm Hex / 84 mm Length (QTY 1)
③	Seat Base Fastener, Rear Horizontal	Rear of seat base	16 mm Hex / 45 mm Length (QTY 1)
④	Seat Back to Seat Base Fasteners	Both sides of the seat back securing the seat back to the seat base	15 mm Hex / 30 mm Length (QTY 4)
⑤	Seat Bottom Cushion Fasteners	Bottom of seat base	8 mm Hex or T-30 Torx (QTY 4)
⑥	Floor Pan Fastener	Rear left side of seat base	T-27 Torx (QTY 1)

1. **Slingshade Equipped Models Only:** Unlock and open Slingshade door.
2. Remove the two front seat fasteners ①.
3. Remove the vertical rear seat fastener ②.
4. Tilt seat forward toward the dash.
