Safety Recall V29 / NHTSA 19V-201

Steering Column

2019 (JL) Jeep® Wrangler

2019 (DT) Ram 1500 Pickup

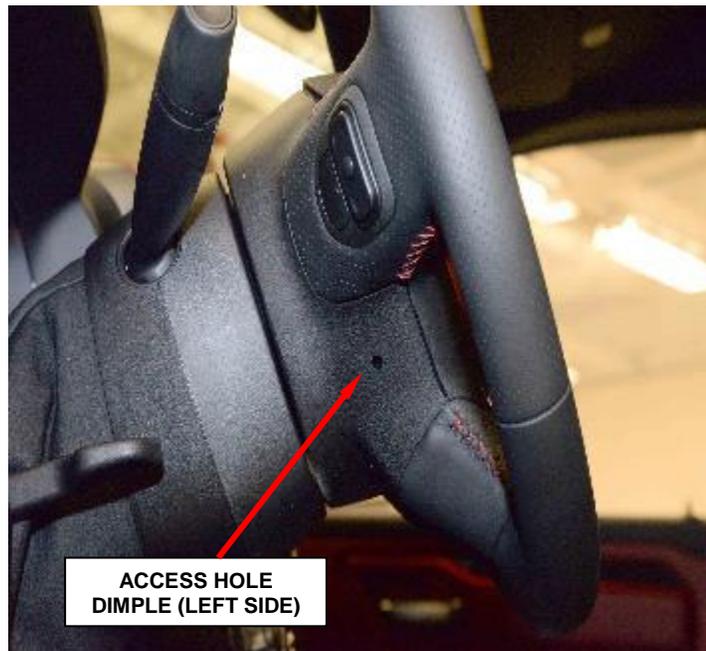
Figure 1 – Access Hole Dimples (DAB)

1. Disconnect and isolate the negative battery cable(s) then wait two minutes for the system capacitor to discharge.
2. **For DT trucks,** Locate the access hole dimples (1) in the lower surface of the steering wheel hub rear trim cover near each of the two horizontal spokes (Figure 1).

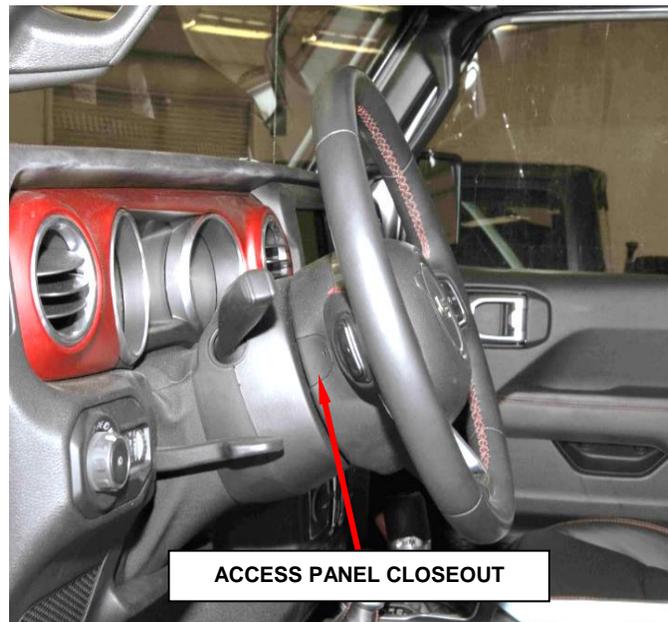
**Figure 2 – Driver Airbag**

6. **For DT trucks,** repeat Steps 3 and 4 for the opposite end of the retainer spring.
7. **For JL vehicles,** remove the two access panel closeouts on the steering wheel near each of the two horizontal spokes (Figure 2).

8. **For JL vehicles,** remove and save the two driver airbag retaining bolts from the driver airbag (Figure 2).

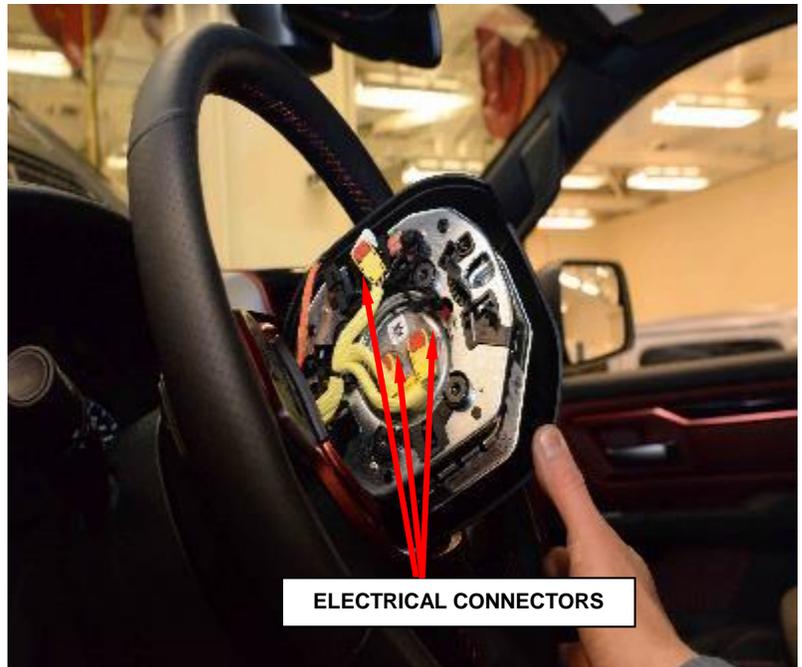
**Figure 3 – Wire Harness Connectors
(DT shown, JL Similar)**

9. Pull the DAB away from the steering wheel far enough to access the steering wheel wire harness connector to the DAB inflator initiators (Figure 3).

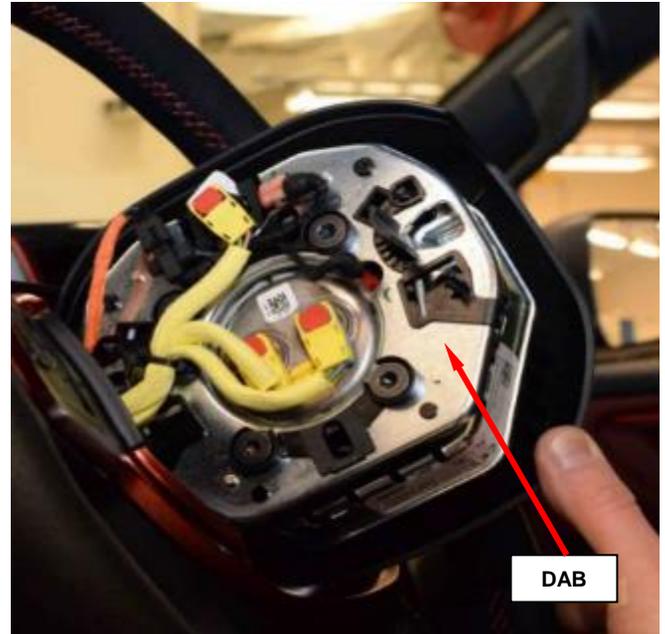
**Figure 4 – DAB
(DT shown, JL Similar)**

11. Remove the DAB and floating horn switch plate from the steering wheel as a unit (Figure 4).

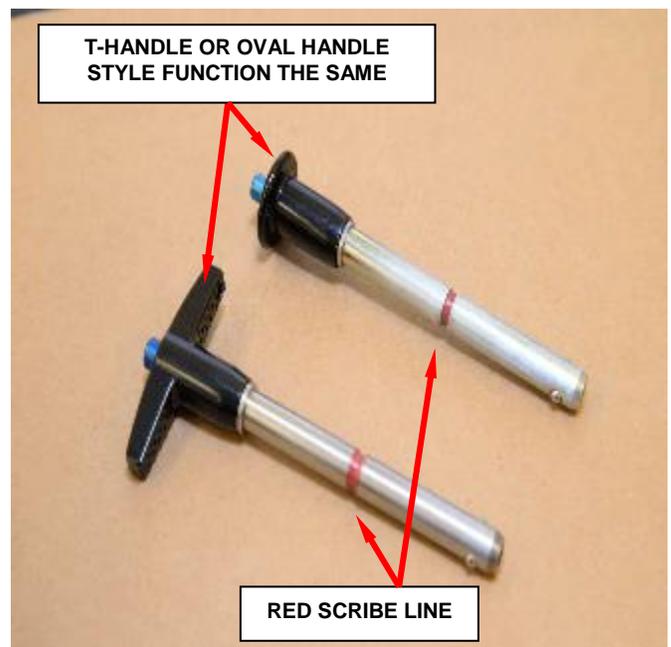
Figure 5 – Check Tool (Two Handle Styles)

12. Use the provided Check Tool, Steering Stub Shaft for the vehicle stub shaft inspection (Figure 5). See Special Tool section for rental instructions.

- Push the blue button on the end of the tool prior to insertion.
- Note the RED scribe line on the tool.

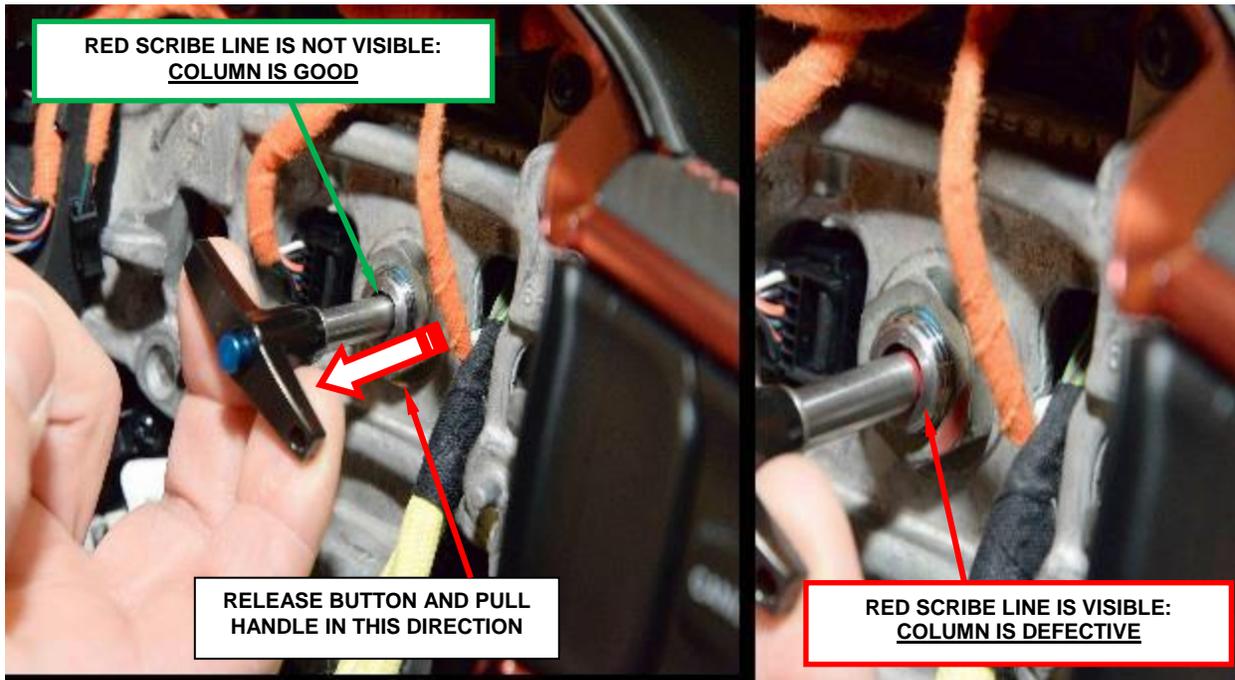
Figure 6 – Inspect Steering Column Stub Shaft

13. Insert the tool into the steering column stub shaft until tool bottoms out in steering column (Figure 6).
14. Release blue button.
15. Pull back on tool until the tool bottoms out inside of the shaft.
 - If you **do not see the RED scribe line** on the tool outside of the column shaft, the column is **GOOD**. **Continue to Step 16.**
 - If you **do see the RED scribe line** on the tool outside of the column shaft. The steering column is **DEFECTIVE**. Vehicle is required to have column replaced. Push blue button to remove tool from shaft. **Continue to Section B. Replace DT Steering Column or Section C. Replace JL Steering Column.**
16. Push blue button to remove tool from shaft.

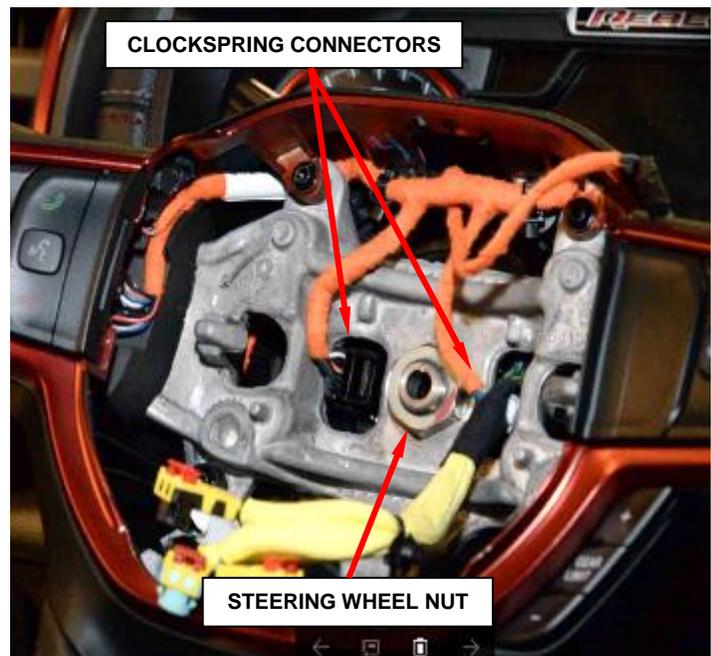
Figure 7 – Steering Wheel Removal

1. Disconnect and isolate the negative battery cable(s).
2. Disconnect the Clockspring electrical connectors (Figure 7).
3. Remove and **DISCARD** the steering wheel retaining nut and remove the steering wheel (Figure 7).

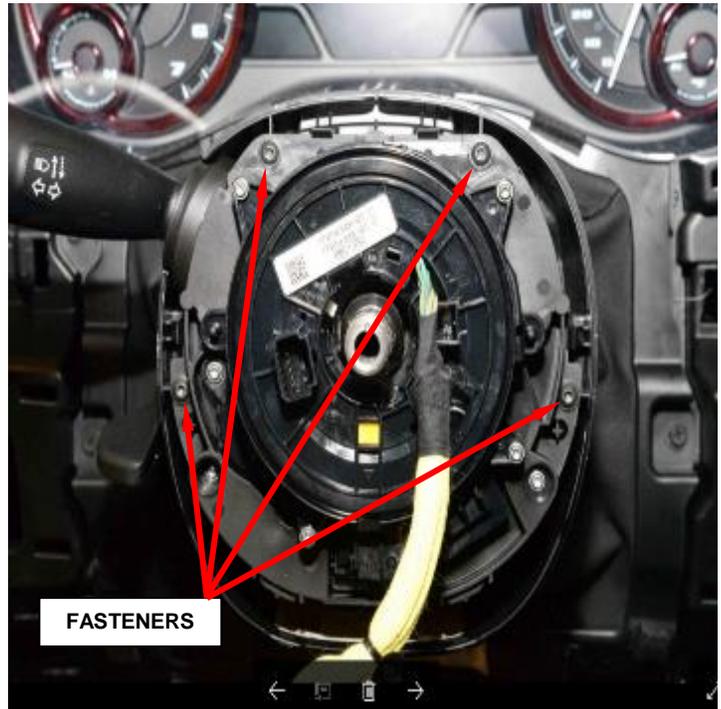
Figure 16 – Inner Shroud Fasteners

19. Remove the Steering Column Control Module (SCCM) (Figure 16).
 - a. Remove four inner shroud fasteners (Figure 16).
 - b. Loosen the SCCM upper set screw and lower clamp bolt.
20. Remove the SCCM electrical connector.
21. Remove the SCCM.

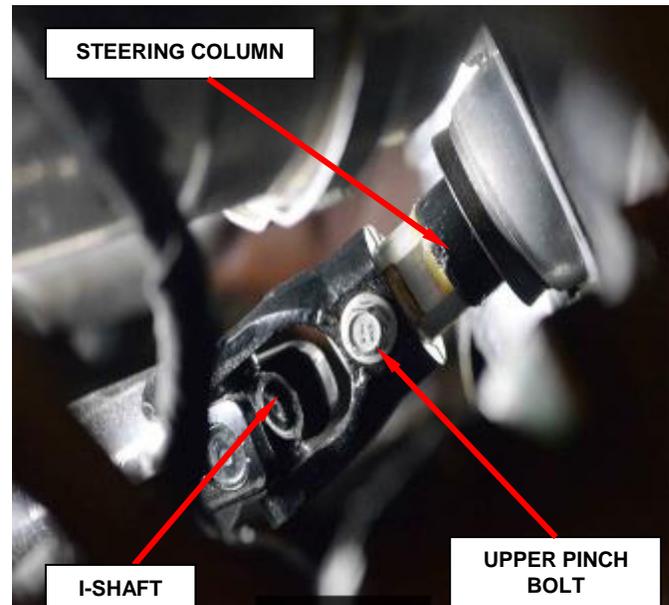
Figure 18 – Upper Pinch Bolt

23. Remove and **DISCARD** the intermediate shaft upper pinch bolt (Figure 18).

24. Remove the intermediate shaft from the steering column shaft.

4. Engage the wire harness routing clip to the steering column.
5. Install the intermediate shaft to the steering column shaft.
6. Install a **NEW** intermediate shaft upper to lower pinch bolt and tighten to 50 N·m (37 ft. lbs.).

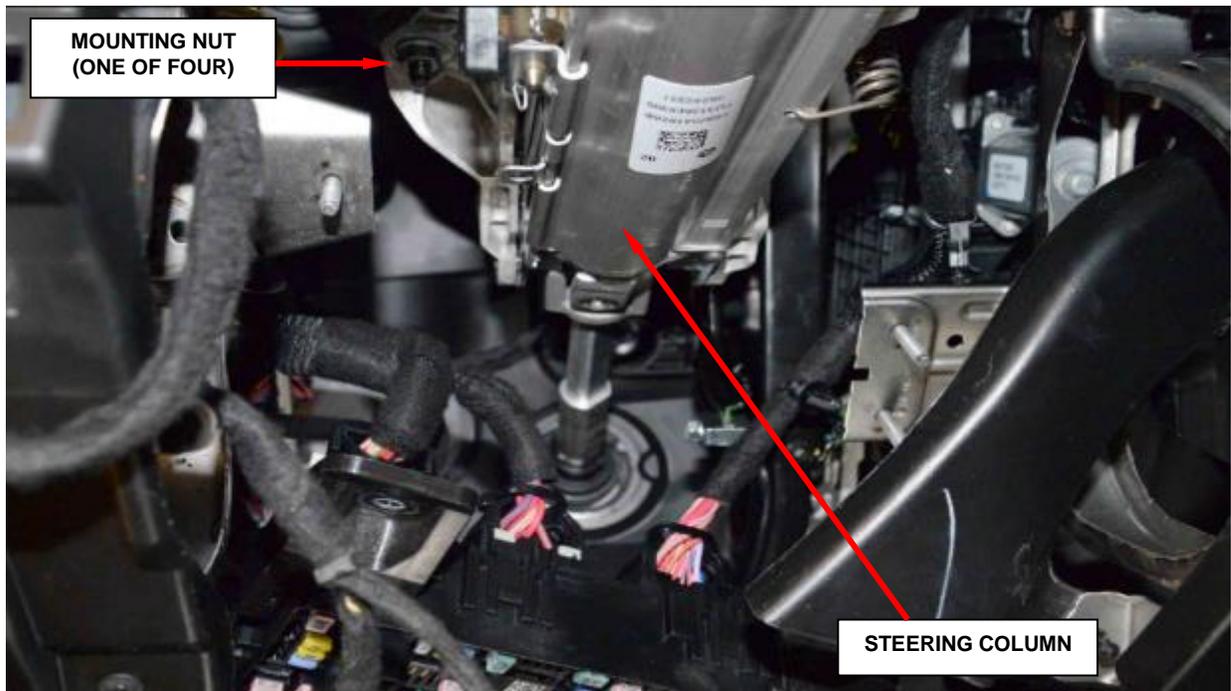
Figure 21 – Steering Column

- 27. Remove the Power Distribution Center (PDC) (Figure 20).
- 28. Remove the four steering column nuts and retain the instrument panel bracket (Figure 21).
- 29. Pull the steering column shaft through bulkhead pass through then remove and **DISCARD** the steering column (Figure 21).

1. Position the **NEW** steering column in the vehicle.
2. Slide the steering shaft through the bulkhead pass through.
3. Place the instrument panel bracket over the left rear steering column stud and install the four steering column nuts then tighten to 28 N·m (21 ft. lbs.).

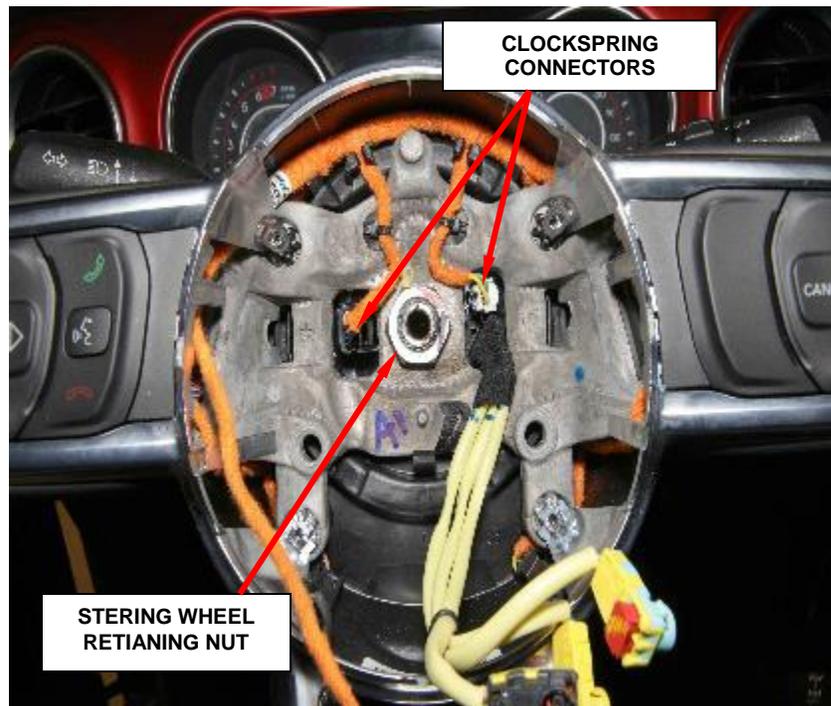
Figure 22 – Remove Steering Wheel Nut

4. Disconnect clockspring electrical connectors (Figure 22)

5. Remove and **DISCARD** the steering wheel retaining nut. Remove the steering wheel (Figure 22).

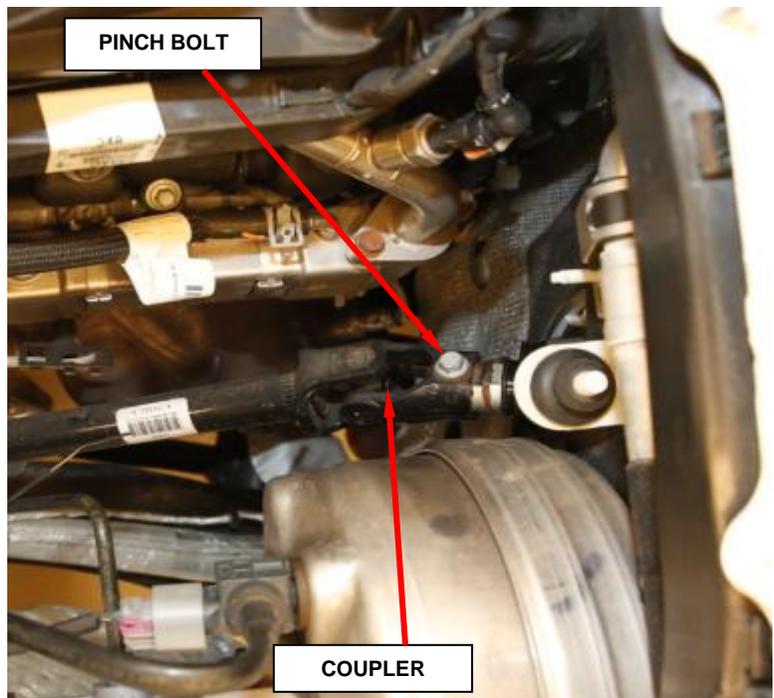
Figure 29 – Pinch Bolt

14. Remove and **DISCARD** the intermediate shaft coupler pinch bolt from the steering column end of the shaft (Figure 30).
15. Disconnect the upper end of the steering intermediate shaft coupler from the steering column shaft (Figure 30).

3. Reconnect the upper end of the intermediate shaft to the steering column shaft
4. Install a **NEW** upper pinch bolt and tighten to 34 N·m (25 ft. lbs.).
5. Install the coolant bottle.

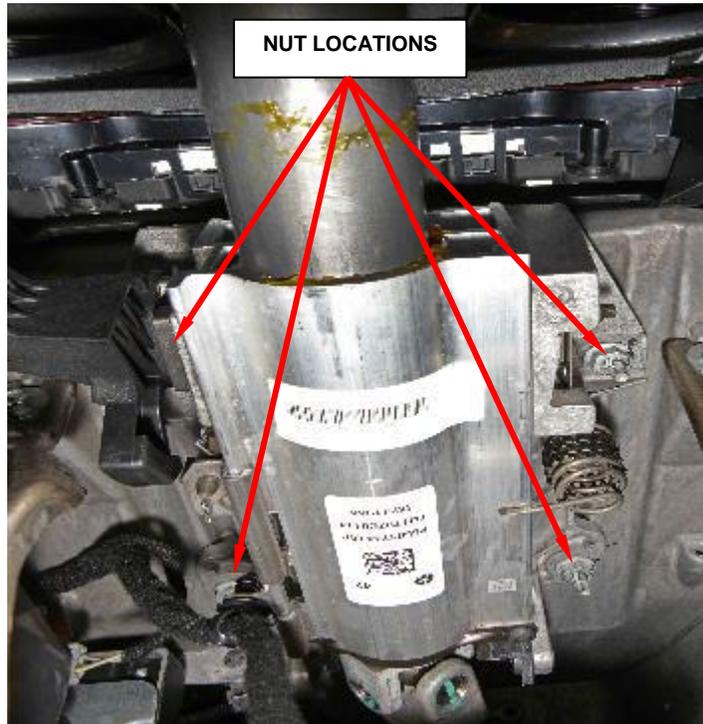
**Figure 30 – Mounting Nuts****INSTALLATION**

16. Release the steering column harness mounting clip.
17. Remove and save the four steering column mounting nuts (Figure 31).
18. Remove and **DISCARD** the steering column.

1. Carefully guide the **NEW** steering column shaft through the bulkhead.
2. Position the steering column mounting holes over the steering column studs and start the four steering column nuts finger tight.

CAUTION: Lower nuts must be installed and tightened first then the upper nuts in order to prevent damage to the capsules.

6. Tighten the four steering column nuts to the proper 27 N·m (20 ft. lbs.).
7. Secure the wiring harness routing clip to the steering column.
8. Install the steering column opening cover.
9. Install the center stack bezel.
10. Install the inner steering column shroud.
11. Tighten the SCCM upper bolt and lower the clamp bolt securely.
12. Install the four SCCM and secure the fasteners.
13. Install the outer steering column shroud.
14. Install the steering column kick panel cover.
15. Install the steering wheel.
 - a. Slide the steering wheel over the splined steering column shaft.
