Compliance Recall

Code: 01D2

Subject	Tire Information Label
Release Date	April 10, 2019
Affected Vehicles	U.S.A. & CANADA: Certain 2019 MY Volkswagen Tiguan <i>Check Campaigns/Actions screen in Elsa on the day of repair to verify that a VIN qualifies for repair under this action. Elsa is the <u>only</u> valid campaign inquiry & verification source.</i> <ul style="list-style-type: none">✓ Campaign status must show "open."✓ If Elsa shows other open action(s), inform your customer so that the work can also be completed at the same time the vehicle is in the workshop for this campaign.
Problem Description	The tire information label on affected vehicles contains incorrect tire dimensions and inflation pressures. This is noncompliant with FMVSS (USA) and CMVSS (Canada) 110 <i>Tire Selection and Rims</i> . Relying on incorrect specifications can lead to erroneous inflation pressure adjustment, or to installing the wrong tire size on the vehicle. Either of these situations can increase the risk of a vehicle crash.

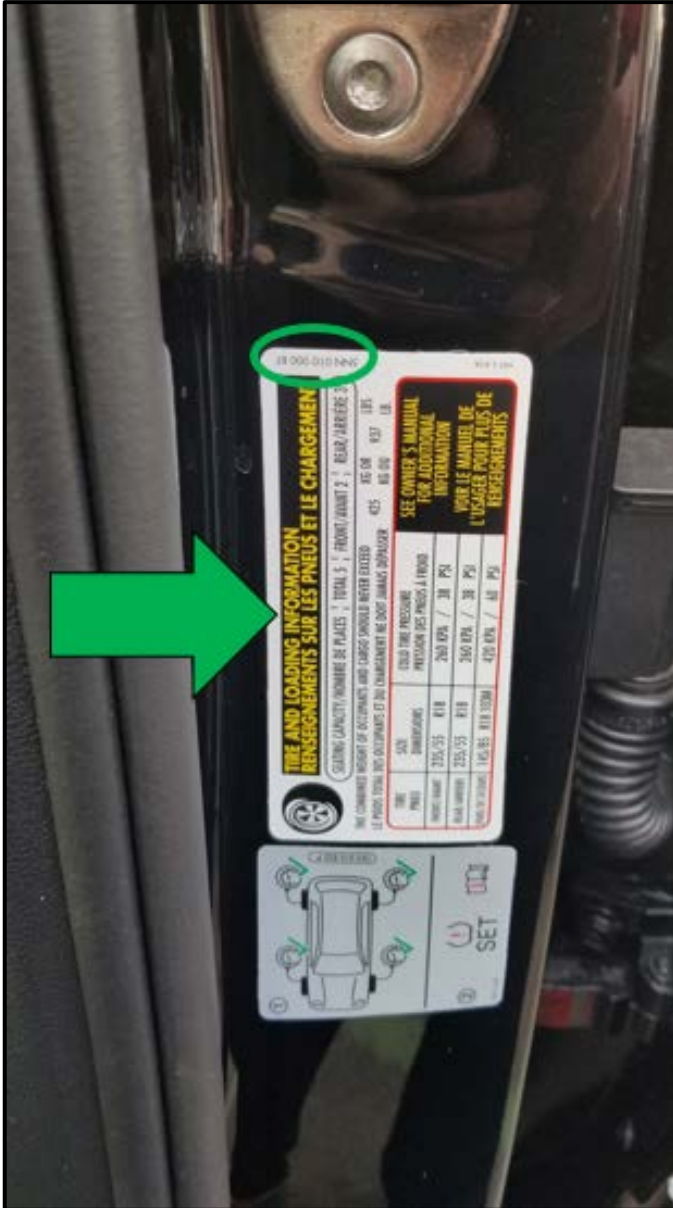
- Open the driver side front door.
- Locate the “Tire and Loading Information” Label on the B-pillar <arrow>.
- Clean the surface of the existing label.

- The surface of the existing label must be clean, dry, and free from oil residue prior to applying the replacement label.
- The replacement label **MUST** cover the existing label completely.
- Handle the replacement label carefully. Do not touch the adhesive backing.

- Peel the replacement label off the backing paper.
- Affix the replacement label over the existing label.

- Ensure minimal air bubbles are created when installing the new label.
