SIB 11 06 19

RECALL CAMPAIGN 19V-273: POSITIVE CRANKCASE VENTILATION SYSTEM HEATER

RE: Recall 19V-273: Positive Crankcase Ventilation (PCV) Valve Heater - B11 06 19

Recall 19V-273: Positive Crankcase Ventilation (PCV) System Heater

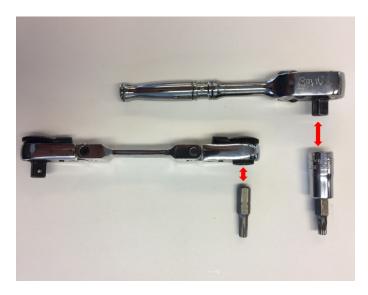
5. Use a suitable tool with T25 Torx bit to release the screws.

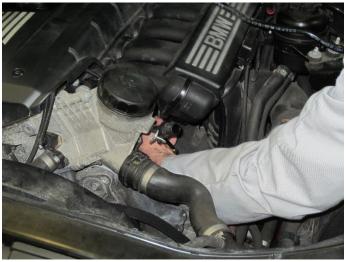
6. Reach under the intake with your left hand/arm to access the crankcase ventilation heater.
