TECHNICAL INSTRUCTIONS
FOR
SAFETY RECALL KLD
DRIVER KNEE AIRBAG NOT PROPERLY FASTENED
CERTAIN 2019 MODEL YEAR ES350

During vehicle assembly, it is possible that the driver knee airbag may not have been properly fastened to the instrument panel. This could have an effect on the deployment of the knee airbag that can increase the risk of injury during a crash.

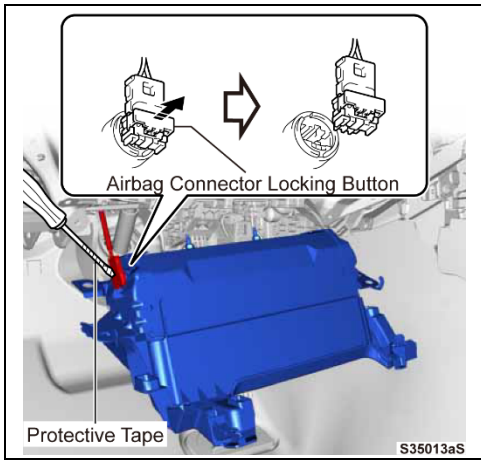
- d. Using a screwdriver with its tips wrapped with protective tape, release the airbag connector locking button
- e. Disconnect the airbag connector to remove the lower No.1 instrument panel airbag assembly

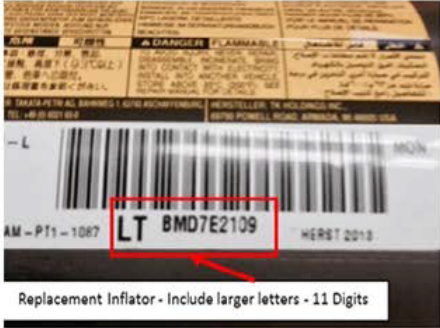
The first two characters of the **Replacement Inflator Serial code** will be either 'LT' or 'LR'.

Replacement Inflator - Include larger letters - 11 Digits

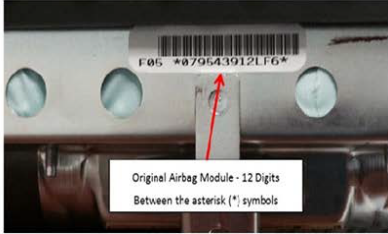
Original Airbag Module - 12 Digits
Between the asterisk (*) symbols

How to Identify an Airbag module Assembly number?
The Airbag module Assembly serial number is a 12 digit code. It can be found along with a bar code on opening the Airbag assembly unit. To manually enter these details into the application, the technician has to identify the 12 digit code between two Asterisks (*) inside the Airbag assembly unit. The first seven characters of this 12 digit code are numbers and the 10th digit is either 'K' or 'L' always.

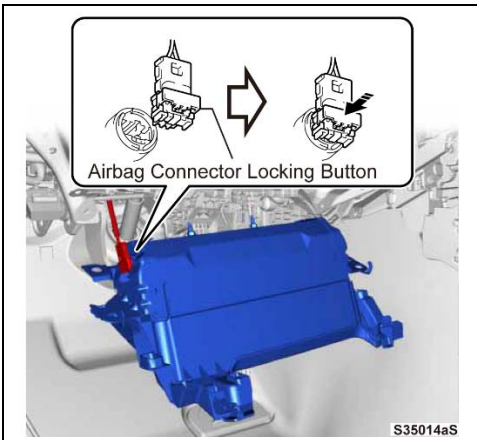
- Connect the airbag connector to the lower No.1 instrument panel airbag assembly
- Push the airbag connector locking button to lock the airbag connector in place.
