TECHNICAL INSTRUCTIONS
FOR
SAFETY RECALL KLE
DRIVER KNEE AIRBAG NOT PROPERLY FASTENED
CERTAIN 2019 MODEL YEAR ES350

IV. BACKGROUND

During vehicle assembly, it is possible that the driver knee airbag may not have been properly fastened to the instrument panel. This could have an effect on the deployment of the knee airbag that can increase the risk of injury during a crash.

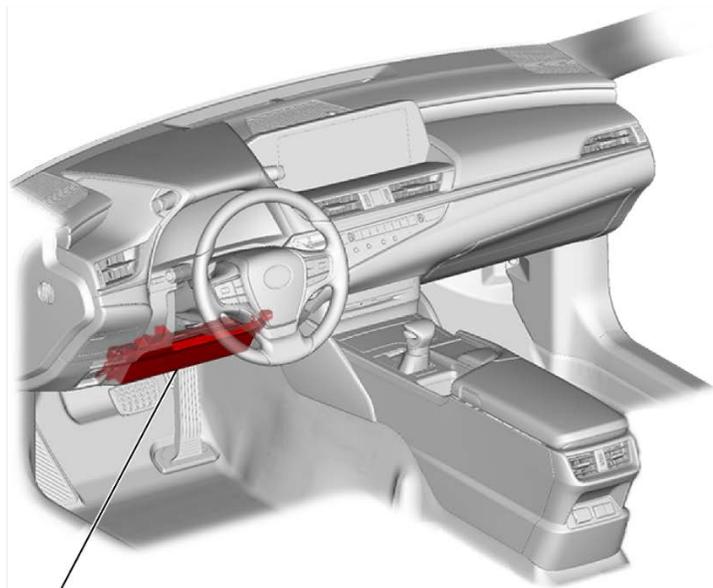
S35001aO

LOWER NO. 1
INSTRUMENT PANEL
AIRBAG
ASSEMBLY

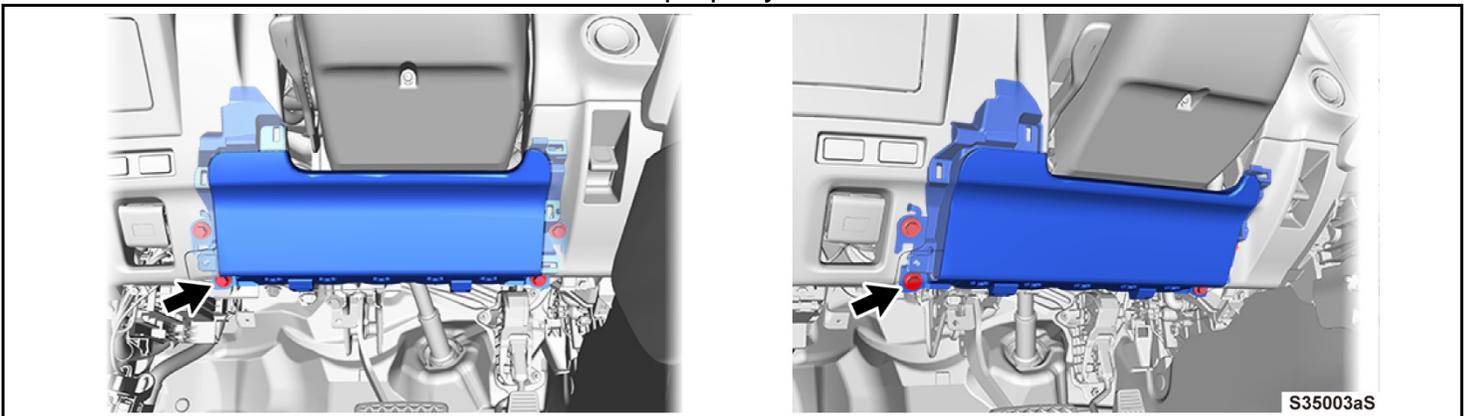
- a) Visually inspect the lower left portion of the lower No. 1 instrument panel airbag mounting bracket to check whether it is installed properly.

Always inspect the lower No. 1 instrument panel airbag mounting bracket visually to see whether it is properly installed.

DO NOT try to check for proper installation by checking for looseness or rattling. This may lead to erroneous judgments as the bracket would not move even when it is improperly mounted.

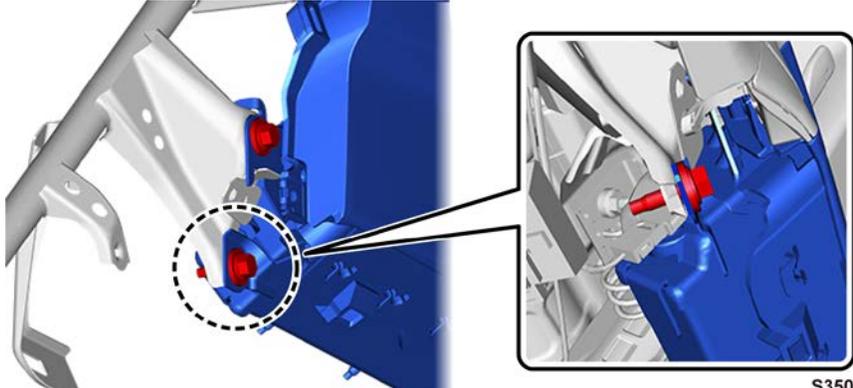
Judgment	Actions to Take
<p>OK The bracket is attached in <i>front</i> of the reinforcement.</p>

<p style="text-align: right;">S35004aS</p>	<p>Campaign completed.</p> <p>Proceed to the next step “3. REINSTALL FOLLOWING COMPONENTS” and restore the vehicle.</p>
<p>NG The bracket is attached <i>behind</i> the reinforcement.</p>

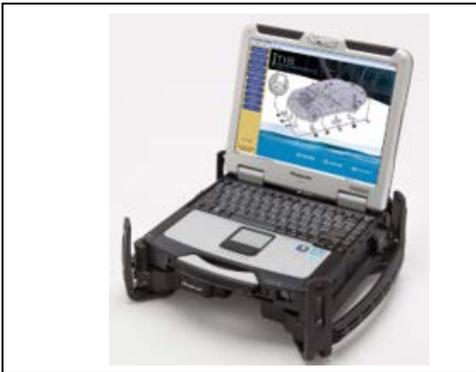
VII. REMOVE LOWER NO.1 INSTRUMENT PANEL AIRBAG ASSEMBLY

1. CHECK FOR DTC'S

- a. Using a Techstream, check for Diagnostic Trouble Codes.

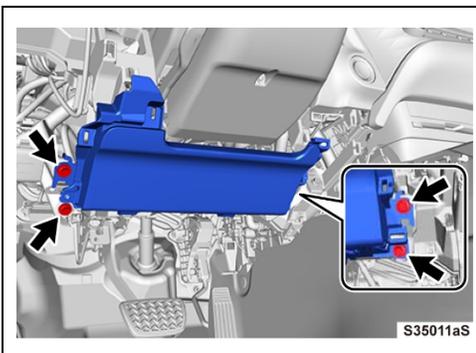
- a. Apply a mark on the lower No.1 instrument panel airbag assembly prior to removal so as not to reinstall it an error

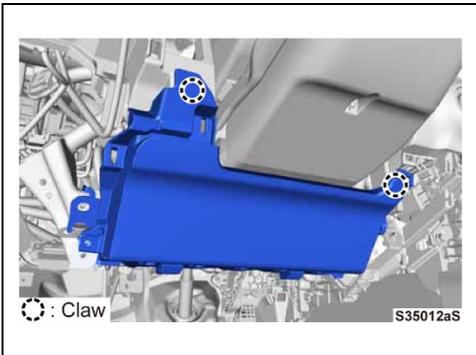
- b. Remove the 4 bolts

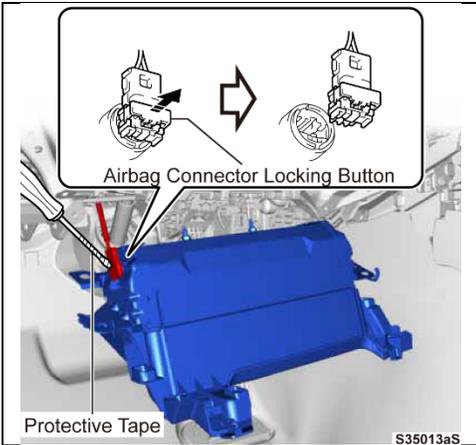
- d. Using a screwdriver with its tips wrapped with protective tape, release the airbag connector locking button
- e. Disconnect the airbag connector to remove the lower No.1 instrument panel airbag assembly

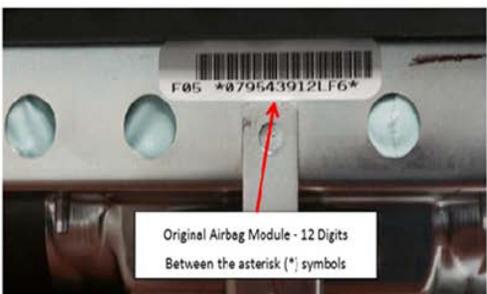
Original Airbag Module - 12 Digits
Between the asterisk (*) symbols

How to Identify an Airbag module Assembly number?
The Airbag module Assembly serial number is a 12 digit code. It can be found along with a bar code on opening the Airbag assembly unit. To manually enter these details into the application, the technician has to identify the 12 digit code between two Asterisks (*) inside the Airbag assembly unit. The first seven characters of this 12 digit code are numbers and the 10th digit is either 'K' or 'L' always.

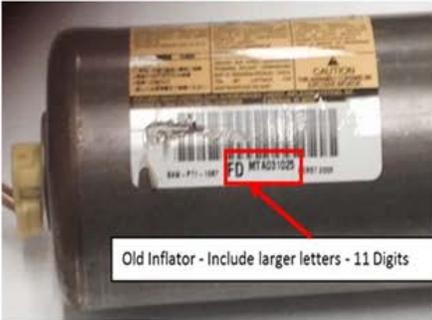
Old Inflator - Include larger letters - 11 Digits

The Inflator serial code is an **11 digit code** on the Inflator can. It can be found with a bar code on removing the Inflator can from the Airbag Assembly unit.

The first two characters of the **Original Inflator Serial code** will be from [AA, AB, AJ, FD or JD].

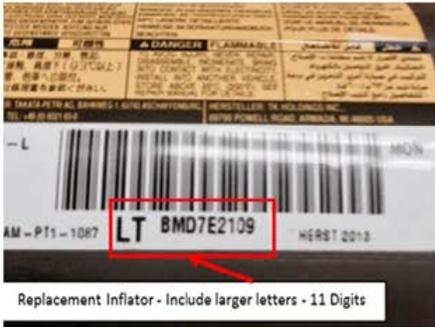
The first two characters of the **Replacement Inflator Serial code** will be either 'LT' or 'LR'.

Replacement Inflator - Include larger letters - 11 Digits

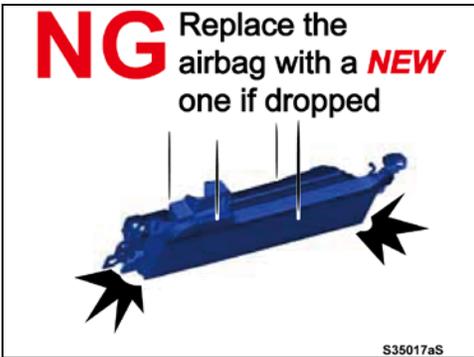
IX. INSTALL THE **NEW** LOWER NO.1 INSTRUMENT PANEL AIRBAG ASSEMBLY

1. INSTALL THE **NEW** LOWER NO1 INSTRUMENT PANEL AIRBAG ASSEMBLY

IF THE NEW AIRBAG IS FALLS OR DROPPED IN ANYWAY IT CANNOT BE USED AND SHOULD BE REPLACED

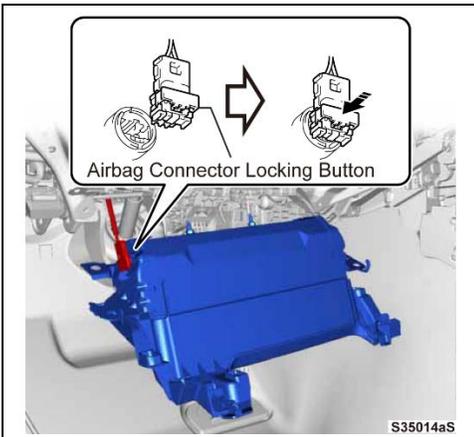
- Connect the airbag connector to the lower No.1 instrument panel airbag assembly
- Push the airbag connector locking button to lock the airbag connector in place.

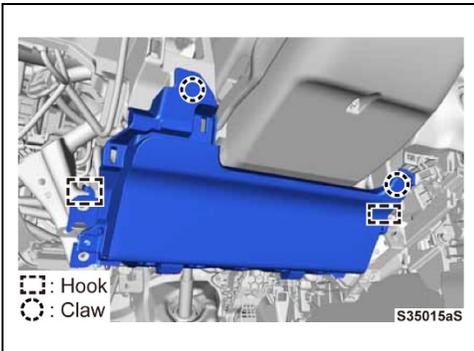
- Hang the airbag by the top hooks to properly align the airbag

ALWAYS align the hooks first before installing the bolts to ensure proper installation.

- Engage the 2 claws

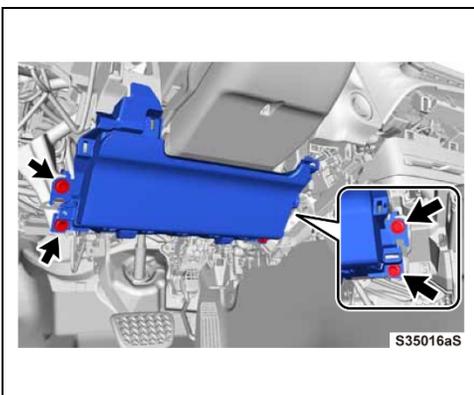
- Install the Lower No.1 Instrument panel airbag assembly with the 4 bolts.

**Specified torque:
7 in.lbf (10 N*m, 102 kgf*cm)**

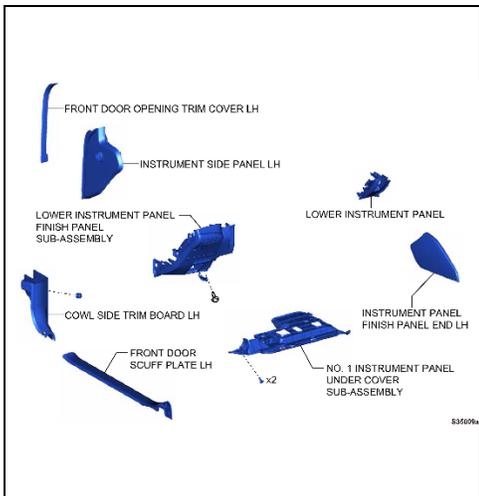
Confirm that the lower No. 1 instrument panel airbag assembly is installed securely without any excessive gaps and is not protruding outward.
