Safety Recall Campaign

RC-19-84-01

MODEL: 2018 Karma Revero

TITLE: Remedy, Replacement Airbag Control Unit (ACU)

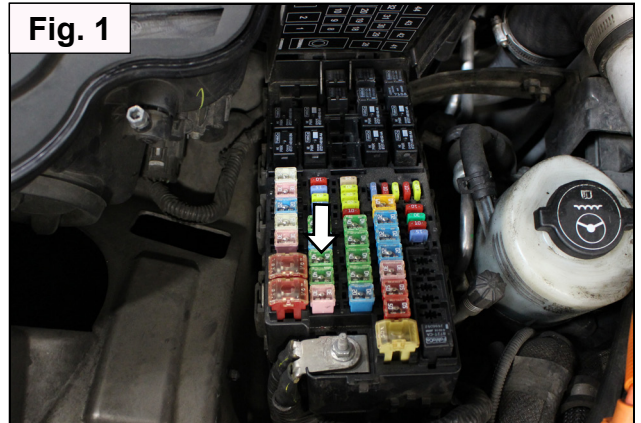
Fig. 1

1. Remove solar panel fuse (#10) from the fuse block, as shown in Figure 1.

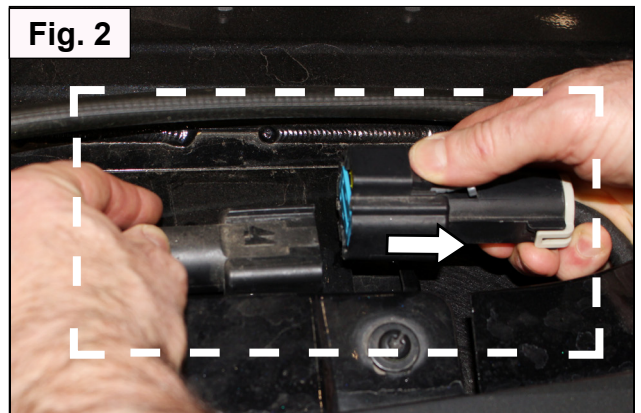
Fig. 2

2. Perform the 12-Volt disconnect procedure (Fig. 2).

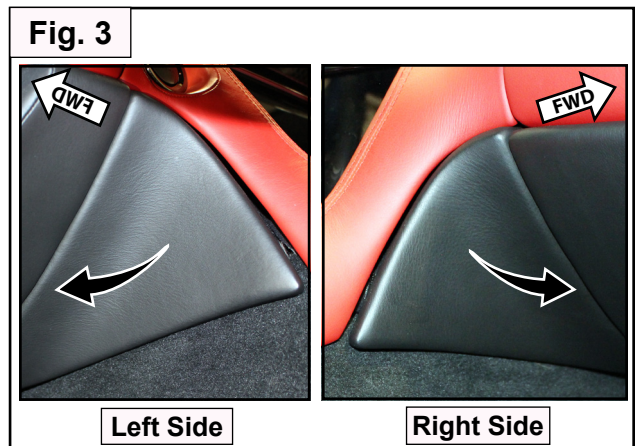
Fig. 3

3. Remove the triangular trim pieces from the left and right sides of the center console, as shown in Figure 3.

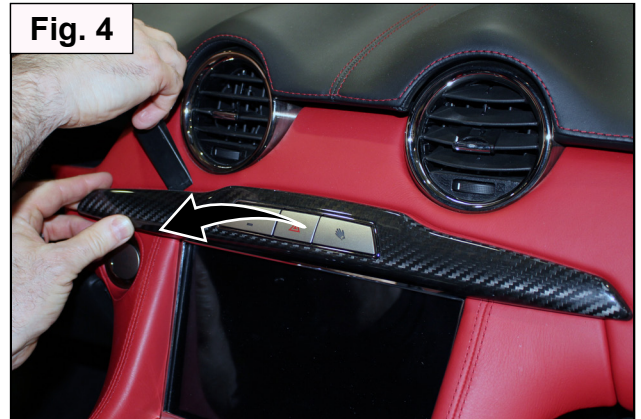
Fig. 4

4. Remove the jewel trim piece from the dash, as shown in Figure 4.

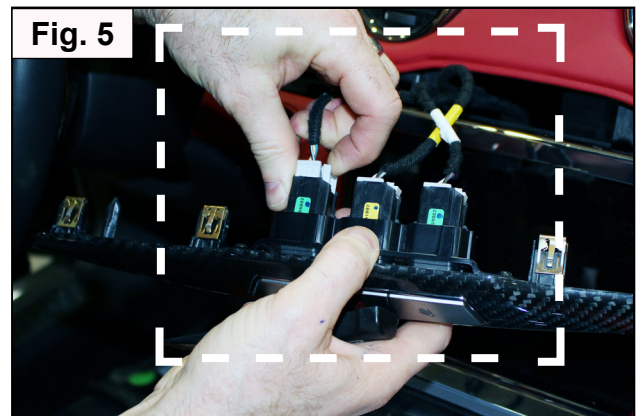
Fig. 5

5. Carefully remove three (3) connectors from the back of the dash jewel trim piece (Fig. 5). **NOTE: Place the dash jewel trim piece in a safe place.**

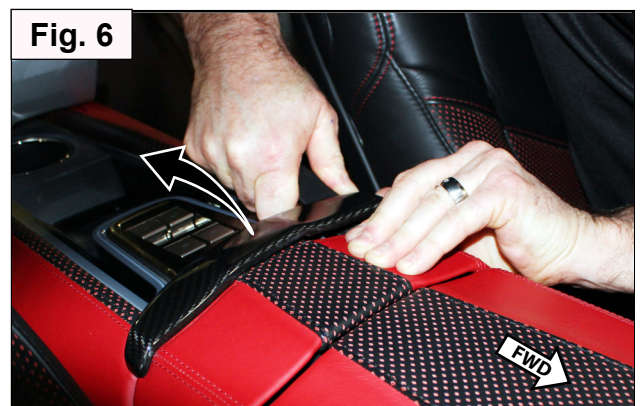
Fig. 6

6. Remove the jewel trim piece from the center console, as shown in Figure 6. **NOTE: Place the center console jewel trim piece in a safe place.**

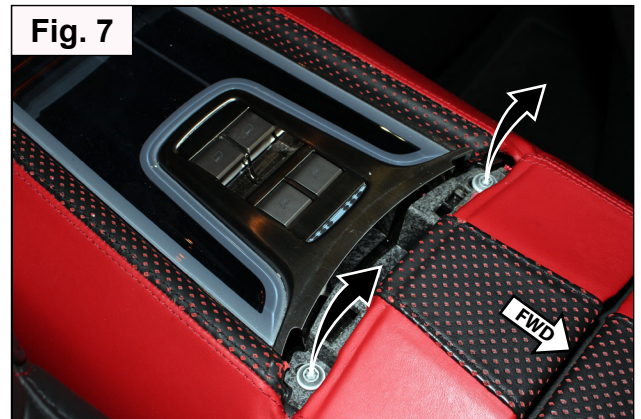
7. Remove two (2) Torx-head screws from the rear-most mounting location of the center console, as shown in Figure 7.

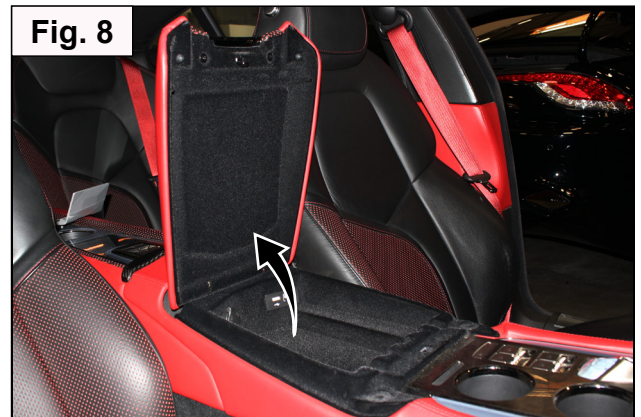
8. Open the center console storage compartment lid (Fig. 8).

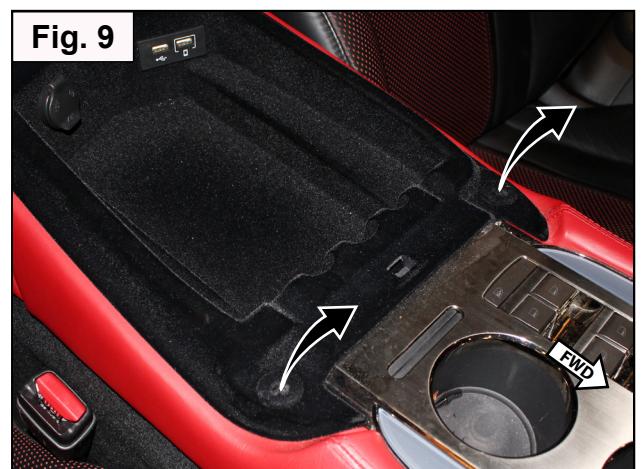
9. Use a pick-tool to carefully remove two (2) felt-trimmed covers from the leading edge of the center console storage compartment, as shown in Figure 9.

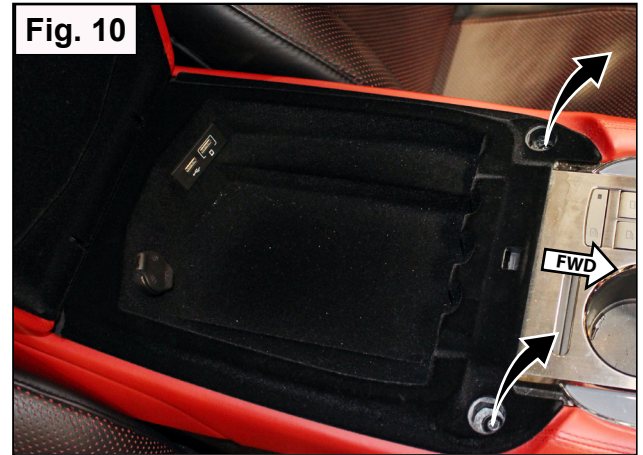
10. Remove two (2) Torx-head screws from the leading edge of the center console storage compartment, as shown in Figure 10.

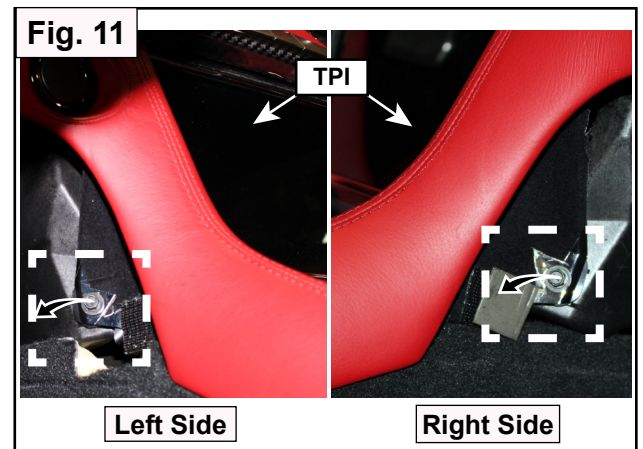
11. Remove two (2) Hex-bolts securing the center console to the dashboard, as shown in Figure 11.

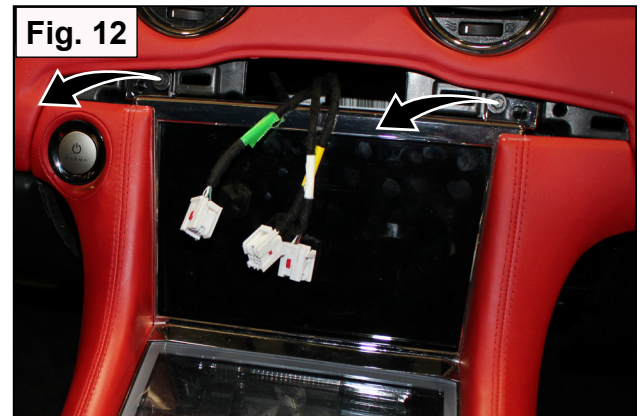
12. Remove two (2) Hex-bolts securing the center console to the dashboard above the Touch Panel Interface (TPI), as shown in Figure 12.

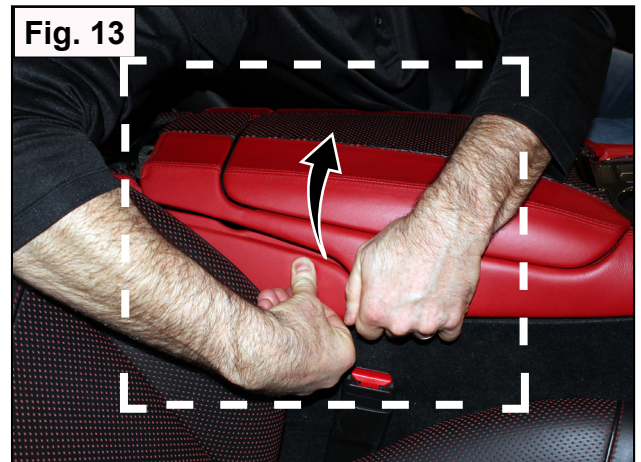
13. Apply pressure to the right side of the center console and pull up in order to release the mounting clip, as shown in Figure 13.

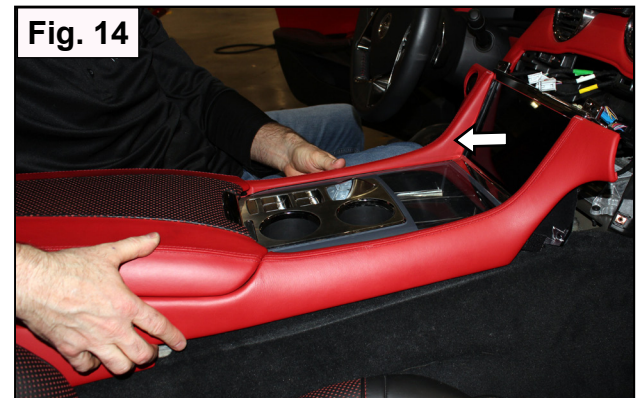
14. Grasp the center console with both hands and carefully pull it away from the dashboard, as shown in Figure 14.

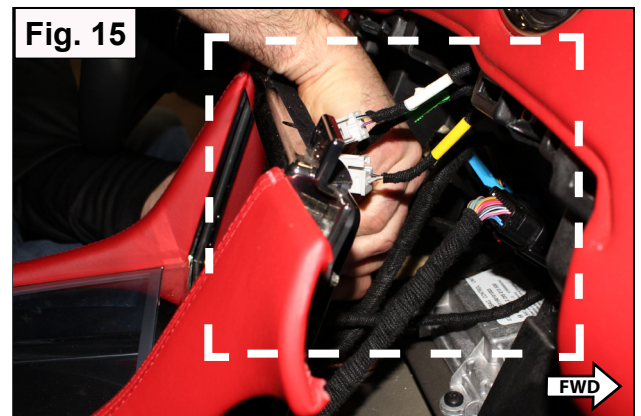
15. Carefully disconnect all connectors at the back of the Touch Panel Interface (TPI), as shown in Figure 15.

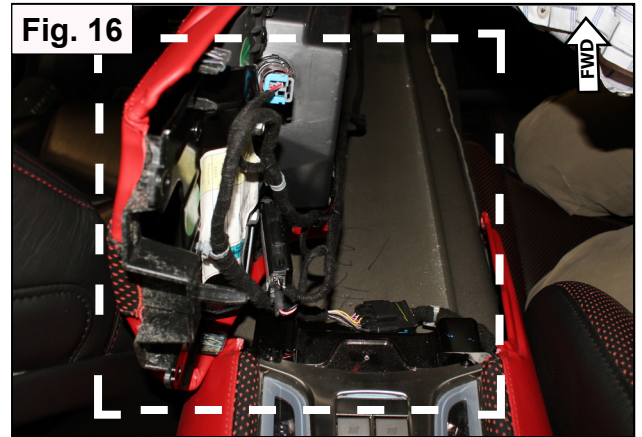
16. Carefully disconnect all the connectors at the trailing edge of the center console, as shown in Figure 16.

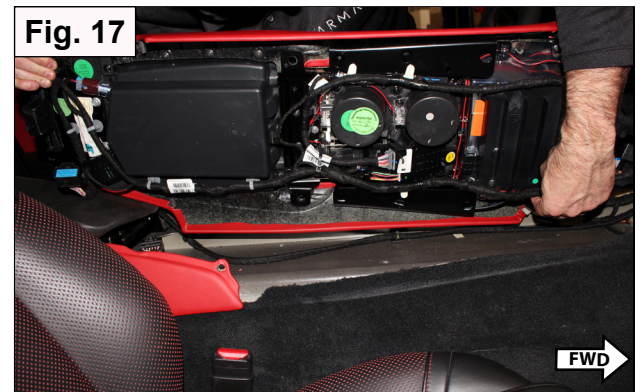
17. Carefully lift and place the center console on its side. Undo any clips securing the harnesses to the bottom of the center console, as shown in Figure 17.

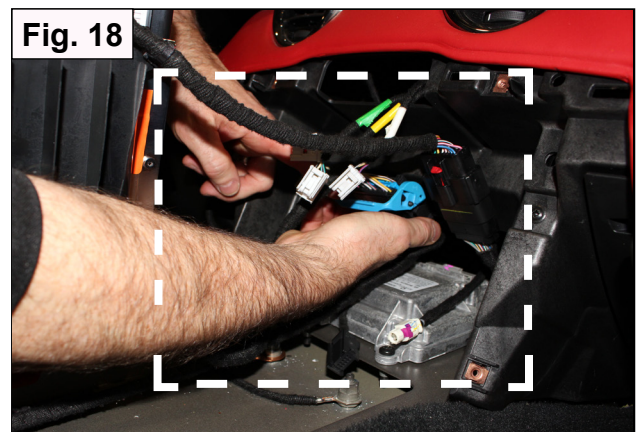
18. Carefully move all TPI harnesses away from the Airbag Control Unit (ACU), as shown in Figure 18.

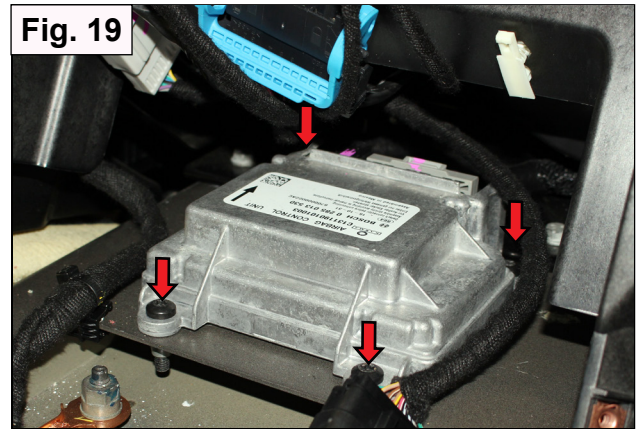
19. Remove four (4) Torx-head screws from the ACU (Fig. 19).

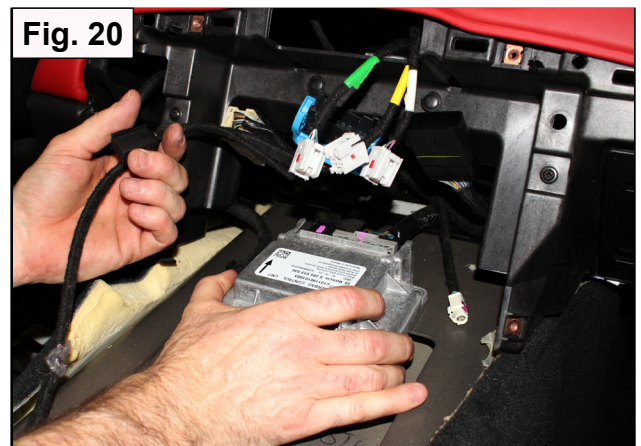
20. Gently pull the Airbag Control Unit (ACU) away from the mounting location on the battery tunnel, as shown in Figure 20.

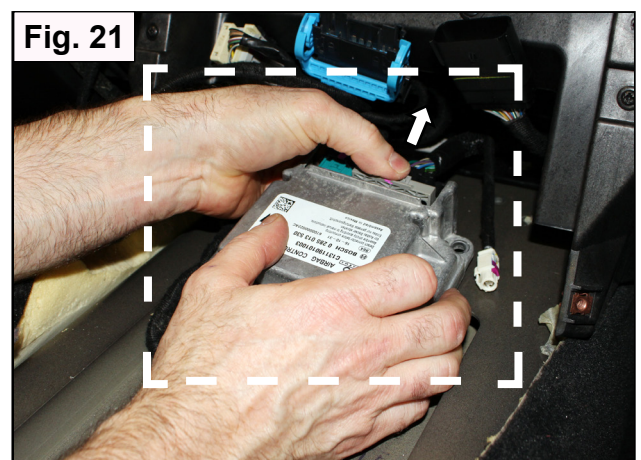
21. Carefully disconnect two (2) connectors from the back of the ACU, as shown in Figure 21.

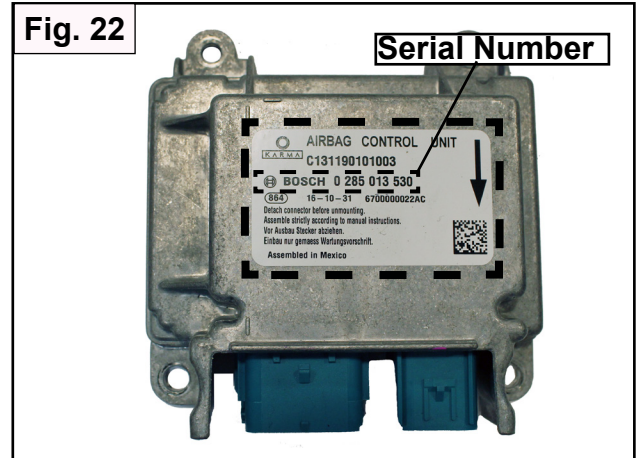
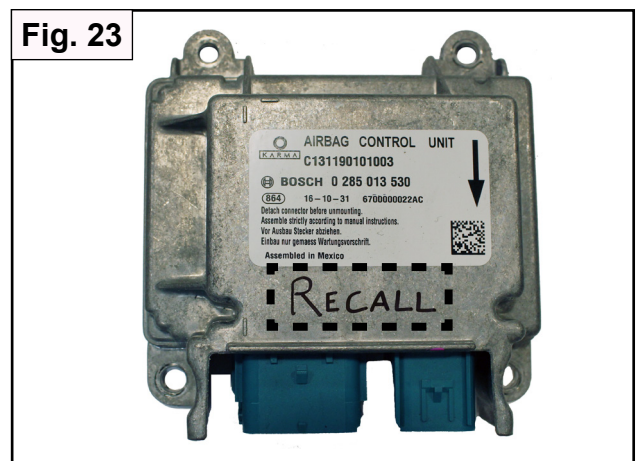
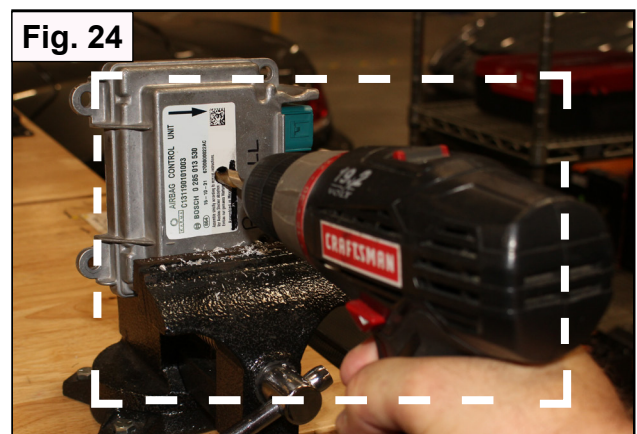
22. Use a camera to take a clear photograph of the serial number on the label for the original ACU, as well as the label on the replacement ACU (Fig. 22).

23. Original Airbag Control Units (ACU), being returned to Karma for disposal, **MUST** have the word “**RECALL**” written on them for identification purposes, as shown in Figure 23.

24. Destroy the original Airbag Control Unit (ACU) by drilling through the body of the ACU, as shown in Figure 24. **NOTE: Do NOT** drill through the serial number on the Airbag Control Unit (ACU).

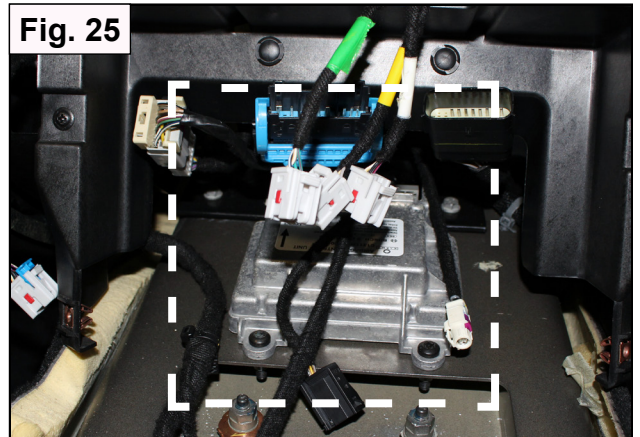
Fig. 25

26. Install the replacement Airbag Control Unit (ACU) (P/N C131190101004), by reversing the removal steps (Fig. 25).

Tightening Torque: 8Nm (± 1.2 Nm)

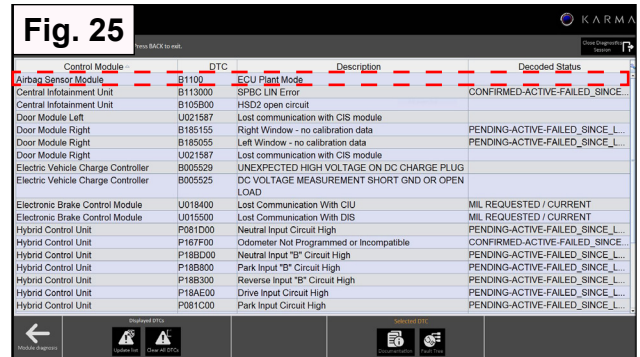
29. Use KarmaSync to scan for DTCs and verify that fault code **B1100** is present in the system (Fig. 25).

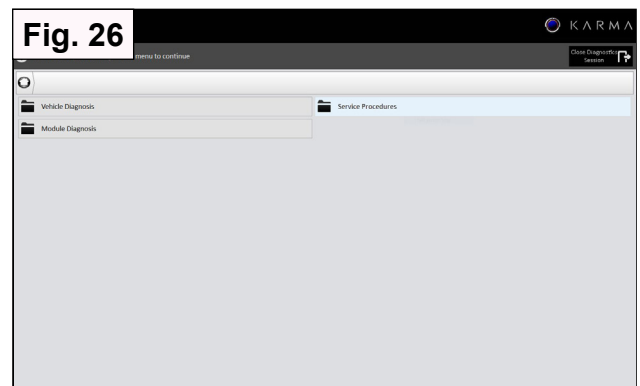
30. After checking for DTCs, return to the homescreen and click on **Service Procedures** (Fig. 26).

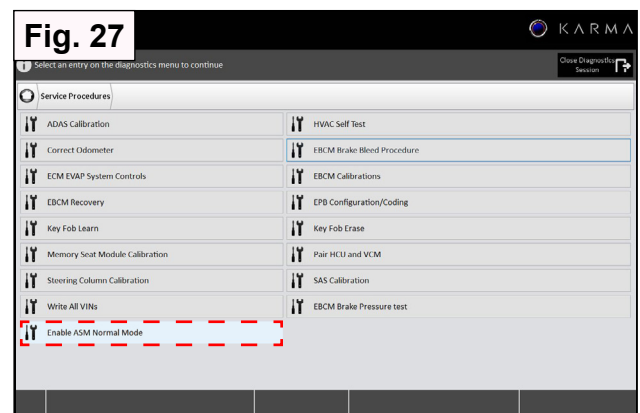
31. Next, click on **Enable ASM Normal Mode** (Fig. 27).

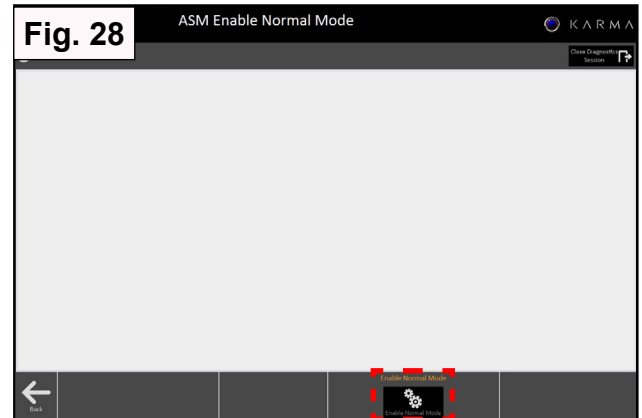
32. Once in the system Enable ASM Normal Mode screen, click on **Enable Normal Mode** (Fig. 28).

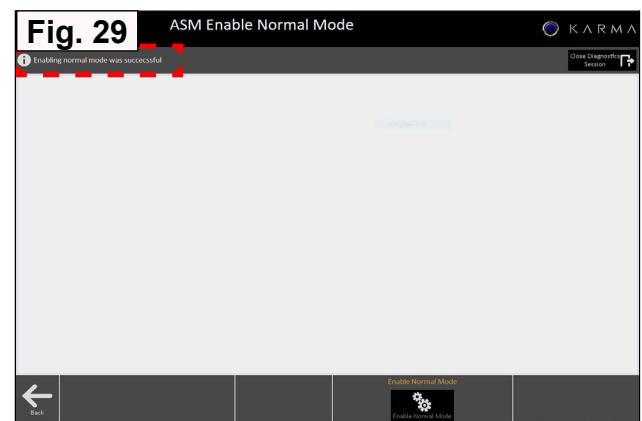
33. If the process is successful, the system will report “**Enabling Normal Mode was Successful**” (Fig. 29). **NOTE: If the operation fails, please update the TSS case with the details and wait for instructions.**

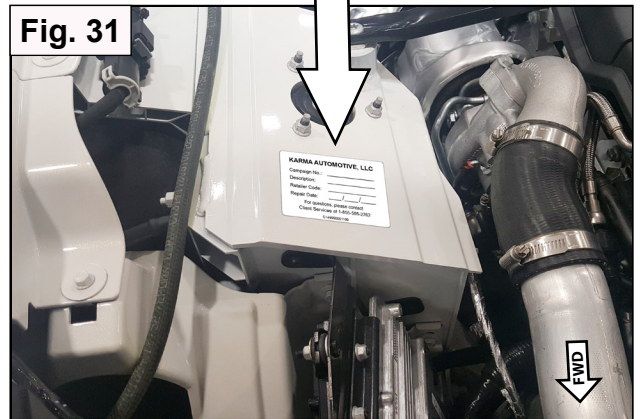
Fig. 31

35. Fill out and adhere the recall campaign completion label (Fig. 30) to the passenger side shock tower, as shown in Figure 31. This will serve as a clear indication that the recall has been performed and is **REQUIRED** to ensure compliance with the Airbag Control Unit (ACU) Safety Recall Campaign.
