Technical Service Bulletin

GROUP	NUMBER	
RECALL	19-01-015H	
DATE	MODEL(S)	
APRIL, 2019	VELOSTER (JS) VELOSTER (JS N)

2019MY VELOSTER (JS) & VELOSTER (JS N) DRIVER'S SIDE DOOR LATCH AND DOOR CHANNEL REPLACEMENT

(RECALL CAMPAIGN 183)

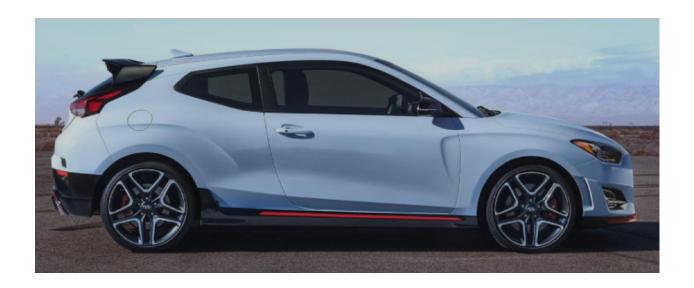
Description: This bulletin describes the procedure to replace the driver's side door latch and lower door channel on certain 2019MY Veloster (JS) and Veloster (JS N) vehicles. In certain side impact crashes, the driver's door latch housing and cable can become damaged allowing the driver's door to open.

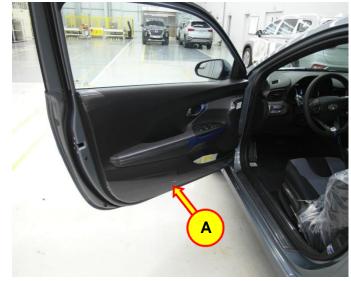
1. Open the driver's side door (A).

Be sure to place the driver's side window in the fully rolled up position.

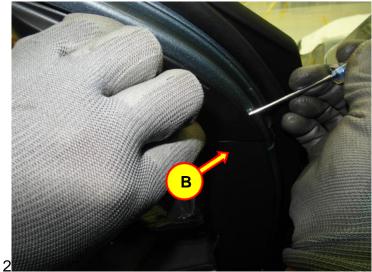
2. Using an automotive trim removal tool, gently pry and remove the front inner door cover (B).

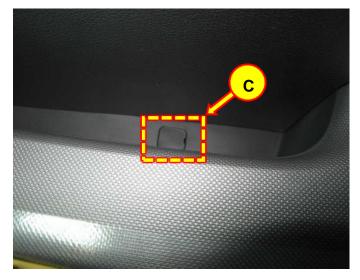
3. Open and remove the trim mounting cap (C), loosen and remove the screw.

Tightening Torque: 2.8 ~ 3.6 lb-ft (3.9 ~ 4.9 Nm)

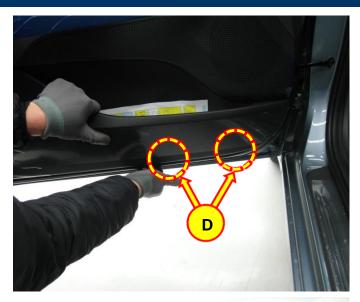
4. Pull the front door trim at the lower edge (D) to separate the trim.

Be careful not to damage the clips. If the trim clips are damaged, replace them with new ones.

5. Release the lock (E) and remove the door inside handle cage.

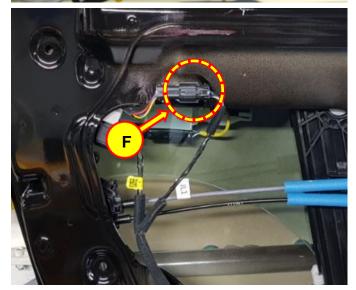
6. Disconnect the outside door handle connector (F).

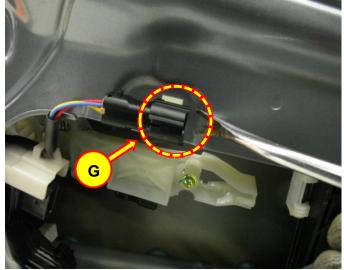
7. If vehicle is smart key equipped, carefully remove the outside door handle connector (G).

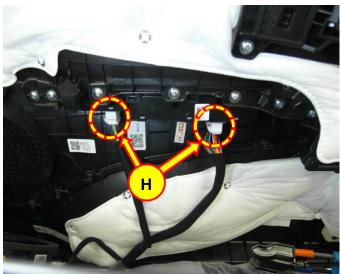
8. Disconnect the door trim connection connectors (H).

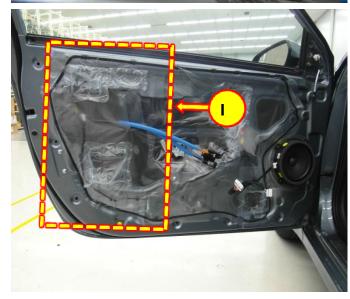
9. Partially separate the door trim seal section (I).

Be careful not to damage the door trim seal. If it gets damaged, replace it with a new one.

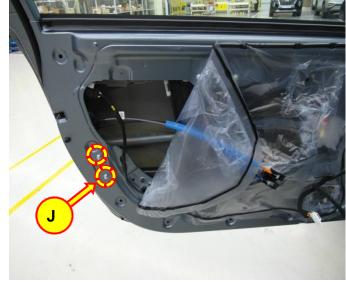
10. Loosen and remove the lower door channel mounting nuts (J).

Tightening Torque: 2.8 ~ 4.3 lb-ft (3.9 ~5.8 Nm)

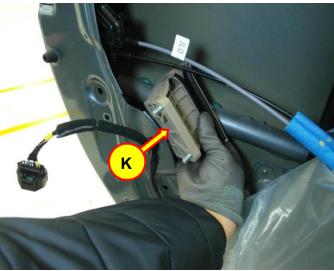
11. Remove the lower door channel (K).

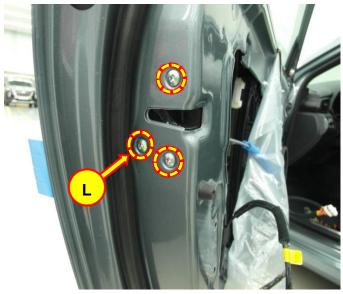
12. Loosen and remove the door latch mounting screws (L).

Tightening Torque: 5.0 ~ 7.9 lb-ft (6.8 ~10.7 Nm)

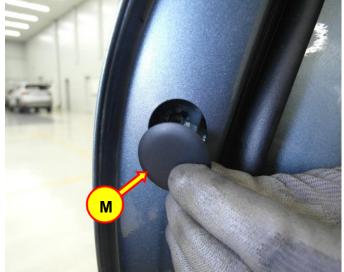
13. Remove the hole plug (M).

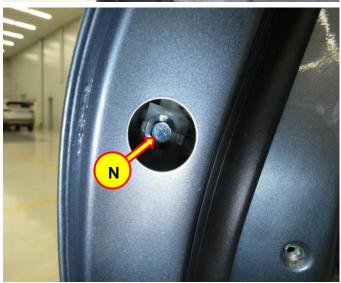
14. Loosen and remove the outside handle mounting bolt (N).

Tightening Torque: 5.7 ~ 8.6 lb-ft (7.8 ~11.7 Nm)

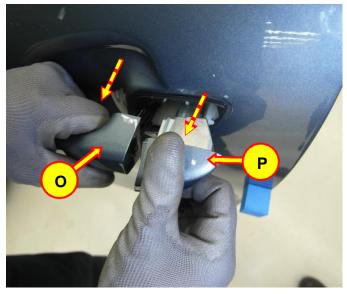
15. Pull the door handle out slightly (O) and remove the door cover (P).

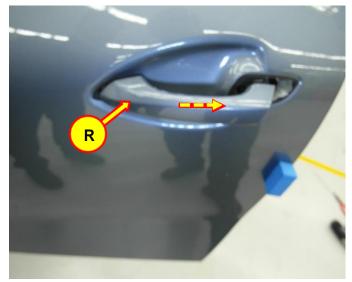
16. Push the outside handle (R) to the right and remove it.

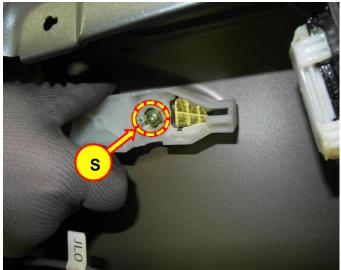
17. Partially loosen the door latch rod mounting bolt (S).

Tightening Torque: 2.8 ~ 5.7 lb-ft (3.9 ~ 7.6 Nm)

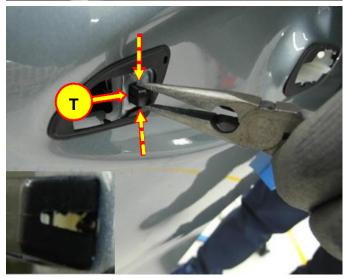
18. Squeeze the upper and lower sides of the door latch rod mounting clip (T) at the same time and remove it.

When removing the mounting clip, wrap the end of the tool with tape.

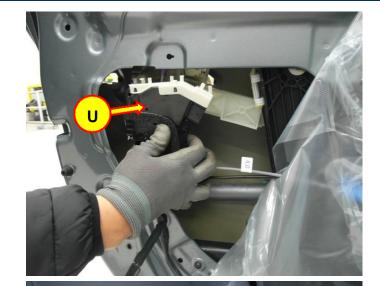
19. Remove the door latch (U).

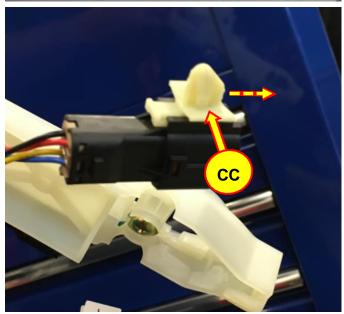
24. If vehicle is Smart Key equipped, remove the wire mounting connector (CC) from the door latch. Keep it as it is needed for the new door latch.

Be careful not to damage the mounting connector. If it gets damaged, replace it with a new one.

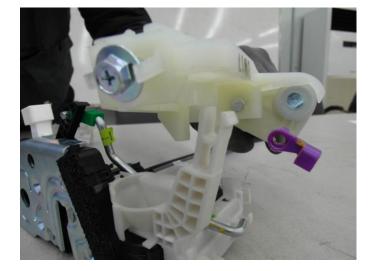
- 25. Using the new door latch and new lower door channel, reinstall the removed parts in reverse order of removal.
 - a. If vehicle is Smart Key equipped, be sure to reuse the wire mounting connector, wire, and door latch rod on the new door latch.
 - b. If vehicle is non-Smart Key equipped, be sure to reuse the door latch rod on the new door latch.
