| RE: Recall Campaign Launch Notification Brake Pedal Plate Welding MY19 177 (A-Class) | DATE: May 24, 2019 |

Campaign No. 2019050002, May 2019

SUBJECT: **Model A-Class vehicles (177 platform)**
Model Year 2019
Check brake pedal, replace if necessary

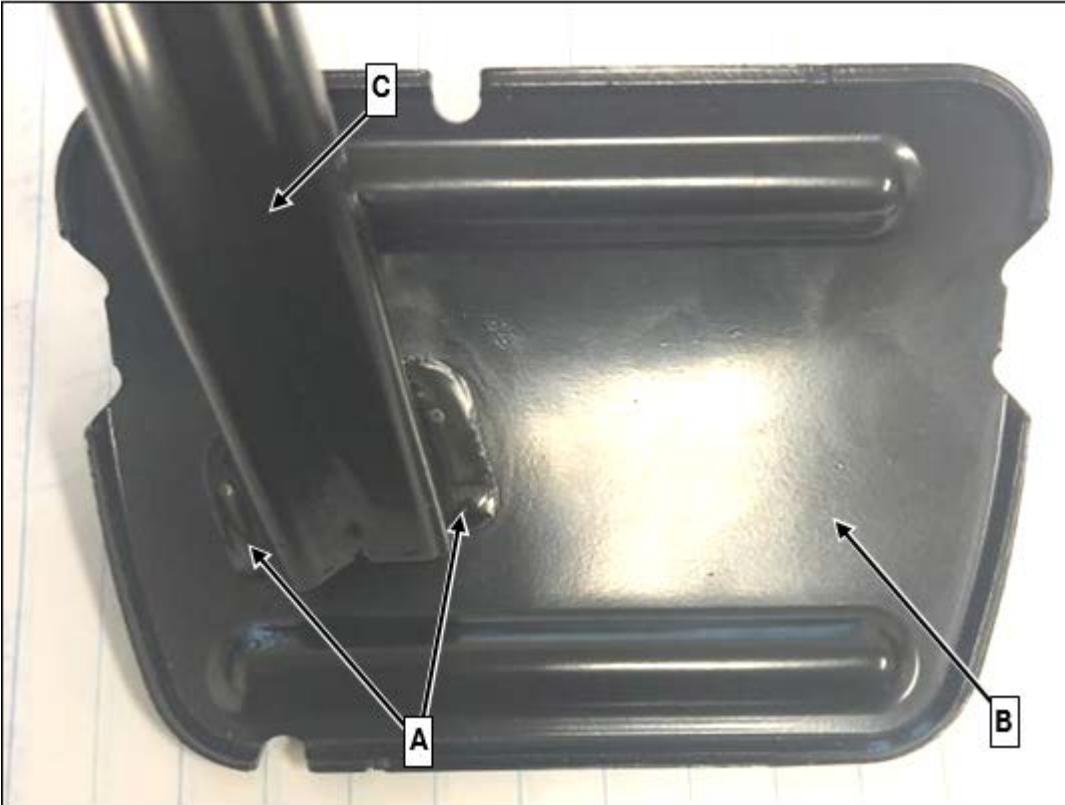
Figure 1

i It is possible that the weld seams (A) connecting the pedal plate (B) to the pedal lever (C) of the brake pedal may have been manufactured incorrectly during production of the brake pedal (Figure 1).

i The pedal plate may bend from the pedal lever when the brake pedal is depressed.

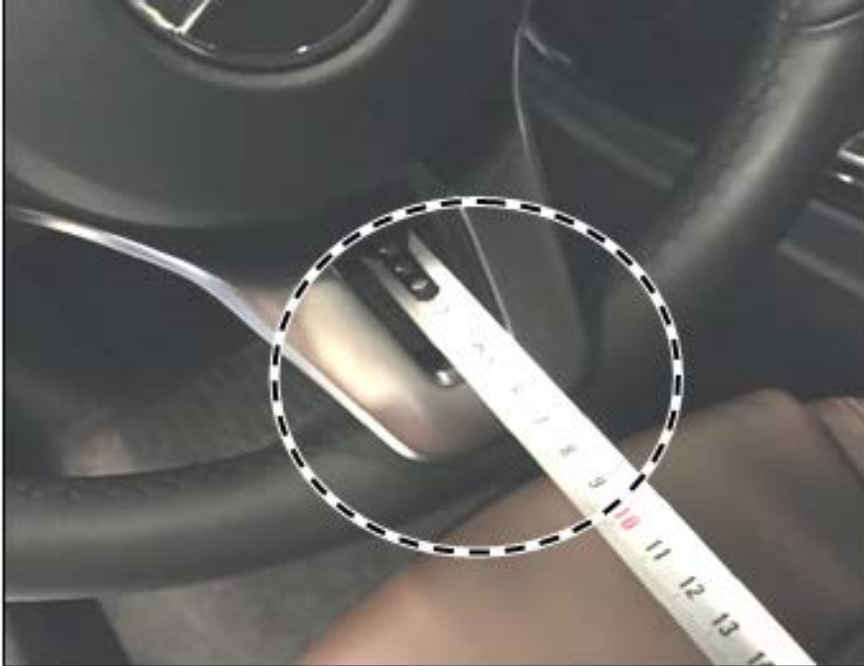
Figure 2

1. The vacuum in the brake booster must be reduced.
i To do this, the brake pedal must be fully depressed five times.
2. Feed a tape measure through the bezels of the steering wheel (**Figure 2**).

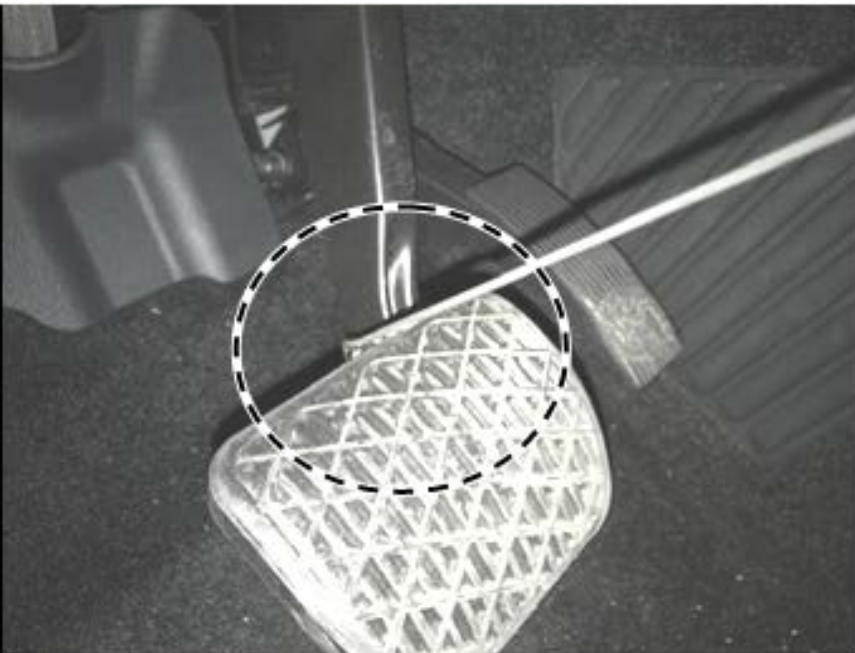
Figure 3

3. Hook the tape measure into the pedal plate of the brake pedal (**Figure 3**).

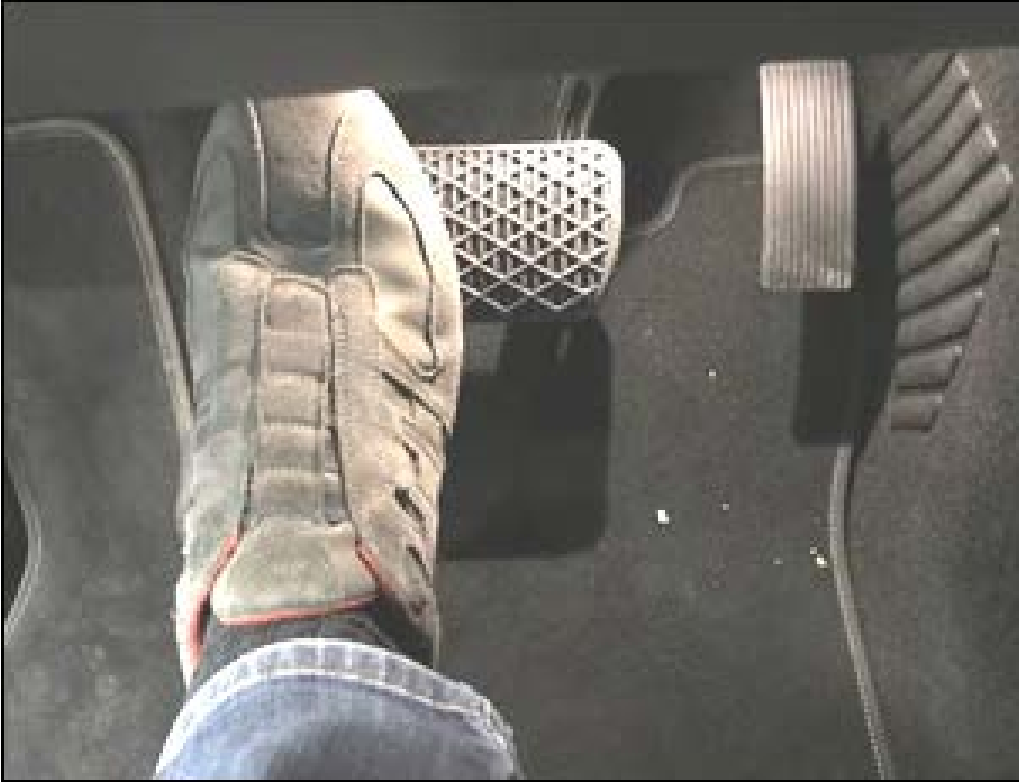
Figure 5

- 3.1. Depress the brake pedal on the outer left side of the pedal plate by at least **7 cm** (**Figure 5**).

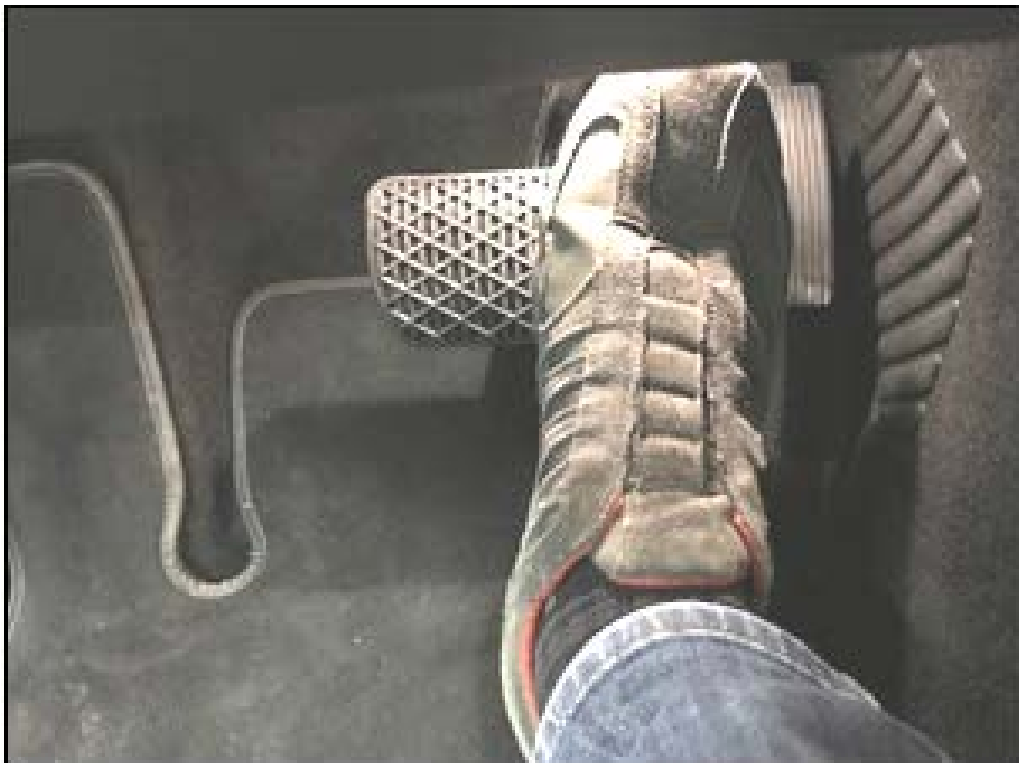
Figure 6

3.2. Depress the brake pedal on the outer right side of the pedal plate by at least 7 cm (Figure 6).

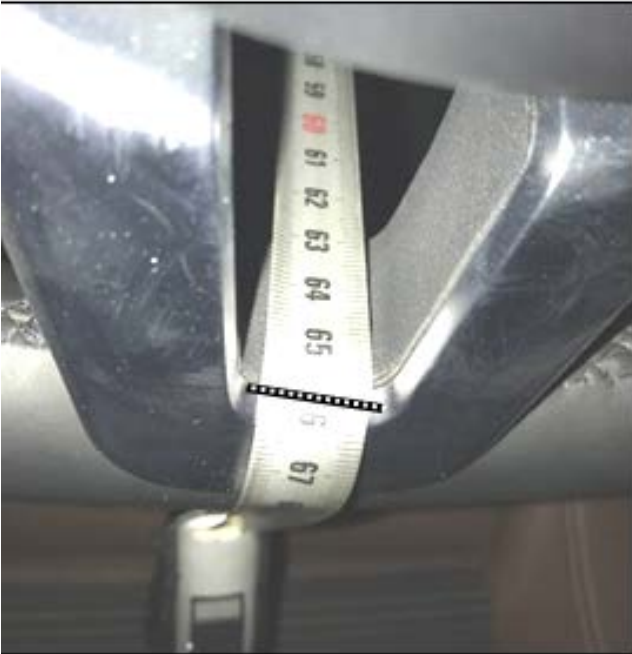
Figure 7

3.3. The pedal travel (**at least 7 cm**) can be determined by reading off the tape measure at the steering wheel (**Figure 7**).

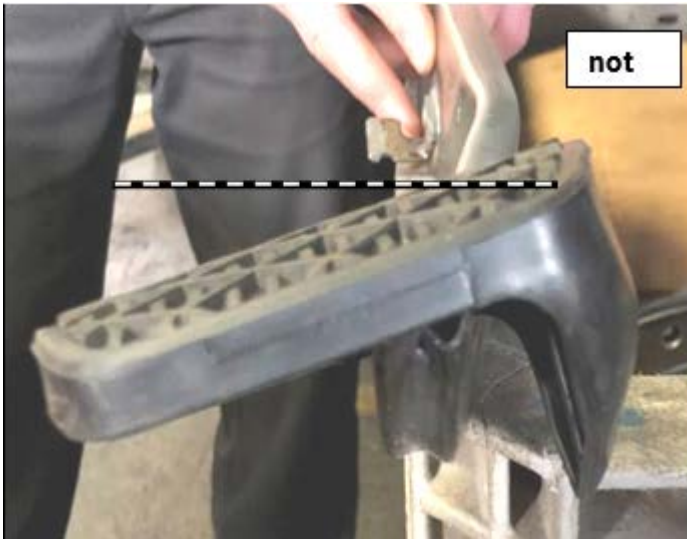
Figure 8 (normal position of the brake pedal =

3.4. Check whether the position of the pedal plate in relation to the pedal lever of the brake pedal has changed.

i The pedal plate must **not** become bent from the pedal lever of the brake pedal!

i Figure 8 shows a **not OK example** of a removed brake pedal.

1. Replace brake pedal.
