# TECHNICAL INSTRUCTIONS

SAFETY RECALL K0G

POTENTIAL UNINTENDED OR NON-DEPLOYMENT OF PASSENGER SIDE  
FRONT SEAT AND CURTAIN SHIELD AIRBAGS

CERTAIN 2019 SIENNA

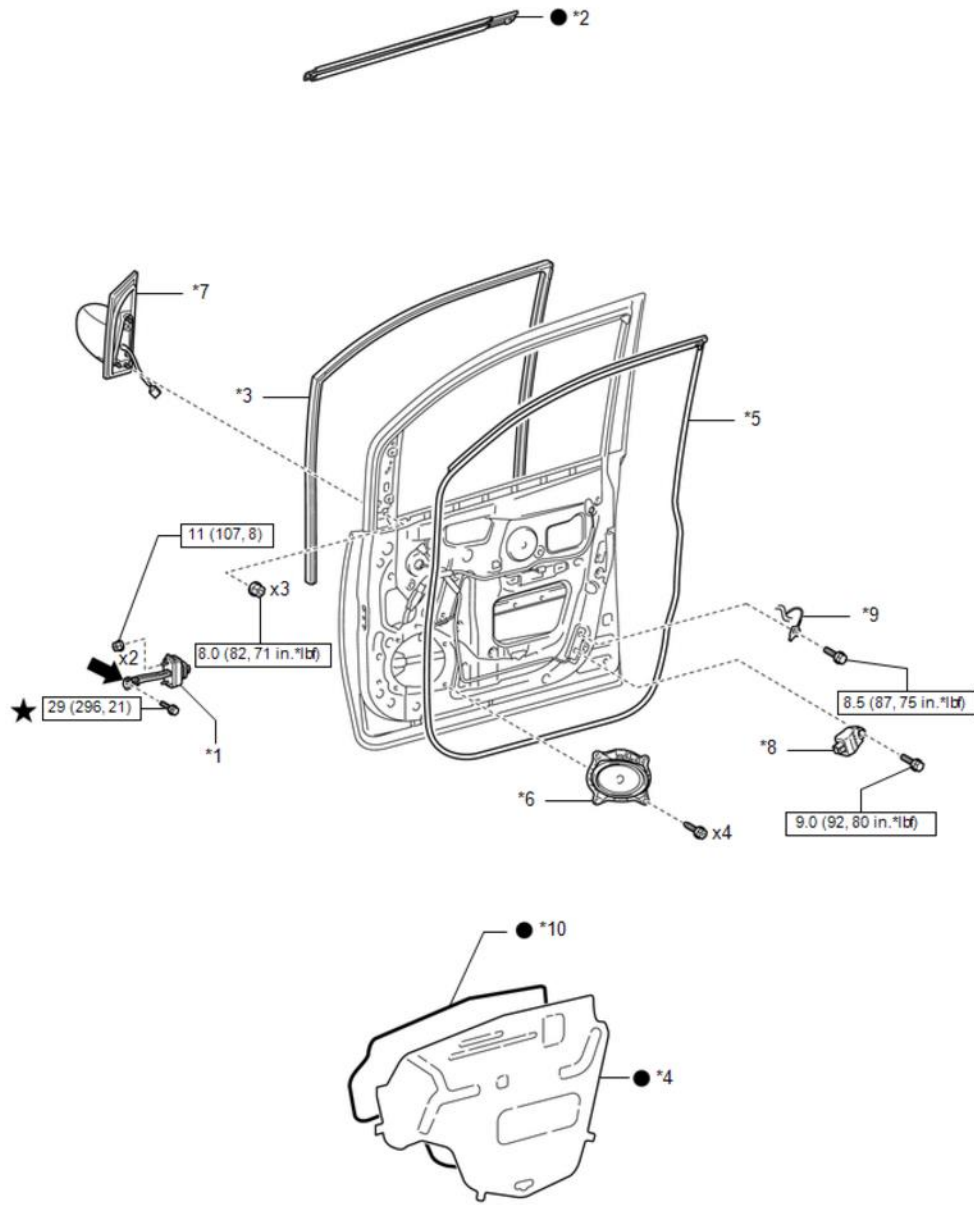
*1	FRONT DOOR CHECK ASSEMBLY	*2	FRONT DOOR GLASS OUTER WEATHERSTRIP ASSEMBLY
*3	FRONT DOOR GLASS RUN	*4	FRONT DOOR SERVICE HOLE COVER
*5	FRONT DOOR WEATHERSTRIP	*6	FRONT NO. 1 SPEAKER ASSEMBLY
*7	OUTER REAR VIEW MIRROR ASSEMBLY	*8	SIDE AIRBAG SENSOR
*9	GROUND WIRE	*10	BUTYL TAPE
	N*m (kgf*cm, ft.*lbf): Specified torque	•	Non-reusable part
	MP grease	★	Precoated part

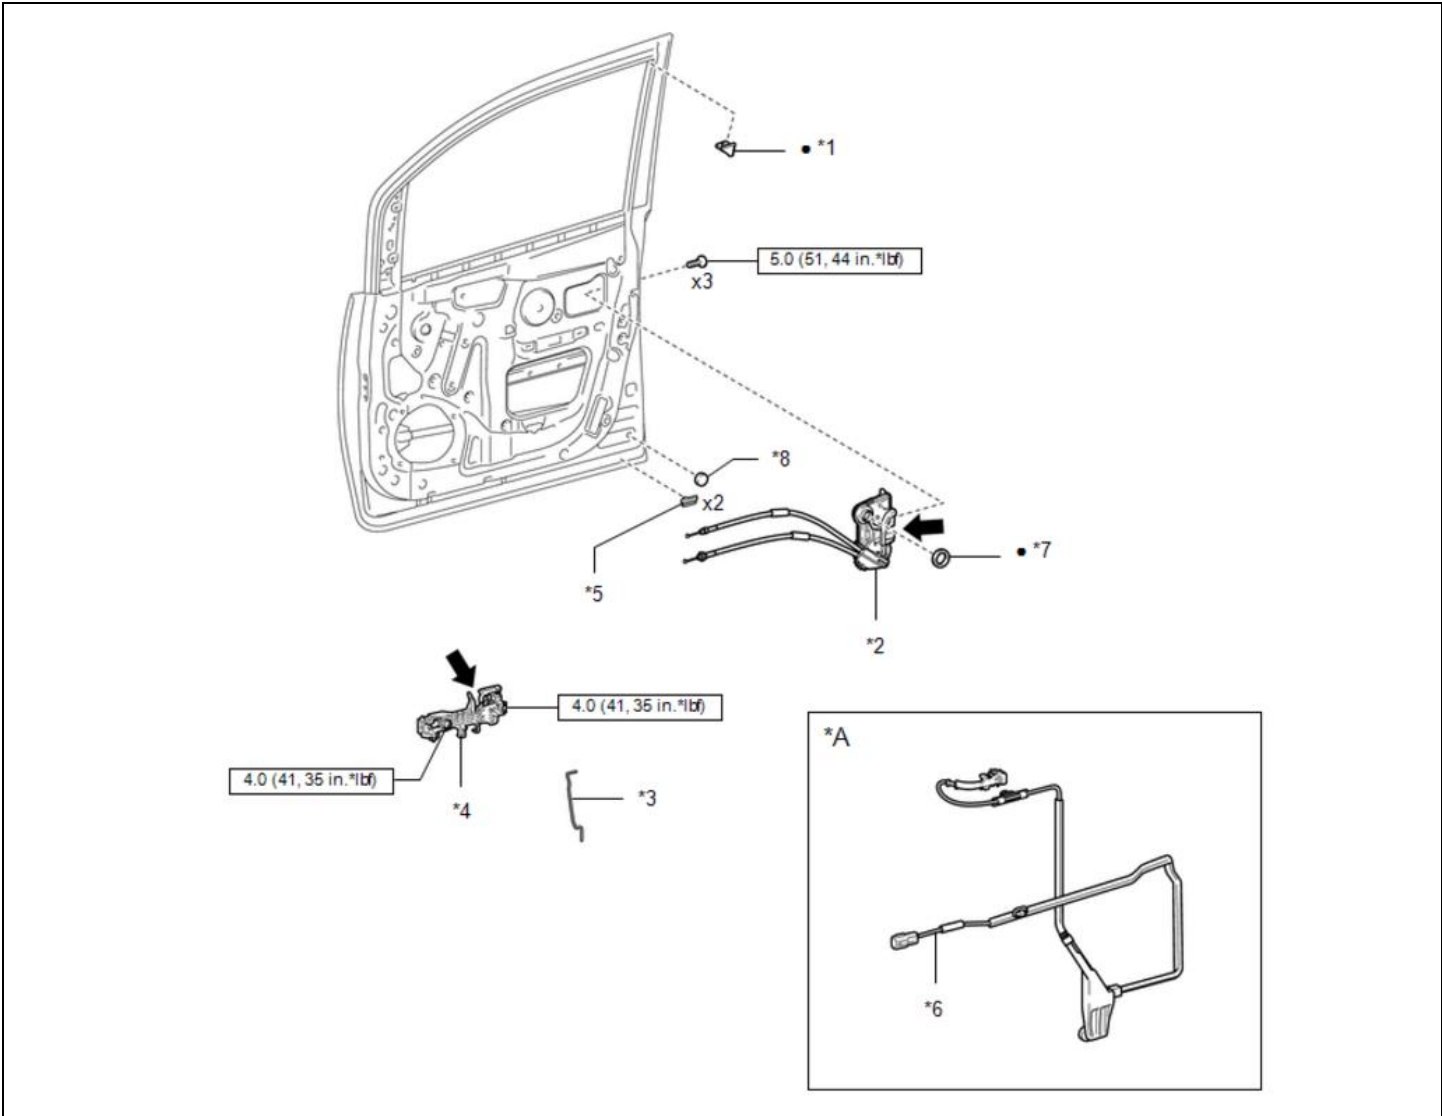
*A	w/ Smart Entry and Start System	-	-
*1	DOOR FRAME GARNISH	*2	FRONT DOOR LOCK ASSEMBLY
*3	FRONT DOOR LOCK OPEN ROD	*4	FRONT DOOR OUTSIDE HANDLE FRAME SUB-ASSEMBLY
*5	FRONT DOOR VENT SEAL	*6	FRONT DOOR WIRE
*7	DOOR LOCK WIRE HARNESS SEAL	*8	CUSHION
	N*m (kgf*cm, ft.*lbf): Specified torque	•	Non-reusable part
	MP grease	-	-

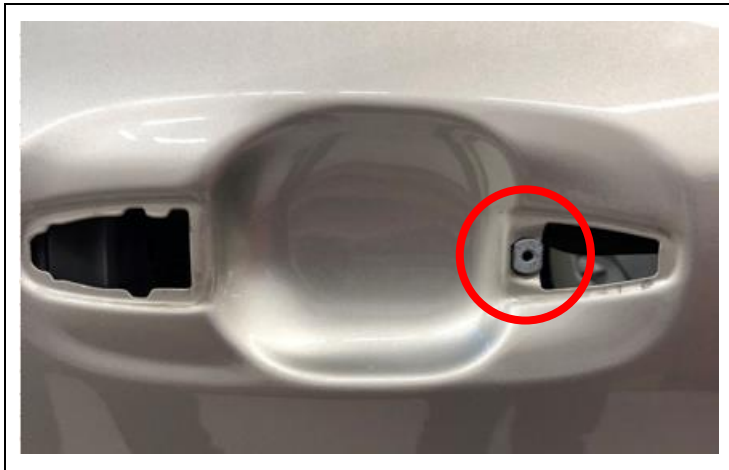
- b. Remove the door handle nut from the original door, as it will be reused. The nut will slide forward to be removed.

c. Install the door handle nut into the **NEW** door, as removed in step VI. 1b on page 8.
