TECHNICAL INSTRUCTIONS

SAFETY RECALL K0F

FRONT SEAT SIDE AND CURTAIN SHIELD AIRBAGS MAY NOT DEPLOY AS INTENDED

CERTAIN 2015 – 2017 MODEL YEAR YARIS

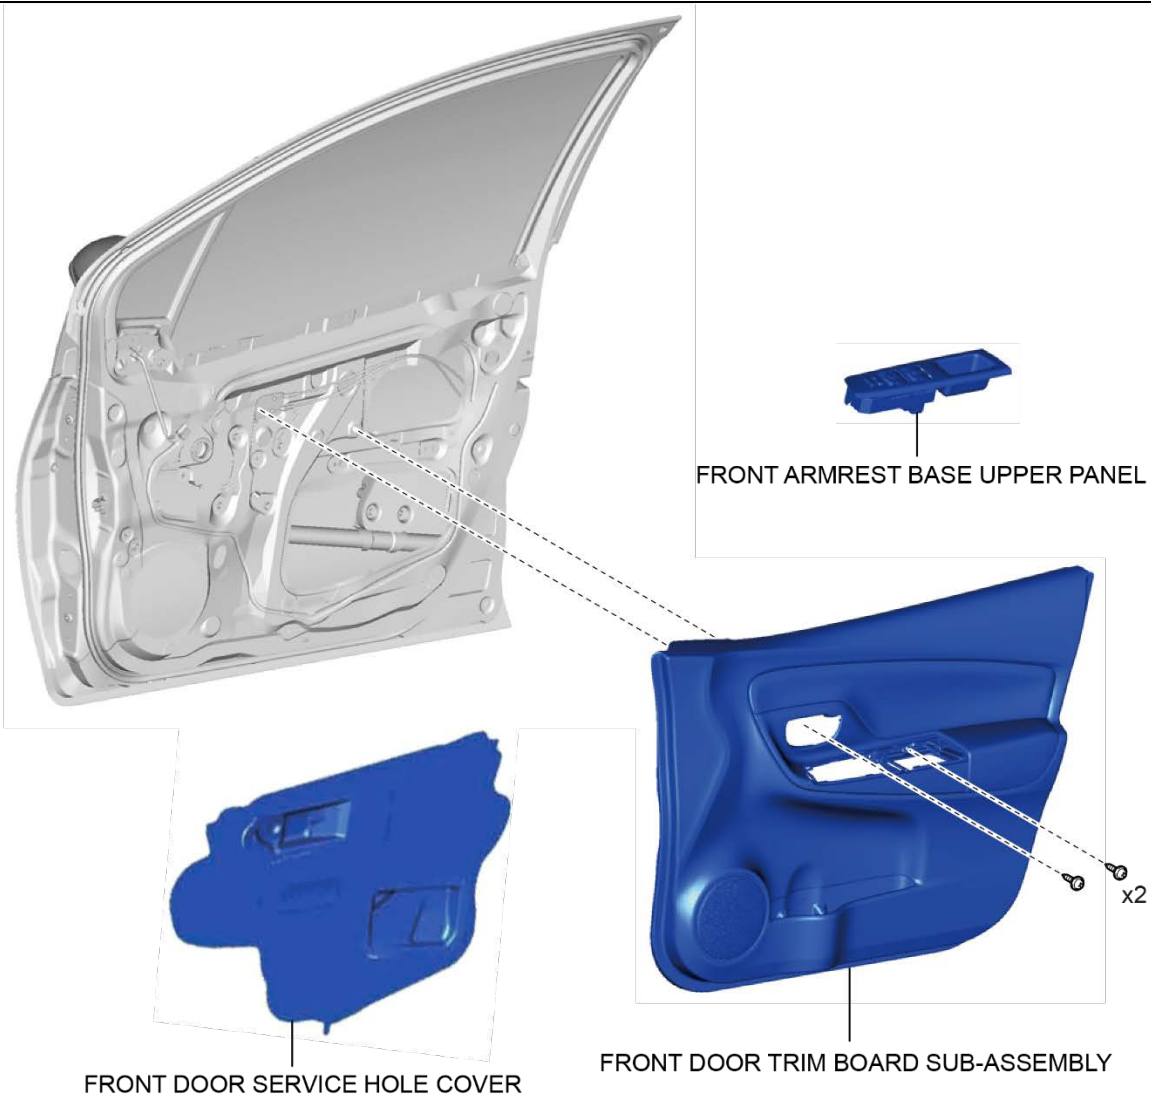
V. WORK PROCEDURE
A. COMPONENTS

BE CAREFUL!
 This component will be reused.
Handle Service Hole Cover With Care

● :Component to be replaced

[N*m (kgf*cm, ft.*lbf)] : Specified torque

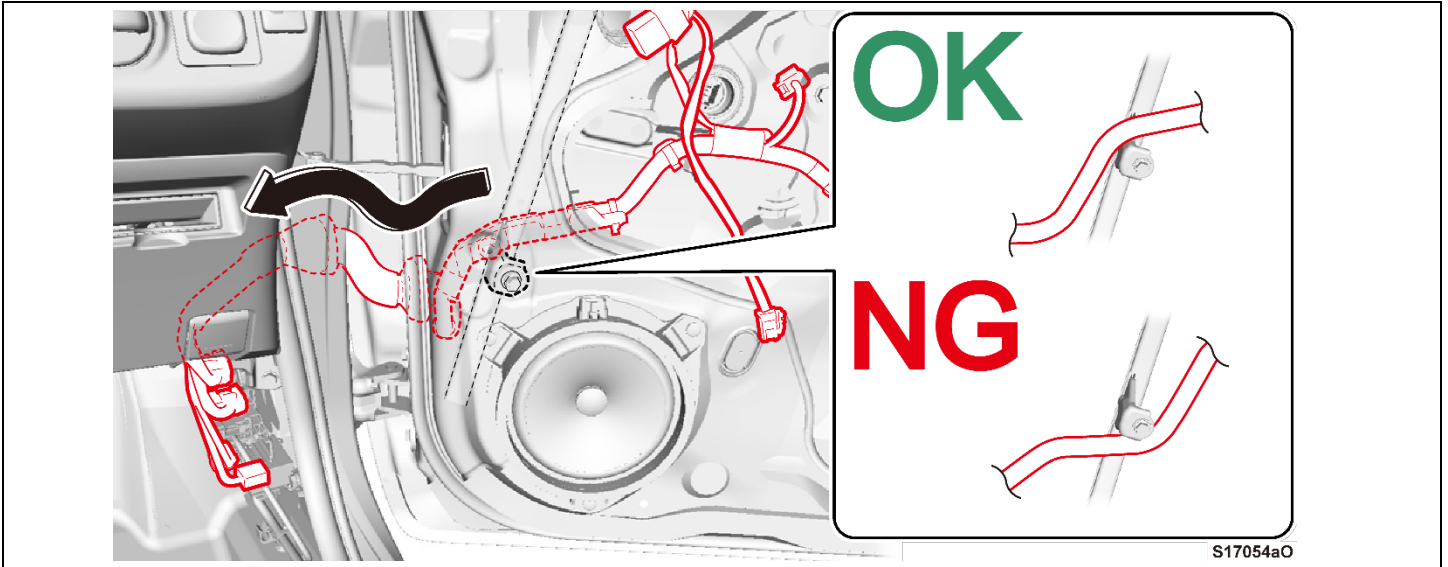
- b. Pass the front door wire through the door toward the vehicle interior, making sure that the alignment marks on the grommets are at the top.

STOP *DO NOT* twist the wire harness.

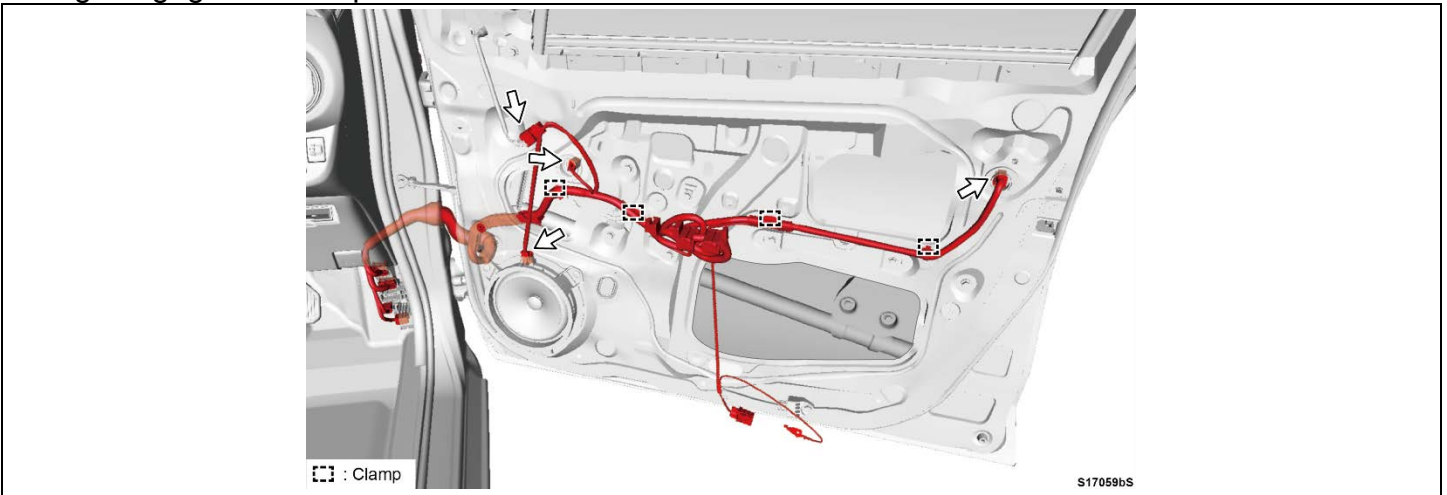
f. Install the front door grommets with the alignment marks at the top (in the range specified in the illustration)

STOP *DO NOT twist the corrugated part.*

g. Engage the clamps and connect the connectors.
