**AKA7 - Checking Control Unit for Air-Conditioning Blower and Replacing it if Necessary (Recall Campaign)**

Revision: **June 26, 2019**

Model line: **Panamera (970)**

Subject: **Control unit for air-conditioning blower**

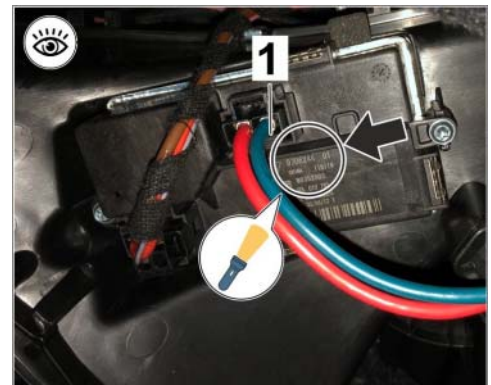
- 2 Illuminate control unit for air-conditioning blower ⇒ *Reading off part number -1-* using a shop light so that the part number is visible.

*Reading off part number*

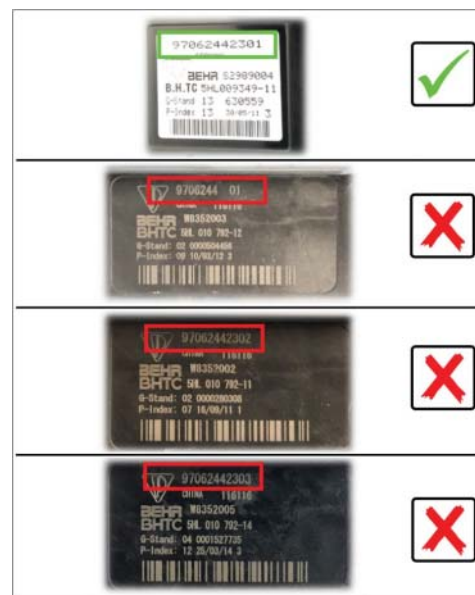
Comparing part number

Part number that was read off	Next steps
97062442301	Control unit for air-conditioning blower <b>does not have to be replaced.</b> -End of action required- Continue with <b>Step 4.</b>
9706244 01 or 97062442302 or 97062442303	Control unit for air-conditioning blower <b>must be replaced.</b> To do this, continue with <b>Step 3.</b>

3 Replace control unit for air-conditioning blower (blower regulator).
