#### **CONDITION OF CONCERN**

On certain subject Mazda6 vehicles in salt belt states, it is possible the front cross member may be corroded due to suspected insufficient paint coating. Continued use of the vehicle may allow the corrosion to progress, causing the support of the right lower control arm to decrease. Passing over a pothole may result in breakage of the cross member and reduced steering control, increasing the risk of a crash.

# **OUTLINE OF REPAIR (Parts are Available to repair failed inspections for all model years)**

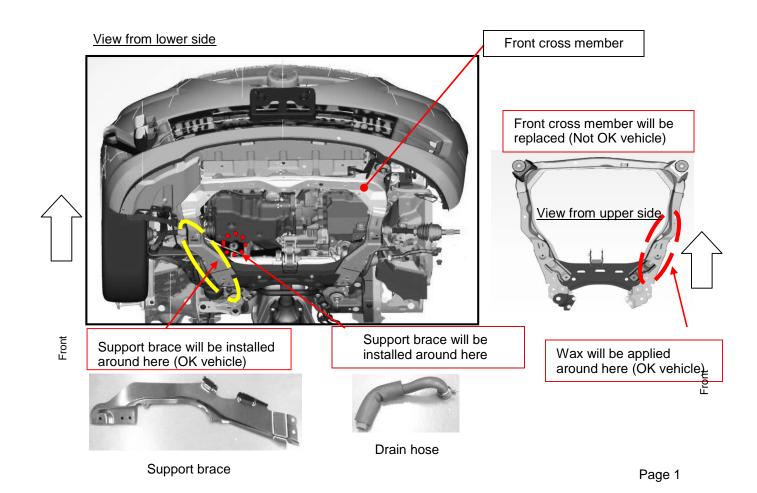
- OK vehicle: If the cross member passes inspection, install a support brace and A/C drain hose, and apply anti-rust cavity wax to the cross member. Parts are currently not available for not launched vehicles. Please return the vehicle back to the owner and wait until parts are available.
- Not OK vehicle: If the cross member fails inspection, replace the cross member with a modified one and install a drain hose.

Please refer to the Inspection and Repair Procedure document on MGSS for the details.
