Product Safety Recall

N182206311 Diesel Engine Block Heater Cord

Release Date: January 2020

Condition	General Motors has decided that a defect which relates to motor vehicle safety exists in certain 2017-2019 model year Chevrolet Silverado 2500/3500 vehicles, certain 2017-2019 model year GMC Sierra 2500/3500 vehicles and certain 2019 Chevrolet Silverado 4500/5500/6500. In vehicles equipped with the Duramax diesel 6.6 liter engine and the optional engine-block heater cord, a short-circuit condition may develop in the engine-block heater cable or in the terminals that connect the heater cable to the block heater. A short-circuit condition can cause damage to engine components and, in rare cases, start a fire in the engine compartment.
Correction	For Silverado 2500/3500 and Sierra 2500/3500: Dealers are to replace the engine-block heater and cord. For Silverado 4500/5500/6500: Dealers are to replace the engine-block heater. For Silverado 2500/3500 and Sierra 2500/3500 INVENTORY Units: Dealers are to cut the heater cord and place the customer disclosure in plain view inside the vehicle prior to sale. For customer vehicles, you do not need to disable the engine-block heater. If the c

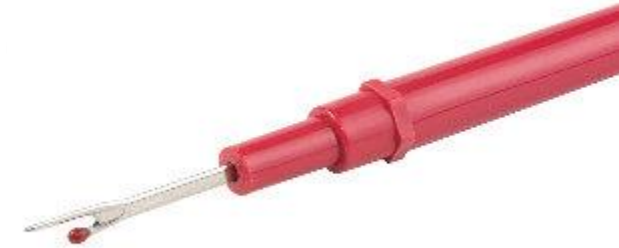
5495374

TIP: A seam ripper is a good example of the type of tool used in the following step.

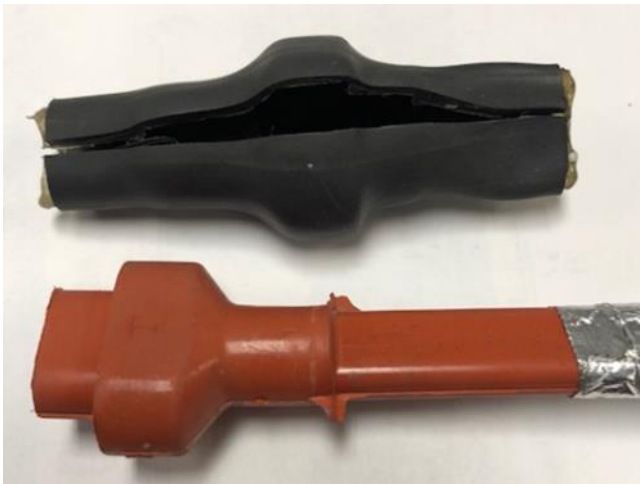
5415696

2. Using an appropriate cutting tool, carefully slice the shrink tube from the power cord. Use care to cut away from the harness itself to ensure that you do not cut into the harness or body of the connector.
3. Inspect the connector cavities and mating surface for any heat shrink tube adhesive. Carefully remove the adhesive if required.

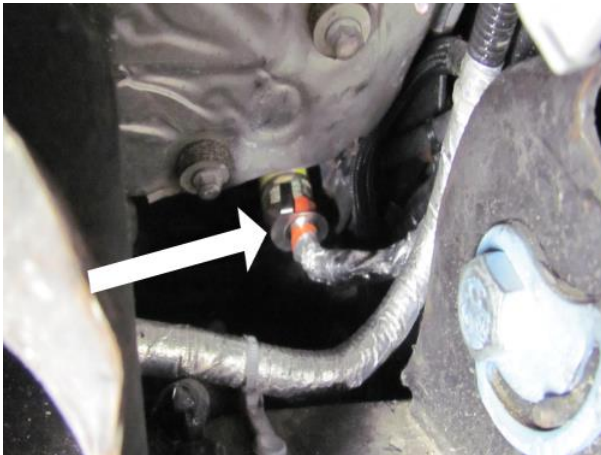
5420813

8. Plug the engine coolant heater cord assembly into the heater and secure it with the metal clip. Be certain the metal retaining clip is secured onto to the deeper of the two grooves.
9. Fill the cooling system. Refer to *Cooling System Draining and Filling (Vac N Fill)* in SI.

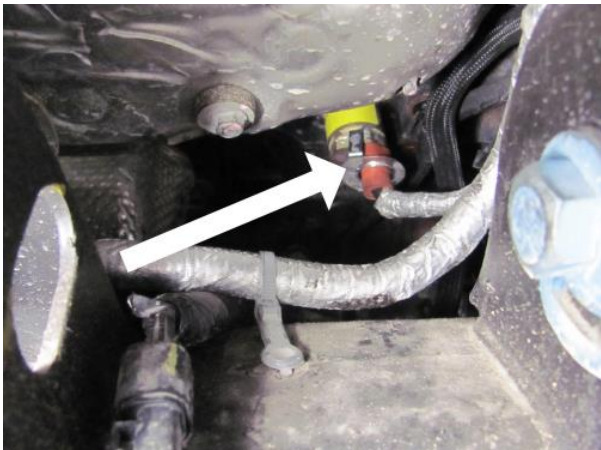
5420809

4. Looking through the area between the wheel house liner and the suspension, locate the engine block heater.
5. Disconnect the engine block heater plug from the heater element by releasing the retainer clip and unplugging.

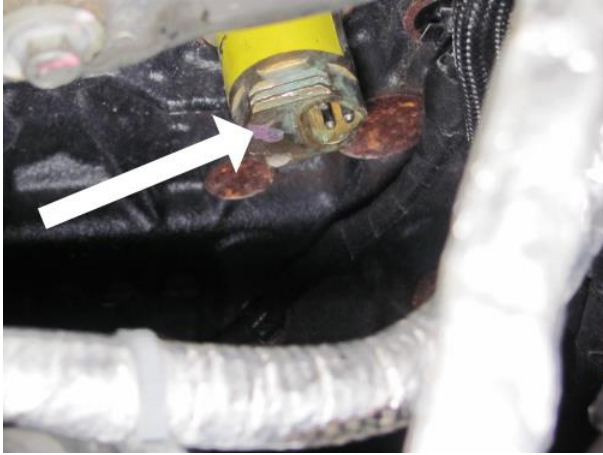
5420812

- Place a large drain pan under the vehicle to capture the coolant. Remove the engine coolant heater. Refer to *Engine Coolant Heater Replacement (L5P)* in SI.
- After removing the original block heater, take care to remove the old cured thread sealant in the block. Failure to remove the old thread sealant will result in cross threading the replacement block heater.

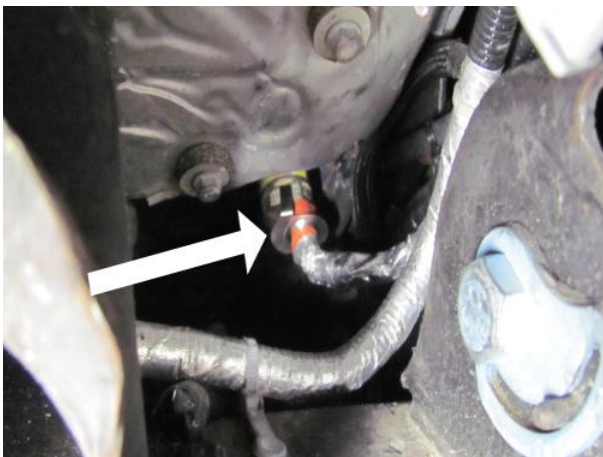
5420813

- Plug the new engine coolant heater cord assembly into the heater and secure it with the metal clip. Be certain the metal retaining clip is secured onto to the deeper of the two grooves.

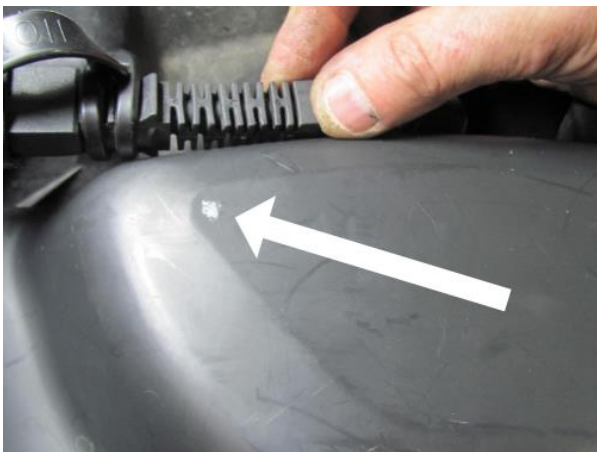
5420818

18. Locate the drill location on the front compartment site-shield. Mark the location.

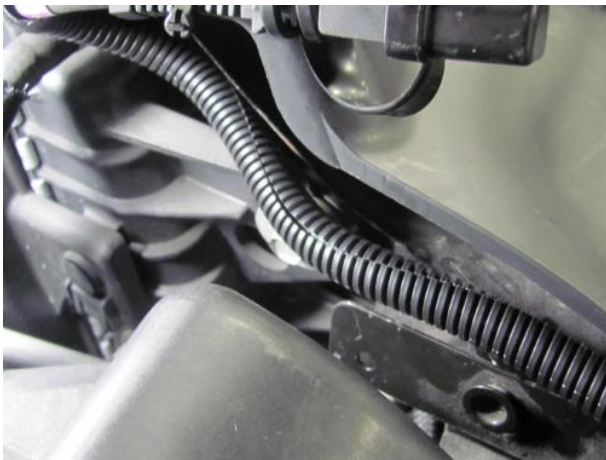
5420820

21. Create a gentle bend in the power cord and place the power cord plug over the hole in the site shield. Ensure the prongs on the power cord plug are facing toward the right fender.

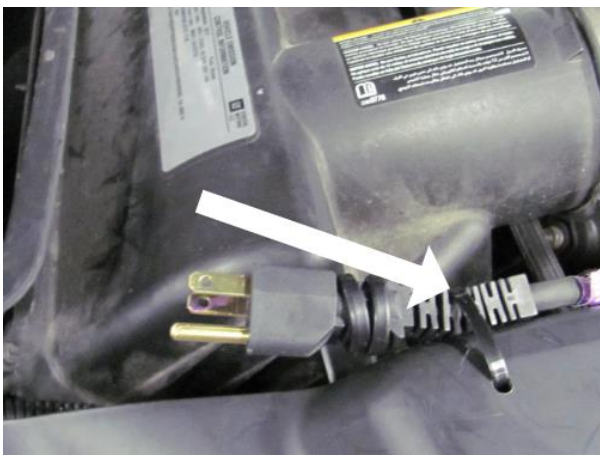
5420823

22. Secure the power cord plug to the to the front compartment shield with a wire tie as shown.

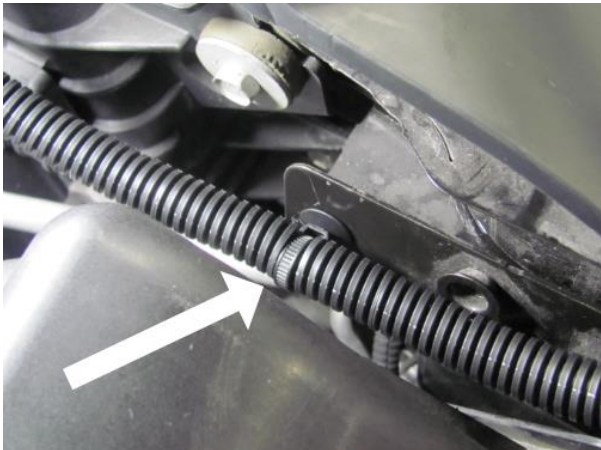
5420825

24. Position the harness up under the front compartment site shield and secure it using the second (closest to the electrical plug) push pin wire tie on the harness.
25. Trim all wire ties as necessary.
26. Fill the cooling system. Refer to *Cooling System Draining and Filling (Vac N Fill)* in SI.

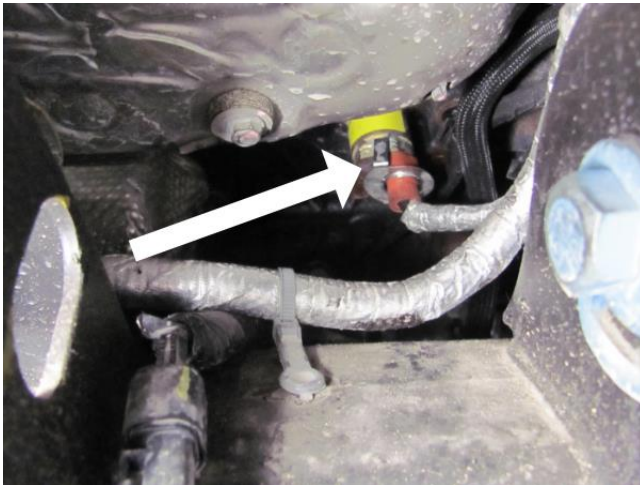
5326653

2. Looking through the area between the wheel house liner and the suspension, locate the engine block heater.

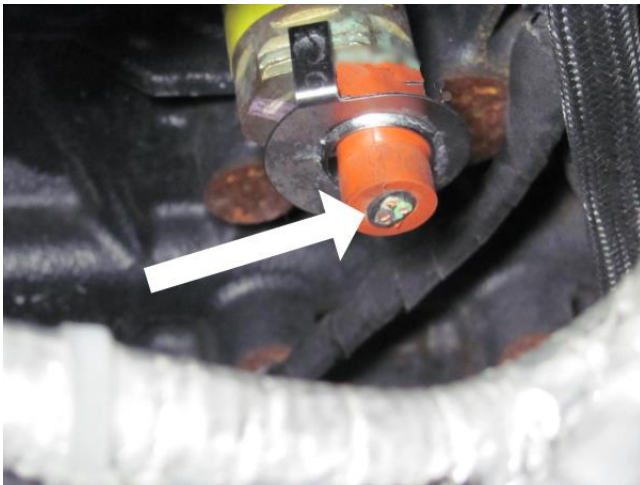
5326659

3. Using a pair of wire cutters, cut the engine block heater power cord from the connector. Cut the cord as close as possible to the connector.
4. With the vehicle still raised, locate and remove any power cord attachments accessible from the underside of the vehicle.
5. Reinstall the right front wheel. Refer to *Tire and Wheel Removal and Installation (8-Lug Wheel)* in SI.
6. With the vehicle lowered, raise the hood and locate the remainder of the engine heater power cord (it should be bundled at the right-side front of dash area).
7. Locate and remove all of the attachment points. Remove the complete engine heater power cord assembly.
8. Discard the power cord assembly.
9. Print the disclosure letter and place it inside the vehicle in plain view.
