Product Safety Recall

N182206310 Diesel Engine Block Heater Cord

Release Date: October 2019

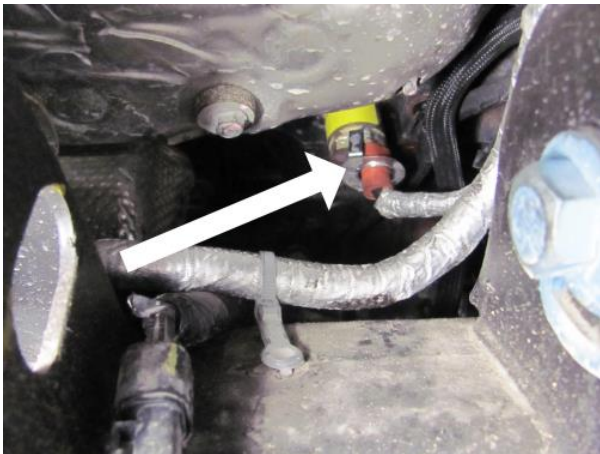
1. Raise the hood and locate the engine heater power cord (bundled at the right-side front of dash area).
2. Locate and remove all of engine compartment power cord attachment points. Route the engine heater power cord assembly to the underside of the vehicle and let it drop.
3. Raise the vehicle and remove the right front wheel. Refer to *Tire and Wheel Removal and Installation (8-Lug Wheel)* in SI.

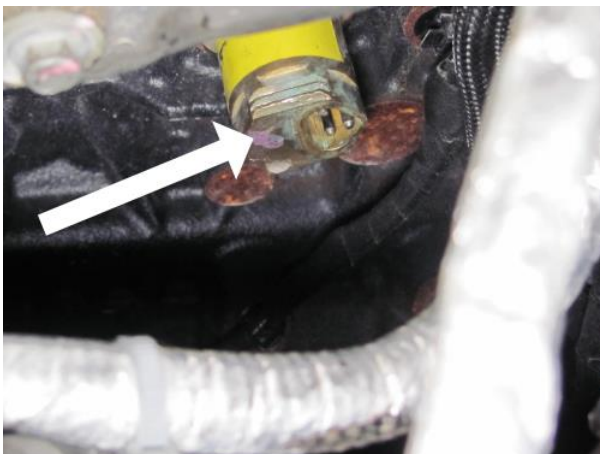
4. Looking through the area between the wheel house liner and the suspension, locate the engine block heater.
5. Disconnect the engine block heater plug from the heater element by releasing the retainer clip and unplugging.
6. Remove any existing engine heater power cord fasteners and remove the power cord. Discard the power cord.

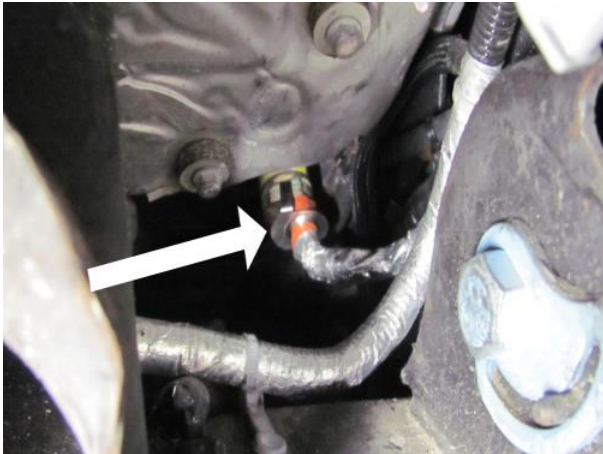
5420813

9. Plug the new engine coolant heater cord assembly into the heater and secure it with the metal clip.

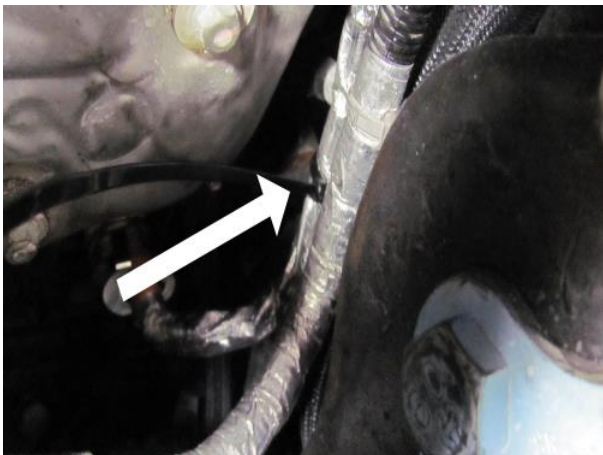
5420814

10. Route the new engine coolant heater power cord to the upper motor compartment. Secure the power cord to the existing wiring harness with a wire tie as shown.
11. Reinstall the right front wheel and tire. Refer to *Tire and Wheel Removal and Installation (8-Lug Wheel)* in SI.
12. Lower the vehicle.

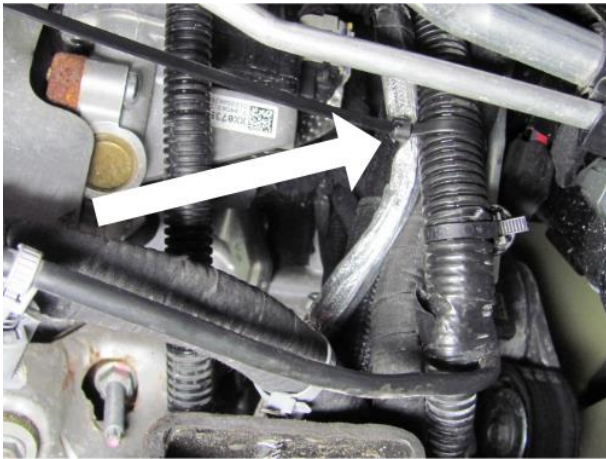
5420815

13. Route the power cord as shown and secure to the existing harness with a wire tie.

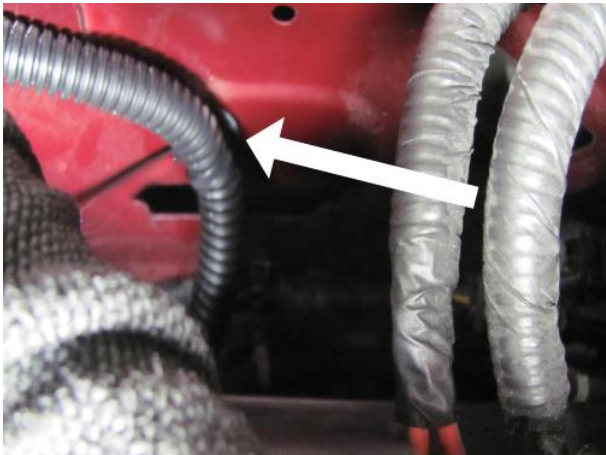
5420816

14. Position the power cord along the inner fender and secure to the existing hole using the first (closest to the heater element) push pin wire tie attached to the harness.

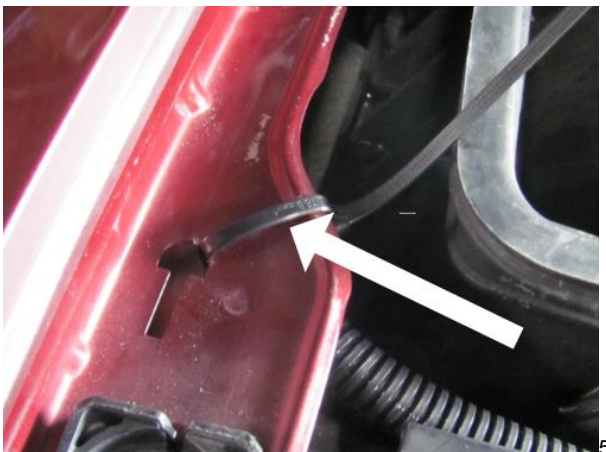
5420817

15. Secure the power cord to the fender flange with a wire tie as shown.

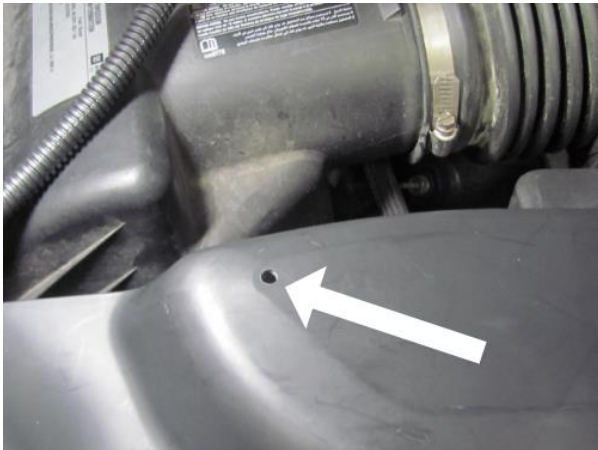
5420819

17. Drill a 5mm (13/64 in.) hole in the marked area. Use care to not damage components below the drill location.
18. Route the power cord from the fender flange area under the front compartment site shield.

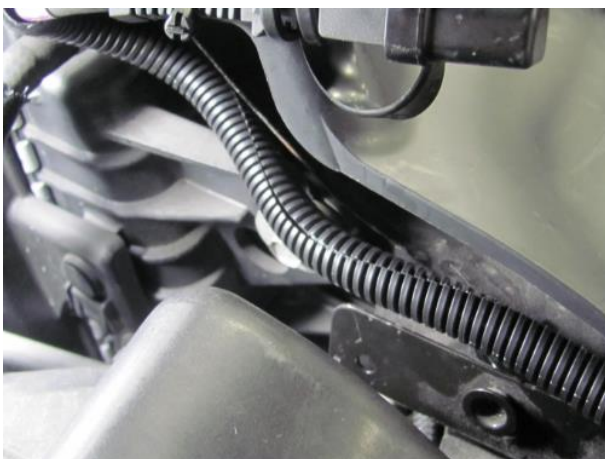
5420820

19. Create a gentle bend in the power cord and place the power cord plug over the hole in the site shield. Ensure the prongs on the power cord plug are facing toward the right fender.

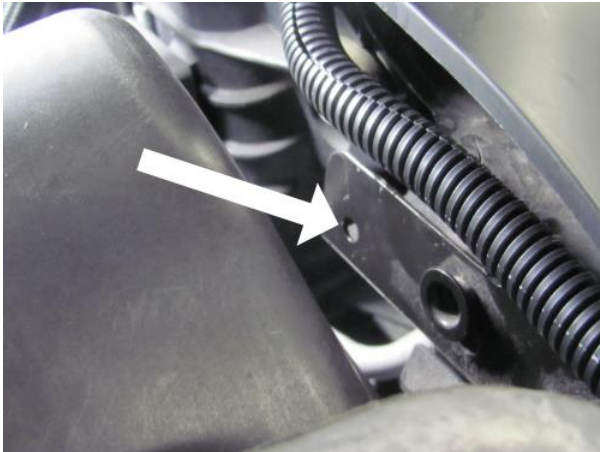
21. Locate the hole on the passenger side upper tie bar bracket.
