N336NAS1

# TECHNICAL BULLETIN

SAFETY RECALL - Door Will Not Latch

MODEL:	MODEL YEAR:	VIN:
Range Rover Sport (LW)	2016	556983-599458
Range Rover Sport (LW)	2016	636516-657901
Range Rover (LG)	2016	258138-298504

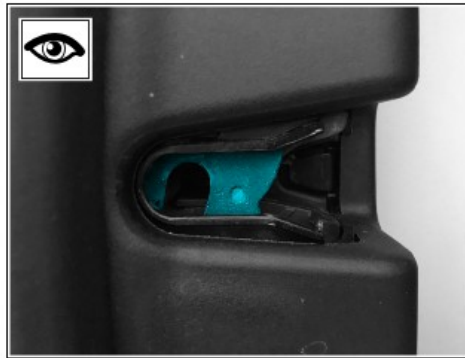
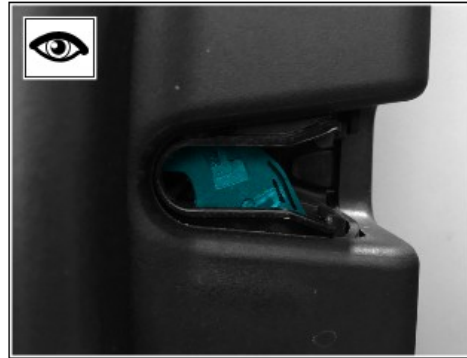
E258158

Use a quick and smooth motion to grasp and pull the exterior door handle, hold the handle in the open/extended position, and observe the position of the door latch lever.

- If the door latch is still in the latched position, as shown by the **GREEN '✓'** in the illustration, **go to step 5.**

- If the door latch is in the unlatched position, as shown by the **RED 'X'** in the illustration, **return to step 2.**

- 
5. Slowly return the exterior door handle to its original position until a 'click' is heard.
- 
6. Pull the exterior door handle to open the door.
-

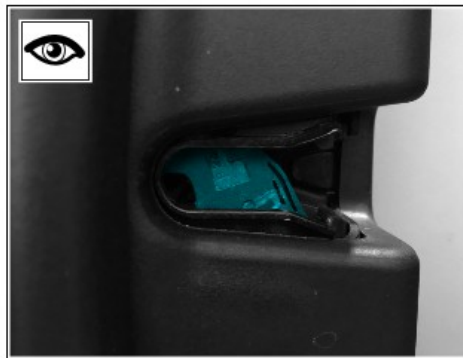
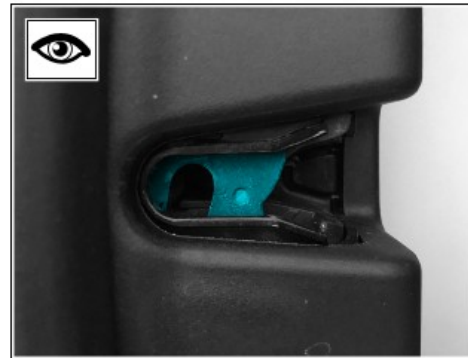
E258160

Observe the position of the door latch lever.

- If the door latch lever is in the unlatched position, as shown by the **GREEN '✓'** in the illustration, the front left door latch has passed the functionality test; **go to Service Instruction 'B'.**
- If the door latch lever is still in the latched position, as shown by the **RED 'X'** in the illustration, **go to step 8.**

- 
8. ■ Renew the front left door latch (see TOPIx Workshop Manual section 501-14: Handles, Locks, Latches and Entry Systems - Removal and Installation - Front Door Latch).
    - When all tasks are complete, **go to Service Instruction 'B'**.

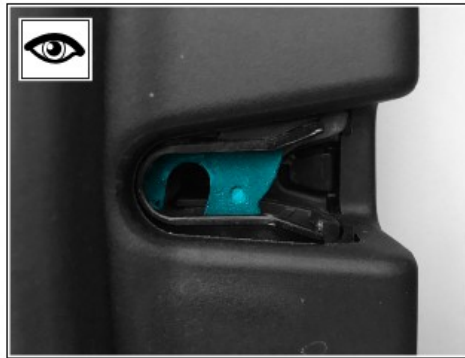
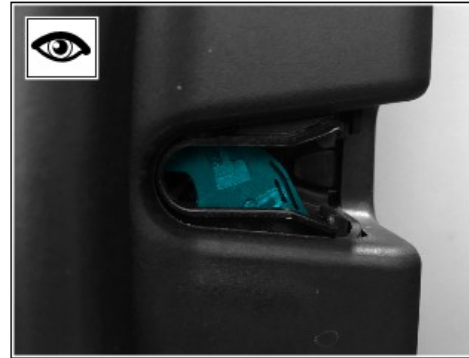
E258158

Use a quick and smooth motion to grasp and pull the exterior door handle, hold the handle in the open/extended position, and observe the position of the door latch lever.

- If the door latch is still in the latched position, as shown by the **GREEN '✓'** in the illustration, **go to step 5.**

- If the door latch is in the unlatched position, as shown by the **RED 'X'** in the illustration, **return to step 2.**

- 
5. Slowly return the exterior door handle to its original position until a 'click' is heard.
- 
6. Pull the exterior door handle to open the door.
-

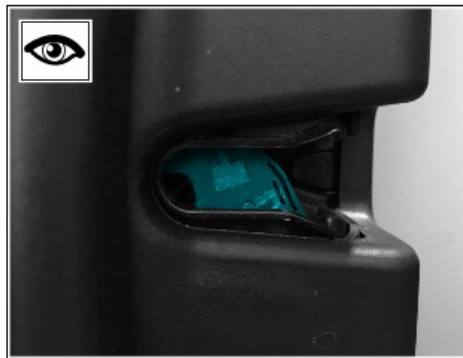
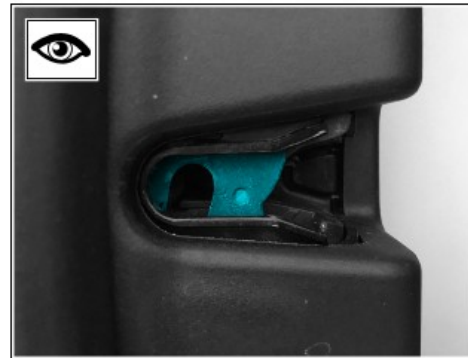
E258160

Observe the position of the door latch lever.

- If the door latch lever is in the unlatched position, as shown by the **GREEN '✓'** in the illustration, the rear left door latch has passed the functionality test; **return the vehicle to the customer.**
- If the door latch lever is still in the latched position, as shown by the **RED 'X'** in the illustration, **go to step 8.**

- 
8. ■ Renew the rear left door latch:
- **Range Rover Sport** - (see TOPIx Workshop Manual section 501-14: Handles, Locks, Latches and Entry Systems - Removal and Installation - Rear Door Latch).
  - **Range Rover - Standard wheelbase** - (see TOPIx Workshop Manual section 501-14: Handles, Locks, Latches and Entry Systems - Removal and Installation - Rear Door Latch - Standard Wheelbase).
  - **Range Rover - Long wheelbase** - (see TOPIx Workshop Manual section 501-14: Handles, Locks, Latches and Entry Systems - Removal and Installation - Rear Door Latch - Long Wheelbase).
  - When all tasks are complete, **return the vehicle to the customer.**
