TOOLS AND PARTS INFORMATION

A. REPAIR PROCEDURE

- a) Slide the front seats to the full rear position.
 - b) Disconnect the negative battery cable.
 - c) Cut the wires at eight (8) joint connectors located in four (4) areas and crimp them using tube sleeves and SST 49JP-03-001. (Locations on repair may be in different order.)
 - d) Connect the negative battery cable and perform the initialization procedures. Refer to MGSS online or the workshop manual "NEGATIVE BATTERY TERMINAL DISCONNECTION/CONNECTION".
 - e) Start the engine and confirm if any DTCs are not stored. If they are stored, clear it according to MGSS online or the workshop manual.
 - f) Install the removed parts in the reverse order of the removal.
 - g) Slide the front seats to the original position.
- Joint Connector Locations

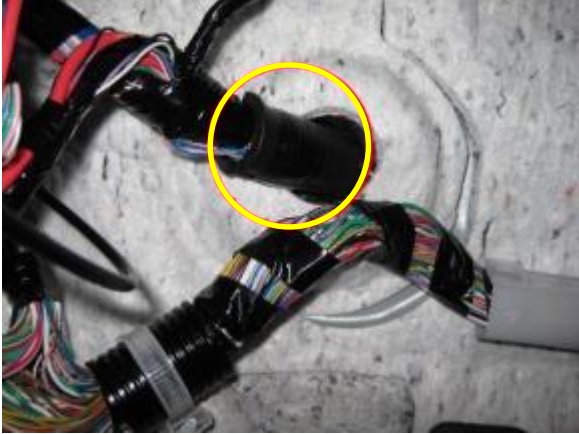
1. Locate Joint Connector C-43 and C-44 (Refer to "Joint Connector Locations")

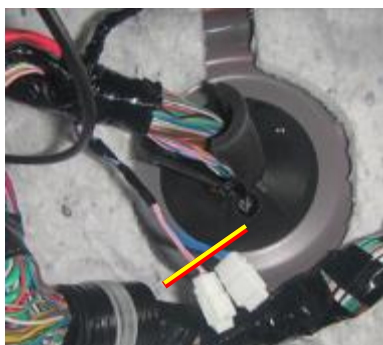
3. Remove Joint Connector C-43 and C-44 by cutting the wiring harness at the joint connectors.

14. Remove Joint Connector C-47 and C-48 by cutting the wiring harness at the joint connectors. (Refer to step 3 image)

20. Remove Joint Connector C-51 and C-52 by cutting the wiring harness at the joint connectors. (Refer to step 3 image)

37. Remove Joint Connector C-54 and C-55 by cutting the wiring harness at the joint connectors. (Refer to step 3 image)

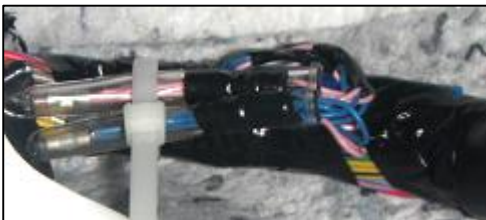
11. Fix the protective caps to the wire harness using a zip tie and cut off the excess material.

16. Fix the protective caps to the wire harness using a zip tie and cut off the excess material. (Refer to step 11 image).

22. Fix the protective caps to the wire harness using a zip tie and cut off the excess material. (Refer to step 11 image)

39. Fix the protective caps to the wire harness using a zip tie and cut off the excess material. (Refer to step 11 image)

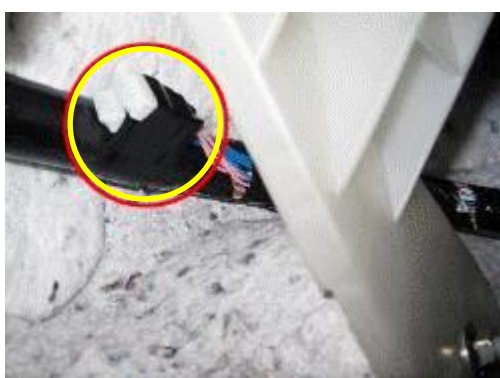
View A-A

19. Carefully cut the tape while holding the connectors and wires in place.

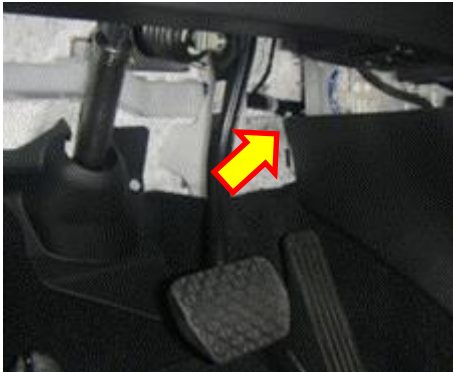
24. Locate Joint Connector C-54 and C-55 (Refer to "Joint Connector Locations")

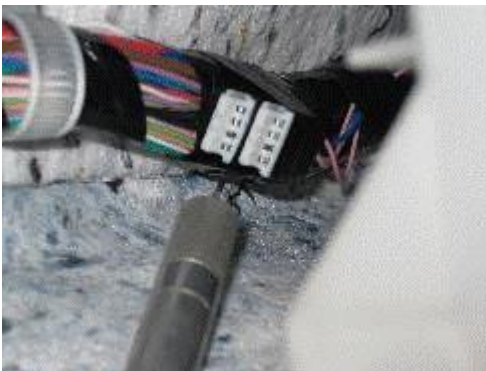
25. Carefully cut the tape while holding the connectors and wires in place.

- An art knife (or equivalent blade) is recommended since it is not easy to access the connectors.
- Take care not to cut wires.

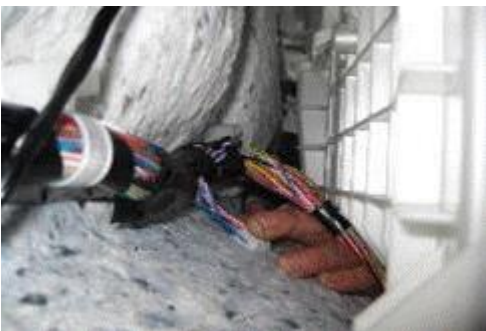
26. Pull the joint connectors to the passenger side for repair reaching under the HVAC Unit from the passenger side.

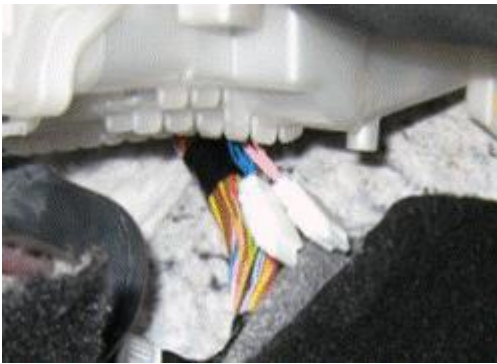
28. If the connectors cannot be pulled out enough for the work, proceed to next step. If it can be, proceed to step 37.

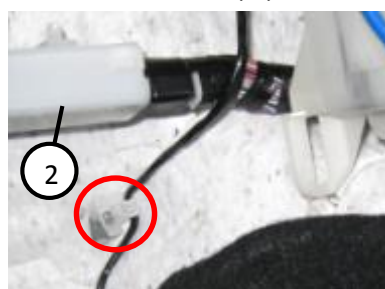
30. Release harness clips near C54 and C55 (1) and harness protector (2)

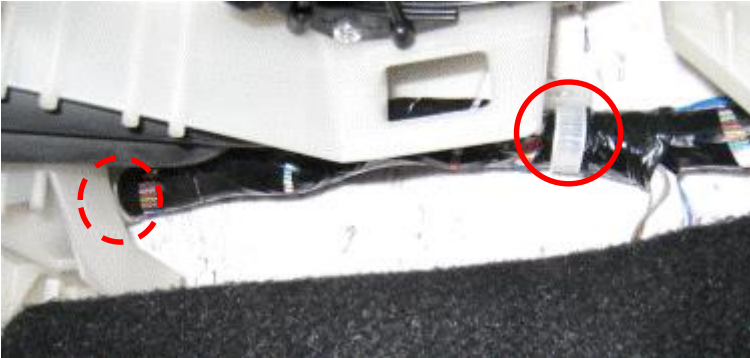
31. Release two harness clips at the passenger side

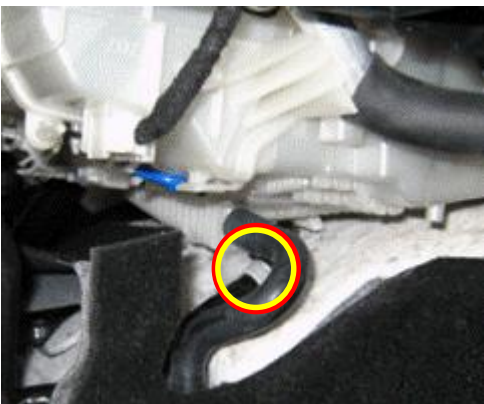
32. Release a harness clip under HVAC
