508875 Rev. A

NHTSA Recall #: 19V410

Rear Brake Line Fitting Inspection and Remedy

Applicable for 2014 to 2019 Model Year Toyota Rear Entry Vehicles Produced January 2018 to May 2019

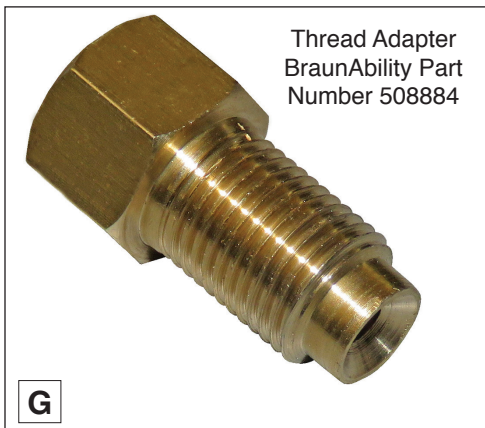
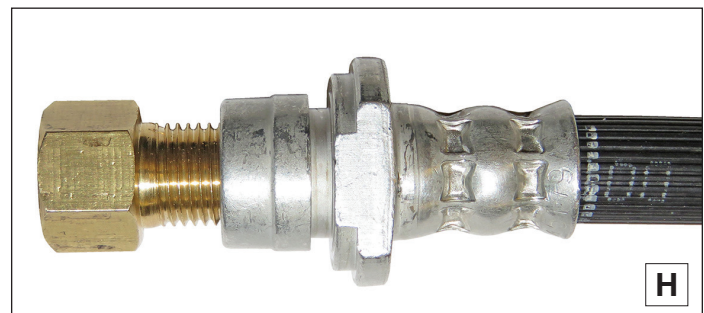
3. Disconnect brake line from flex hose. See Photo F.
4. Install thread adapter (included in kit) to flex hose. Torque to 13 ft•lbs. See Photos G and H.
