Safety Recall 2A89: UH200A CVT Driven Face Replacement

Suzuki has issued a safety recall for certain 2018 and 2019 UH200 (Burgman 200) scooters.

Safety Recall 2A90: GSX250R Rear Brake Light Switch

Service Reminder Reset for the LT-A500X/XP and LT-A750X/XP

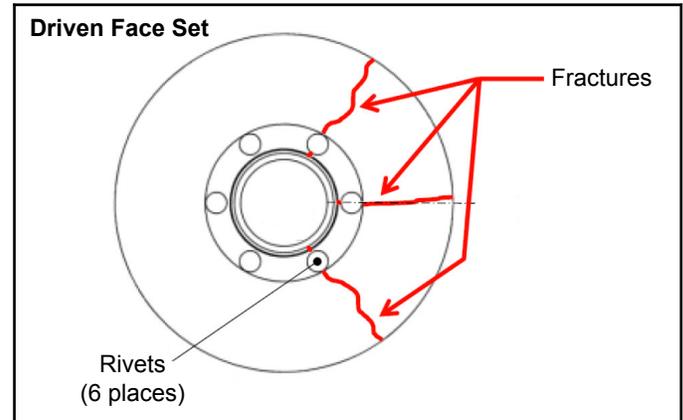
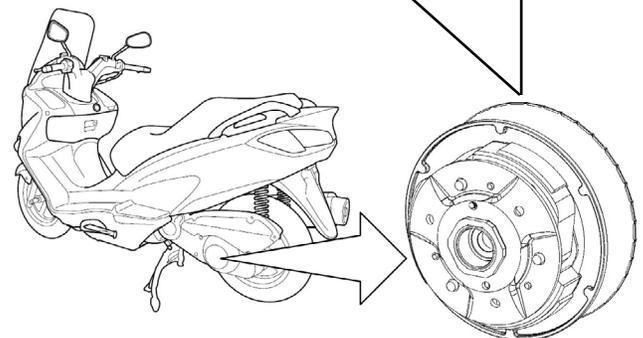
As outlined in [GV/AN/UH No. 053](#), holes for the rivets that fasten the component parts of the continuously variable transmission (CVT) movable driven face (drive plate) have a shape that may cause the rivet connections to be insufficient.

Continued use of the scooter with this condition may allow excessive stress to be applied to the rivet connections when accelerating, and the movable driven face of the CVT may break while riding.

If the movable driven face of the CVT breaks while riding, the scooter will become disabled, increasing the risk of a crash.

As always, be sure to access the Vehicle Master Inquiry in Suzuki Connect to check if a customer unit or any unit in your inventory is affected by this safety recall. If a unit is affected, follow the repair procedure as outlined in the Technical Service Bulletin (TSB) and submit a warranty claim before selling or delivering the unit to a customer.

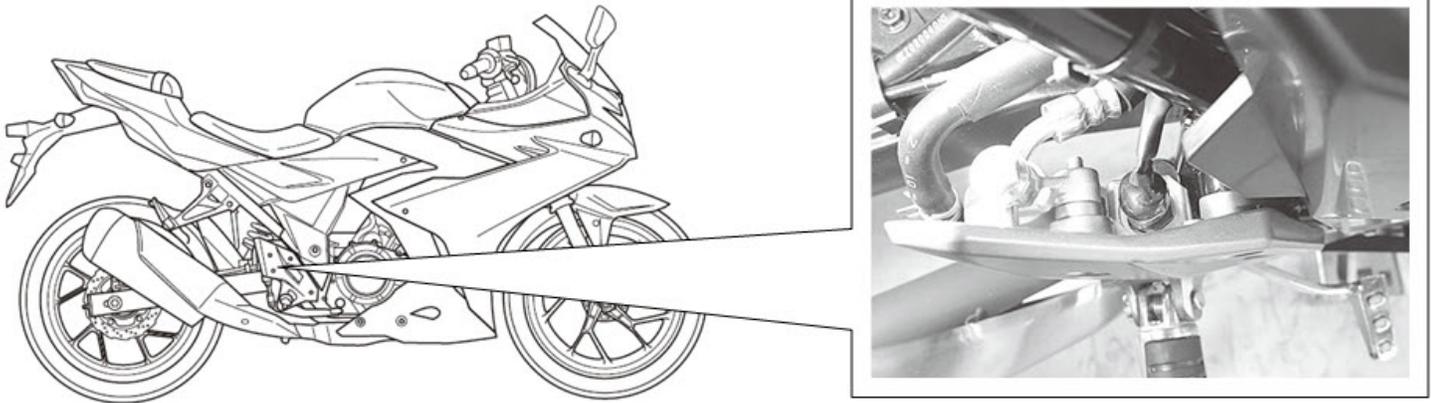
As referenced in Suzuki's official Stop Sale Bulletin, water can get into the rear brake light switch and cause corrosion, resulting in the brake light not activating or remaining turned on continuously.

- 1) Check the Suzuki Connect Vehicle Master Inquiry to see if units in your inventory, as well as customer units in your shop for service, are affected by this recall.
- 2) If the Vehicle Master Inquiry shows a unit as being affected, replace the rear brake light switch assembly with the countermeasure part.
- 3) File a warranty claim for it on Suzuki Connect.

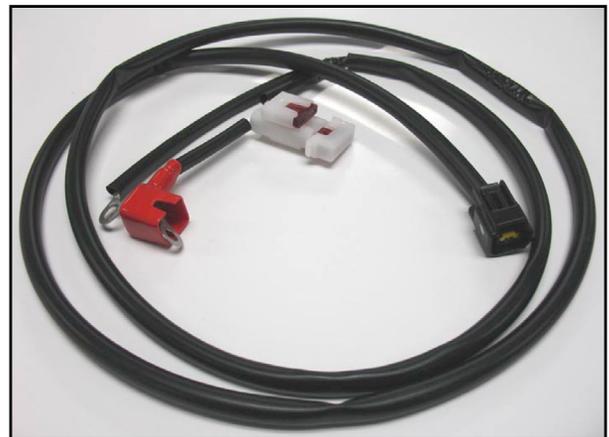
Battery Lead Wire, P/N 36890-28H00
Dealer cost: \$37.21

The Battery Lead Wire is plugged into the RM-Z's ECU coupler, as well as an external battery. This enables the RM-Z's ECU to be powered up without the engine running; it also supplies power to SDS-II.

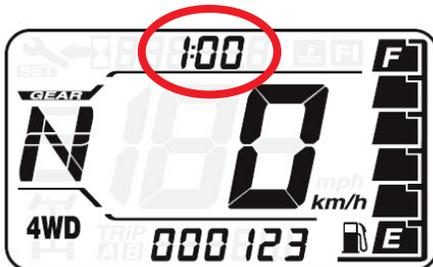
Clock

1. Before you start, confirm the current time, number of running hours or service reminder hour displayed on the combination meter.

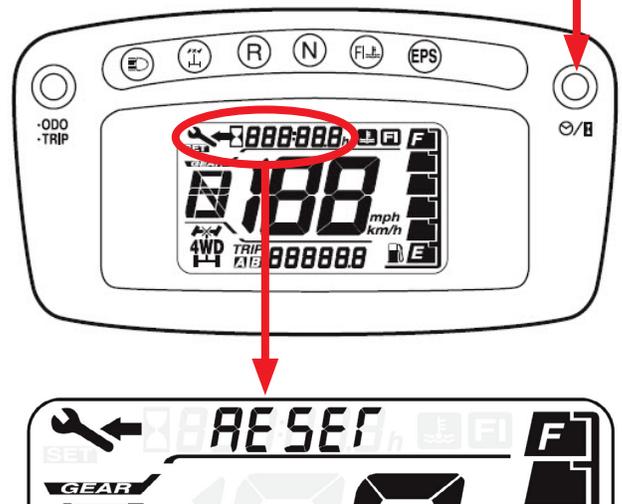
Combination Meter Button

4. Turn the ignition switch **ON**.
5. Turn the mode select switch **ON**.
6. Press the combination meter button to show **RESET** on the display.

7. Press the button a second time and hold it for about 2 seconds to enter the reminder reset mode.
