Mercedes-Benz

Campaign No. 2019070011, August 2019

SUBJECT: **Model GLE-Class vehicles (167 platform)**
Model Year 2020
PSAB Incomplete Deployment

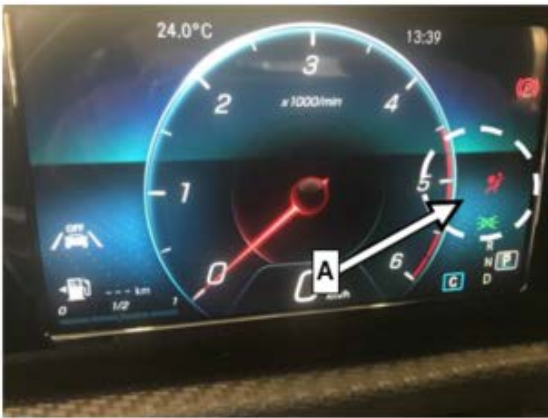
1. Disconnect ground line from the on-board electrical system battery.
 2. Replace front passenger airbag (**AR91.60-P-0664ME**).
 3. Connect ground line to on-board electrical system battery.
 4. Switch ignition to position 1. To do so, press start button once without touching the brake pedal. Check if the airbag indicator lamp (**A, Figure 1 or 2**) goes off permanently after a few seconds.
- i** The SRS check after airbag replacement verifies correct installation.
