Maserati Technical Bulletin

Date: July 15, 2019
Bulletin Number: MAS001916 – MTB -1912 -
Recall 386 – Air Bag Control Module
Replacement_US
Supersedes: N/A
Section: Compliance

Model Type: GranTurismo & GranCabrio (M145)

Subject: Vehicle Safety Recall Campaign 386, Air Bag Control Module replacement

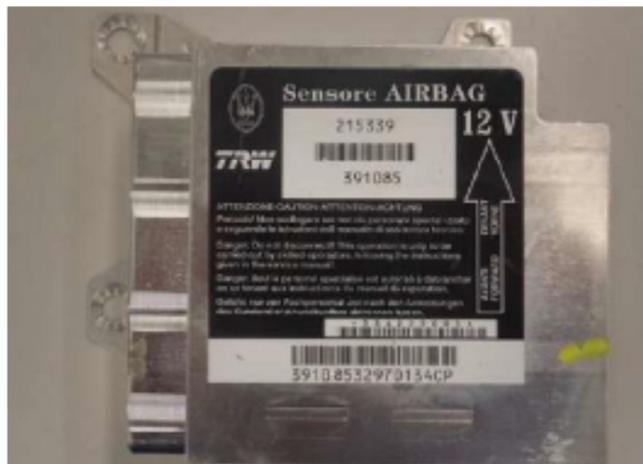
Fig.1

Maserati S.p.A. and MNA have determined that the above described vehicles were manufactured with an Air Bag Control Module (Fig.1) that may contain a voltage supply capacitor that was improperly manufactured. If the voltage supply capacitor fails, the air bag may inadvertently deploy or not deploy at all.

Out of an abundance of caution, Maserati has decided to initiate this Voluntary Safety Recall #386 to replace the Air Bag Control Module with a new Module.

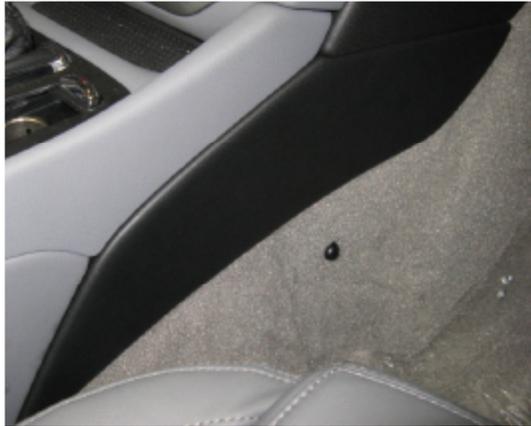
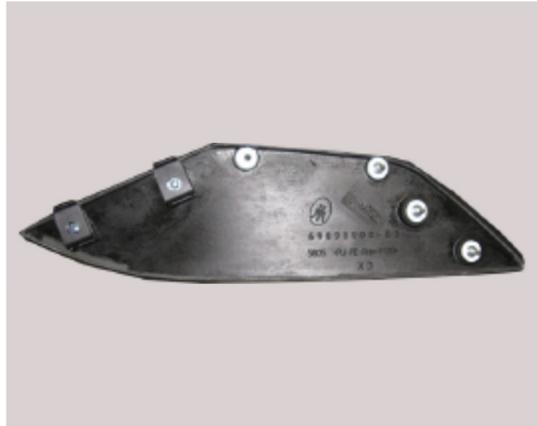
1. Disconnect the battery.
2. Remove the central fixing plate on the center console as shown below and in Section 09.51.084 of the Workshop Manual.
 - a. Remove the two pressure-fitted side panels (Fig.1 and Fig.2).

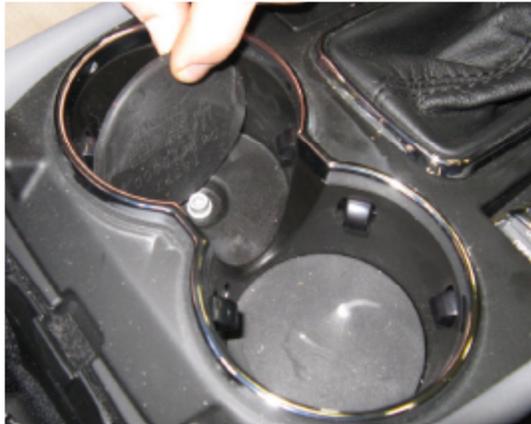
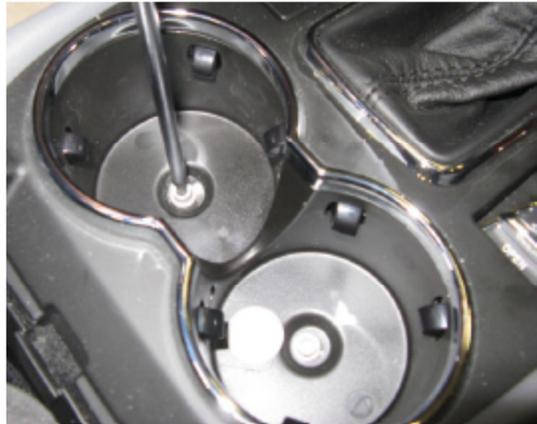
- b. Lift and remove the rubber base from both cup holders (Fig.3) and remove the 2 fastening screws (Fig.4)

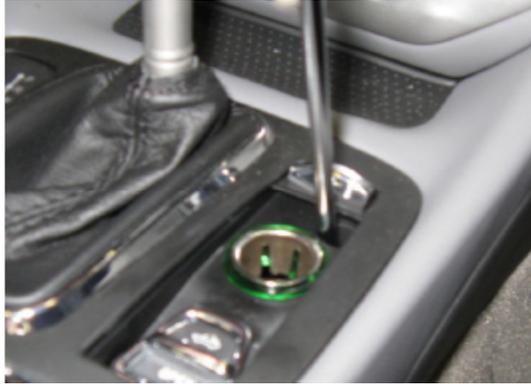
Fig.5

- c. Remove the fastening screw above the power outlet (Fig.5).

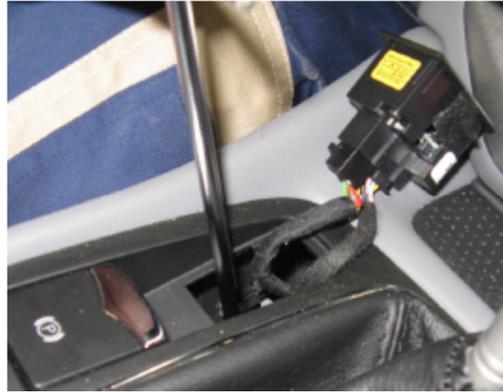
Fig.6

- d. Working from the left side, push the gear selector display upward, unhook the electrical connector, remove the display unit, then remove the screw below it that secures the center console to the mounting bracket (Fig.6).

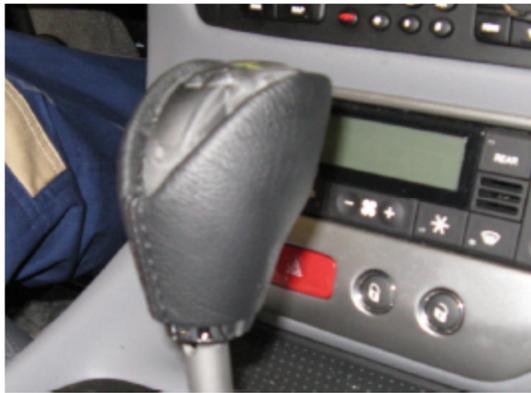
Fig.7

- e. Pull the knob off the gearshift lever (Fig.7)

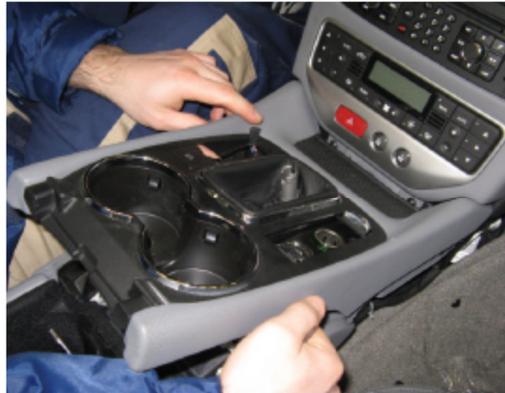
Fig.8

- f. Lift the front panel on the center console, remove the electrical connectors then remove the panel (Fig.8).

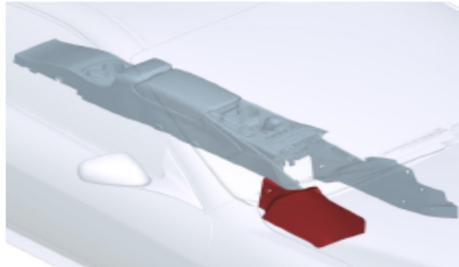
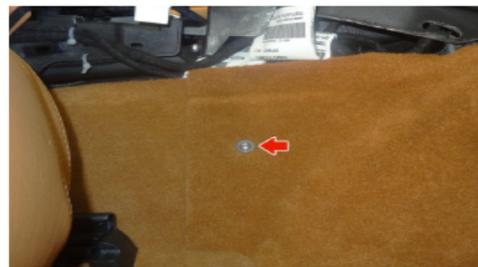
Fig.9

3. Remove the center console side covering on both sides as shown below (Fig.9), and in Section 09.51.000 2 of the Workshop Manual.

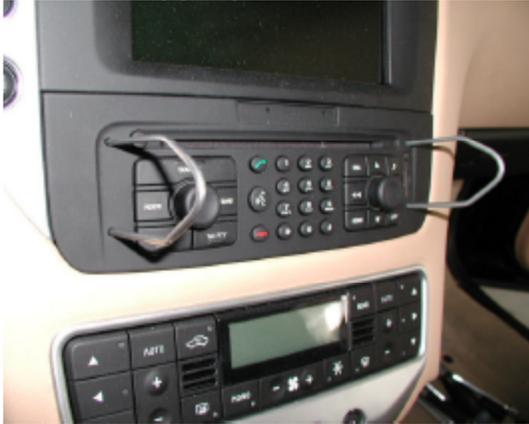
Fig.10

4. With the appropriate tools, remove the radio (Fig.10).

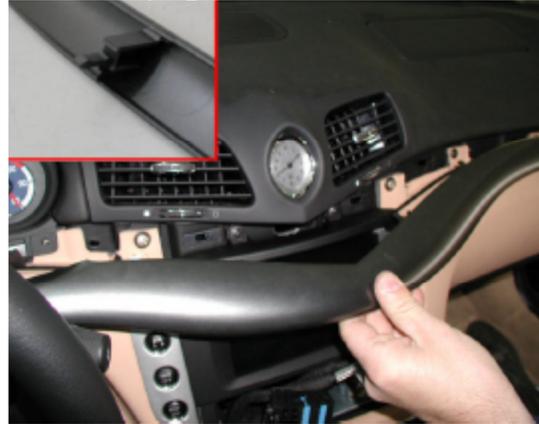
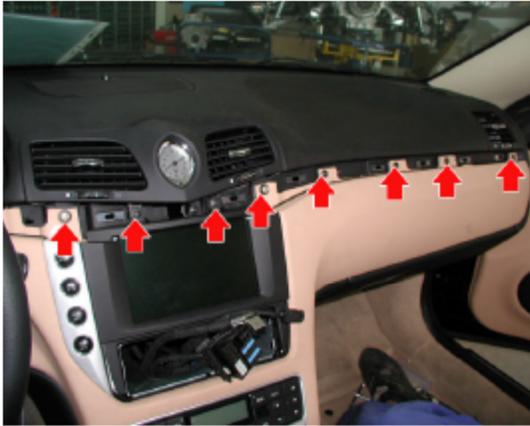
5. Remove (pull) the aesthetic moulding from the center of the dashboard (Fig.11).
6. Remove the screws from the center of the dashboard (Fig.12).

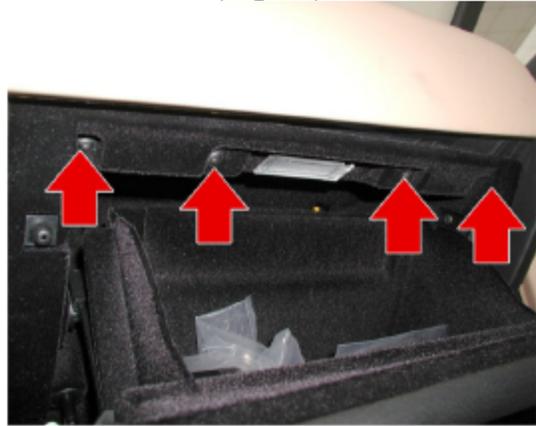
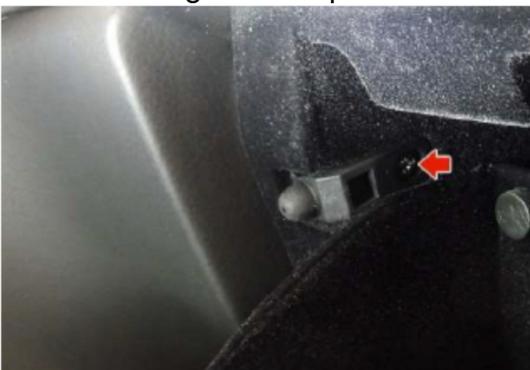
7. Open the glove compartment and remove the upper securing screws (Fig.13).
8. Remove the glove compartment side screws (Fig.14).

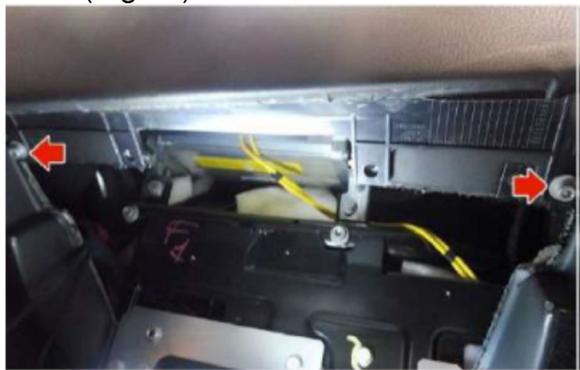
Fig.15

9. Lower the glove compartment and remove the housing side screws (Fig.15).

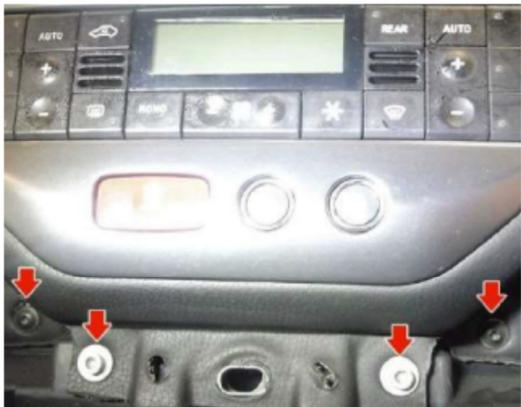
Fig.16

10. Remove the lower central dashboard screws (Fig.16).

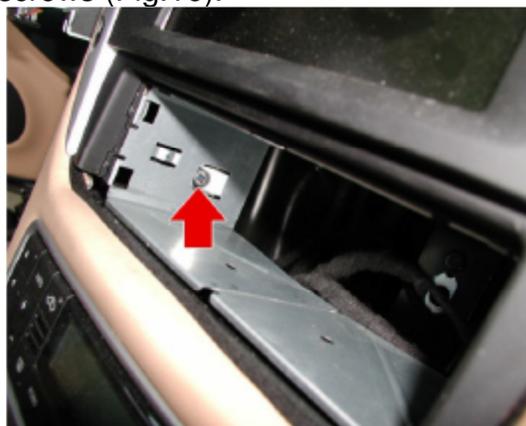
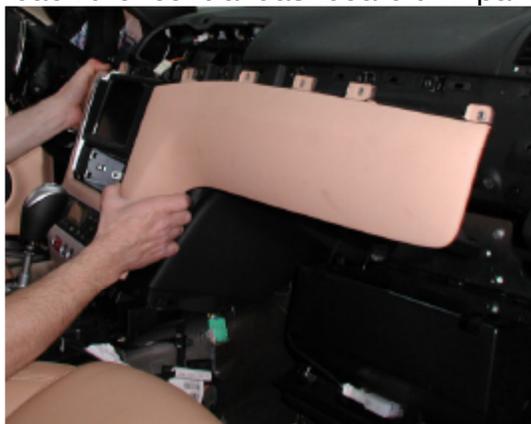
11. Remove the 2 screws inside the radio compartment (Fig.17) then gently, pull back the central dashboard trim panel (Fig.18).

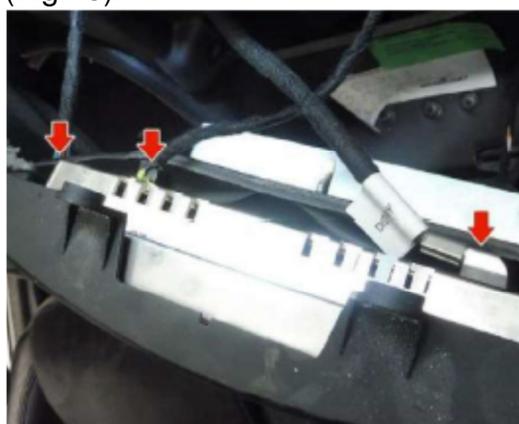
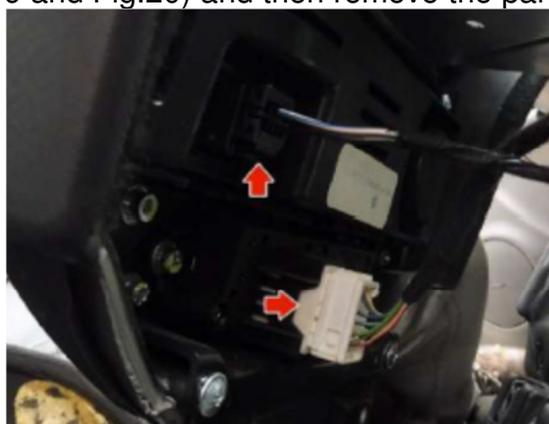
12. While supporting the central dashboard trim panel, disconnect the wire connectors (Fig.19 and Fig.20) and then remove the panel.

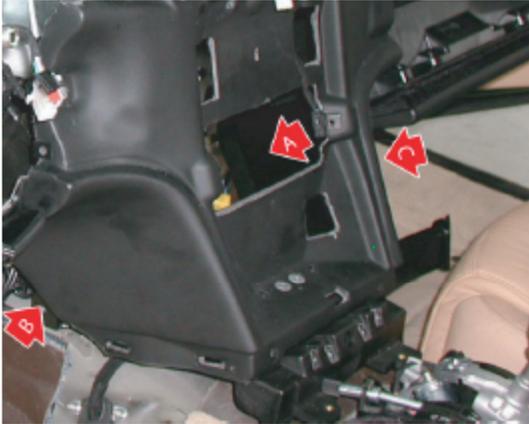
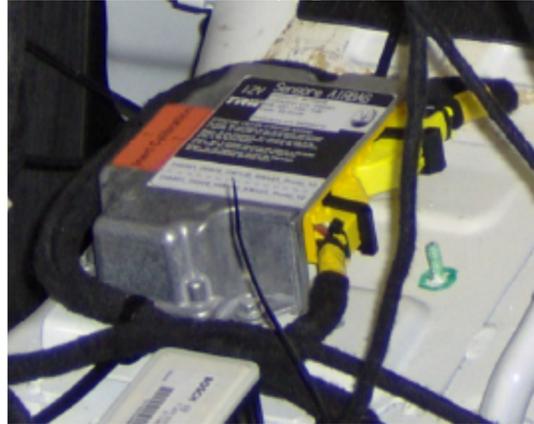
13. Working through area's A ,B and C (Fig.21), unhook the electrical connectors, unscrew the fastening nuts and remove the AIRBAG ECU (Fig.22).

14. Install the new airbag control module. Torque the securing fasteners to 10 N-m (7.4ft-lbf).
20. Reinstall all of the parts you have removed following the removal procedures in reverse order.
21. Perform a vehicle Proxy Alignment for the new Airbag ECU.
22. Perform the Airbag Control Module Initialization Procedure as described in Attachment "C".

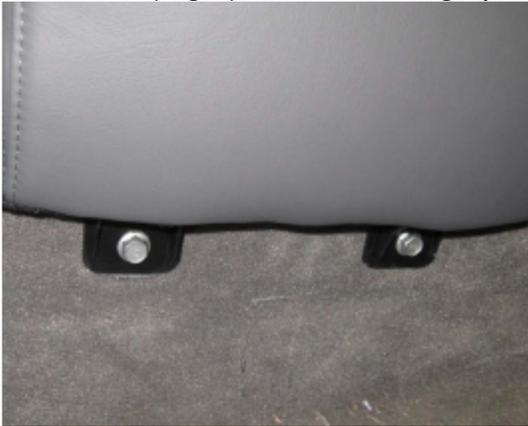
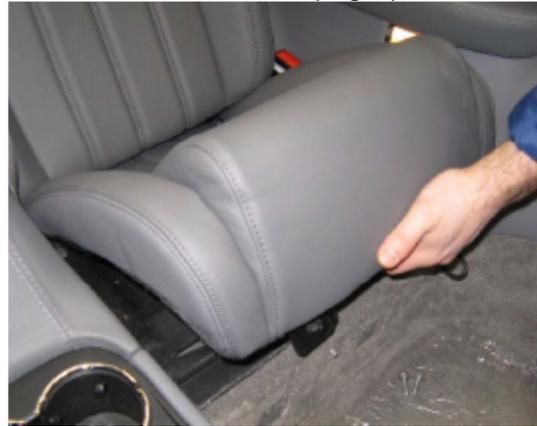
1. Disconnect the battery.
2. Remove the center console as shown below and in Section 09.51.001 of the Workshop Manual.
 - a. Remove the rear seat cushions (bottoms) by removing the 2 securing bolts on each side (Fig.1) and then lifting up and out with the cushion (Fig.2).

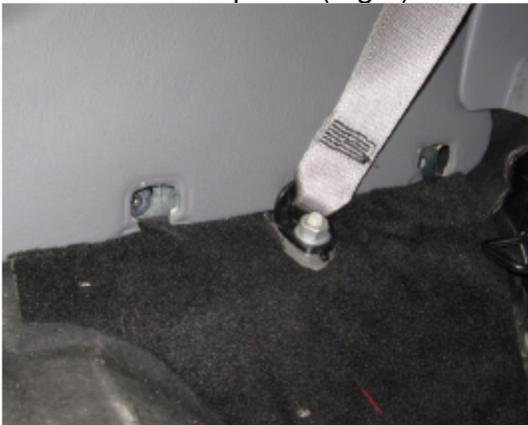
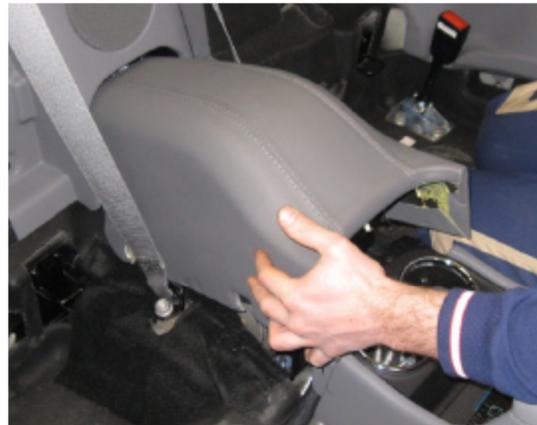
- b. Remove the rear trim panel caps (Fig.3), remove the securing screws and then remove the trim panel (Fig.4).

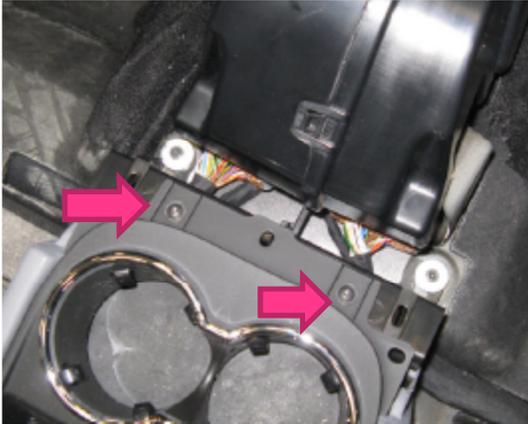
Fig.5

c. Remove the screws from the cup holder trim panel (Fig.5)

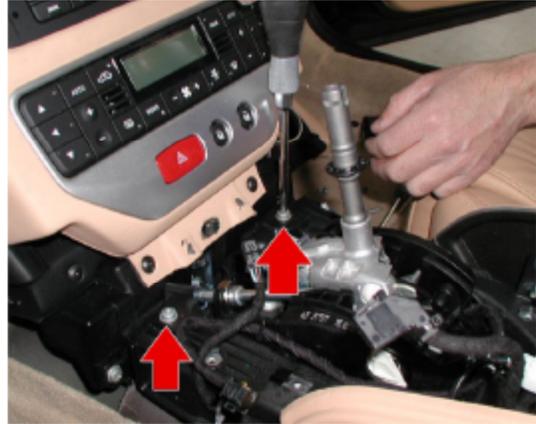
Fig.6

d. Remove the screws located on the front of the trim panel (Fig.6)

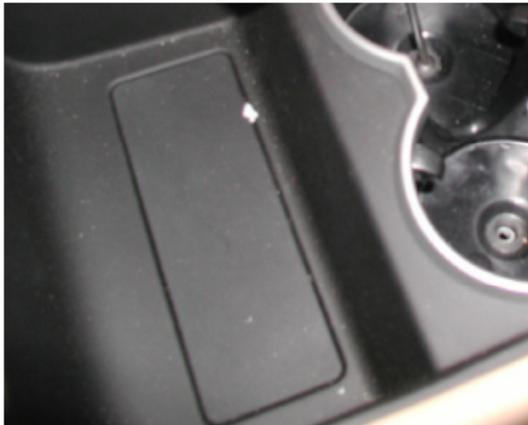
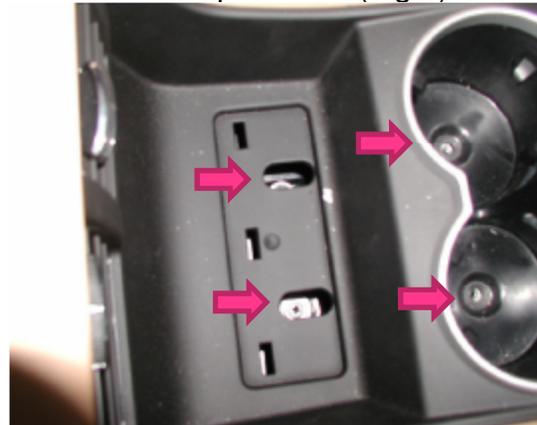
e. Remove the cover plate (Fig.7) on the rear of the trim panel. Remove the screws from underneath and from the bottom of the cup holders (Fig.8)

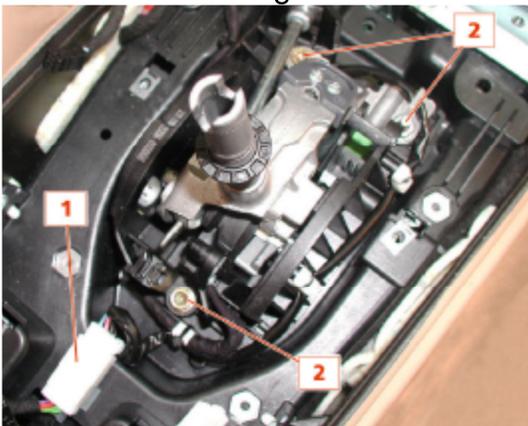
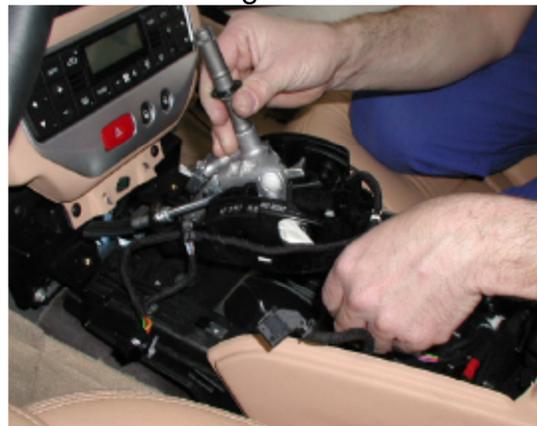
g. Unhook the wire connector (1) and remove the screws (2) from the shifter

(Fig.9). Move the lever over to the side (Fig.10).

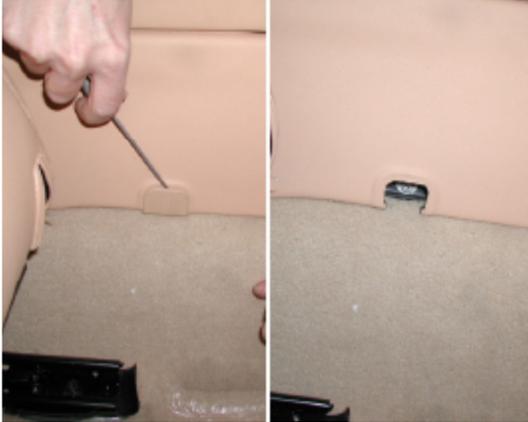
Fig.11

- h. With the front seats fully forward, remove the center console caps and securing screws at the rear (Fig.11)

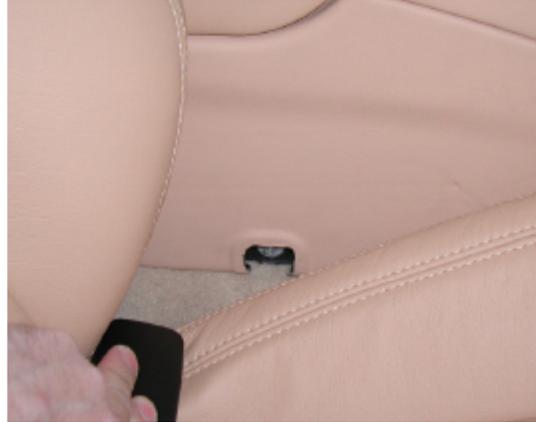
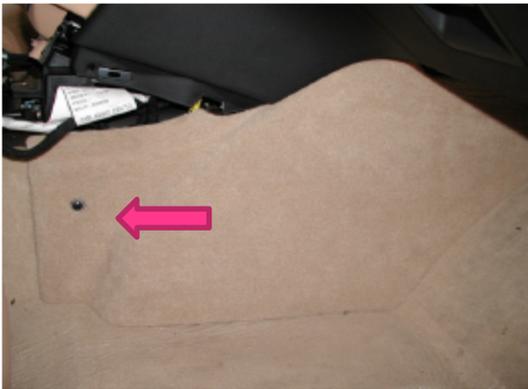
- i. Move the seats forward and remove the caps and securing screws from the center of the console (Fig.12).
- j. Remove the caps and screws then remove the carpet side panels (Fig.13).

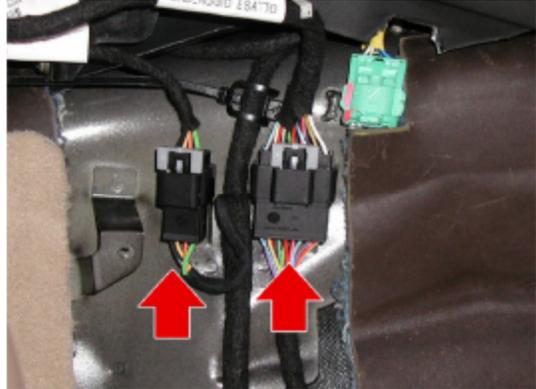
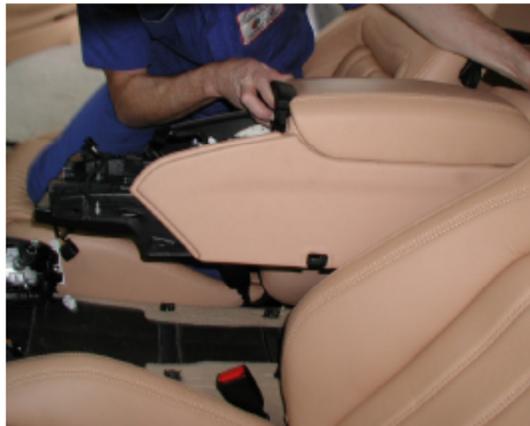
- k. Disconnect the 2 wire connectors (Fig.14) then remove the center console (Fig.15)

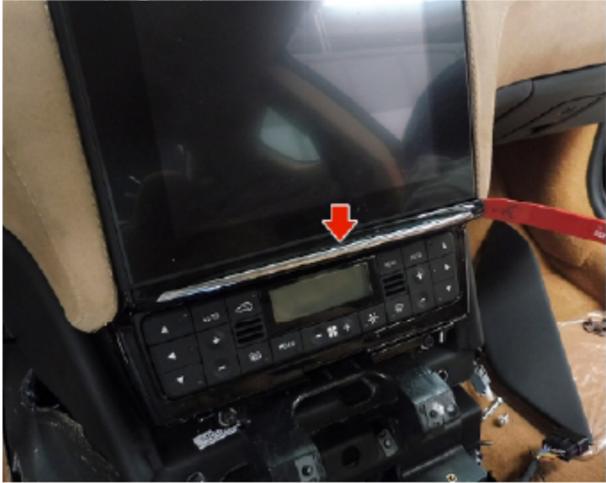
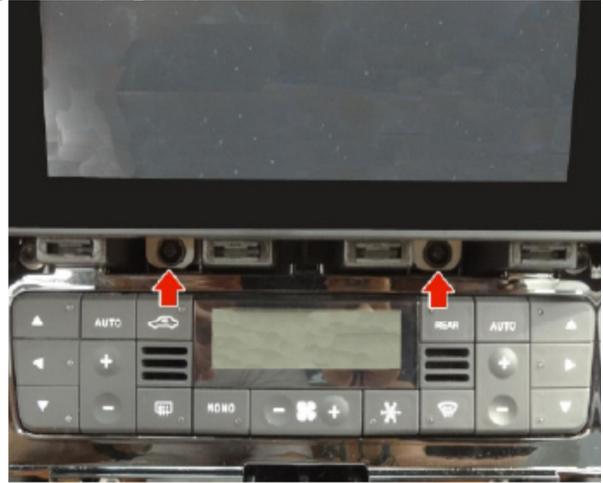
- Using a Teflon wedge, carefully remove the trim from the bottom of the MTC (Fig.16) and then remove the securing bolts (Fig.17)

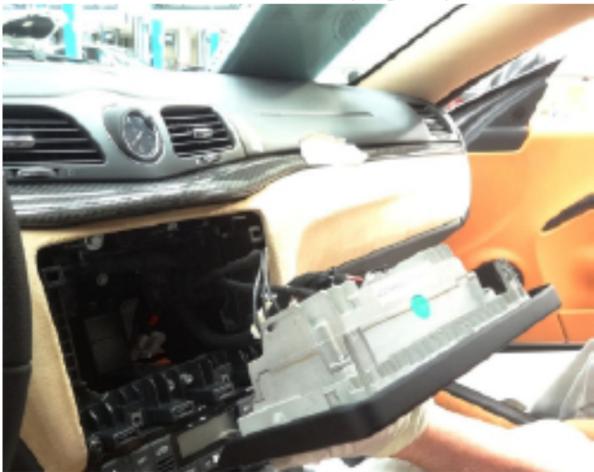
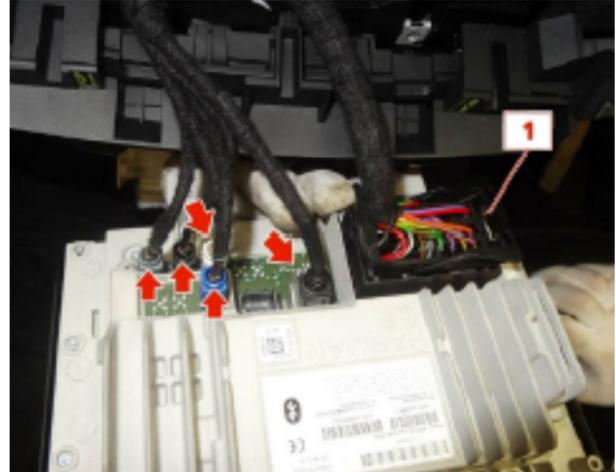
- Pull out the MTC (Fig.18) and disconnect the wire connectors (Fig.19)

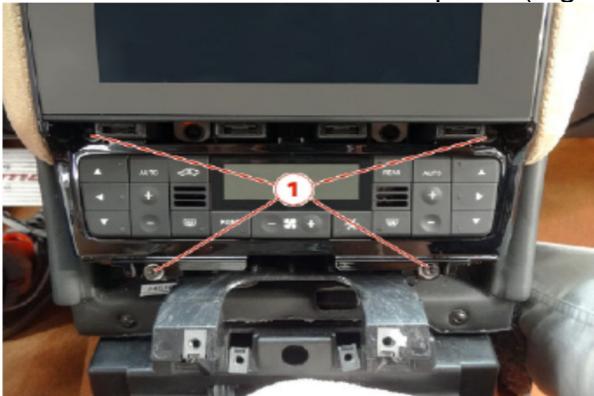
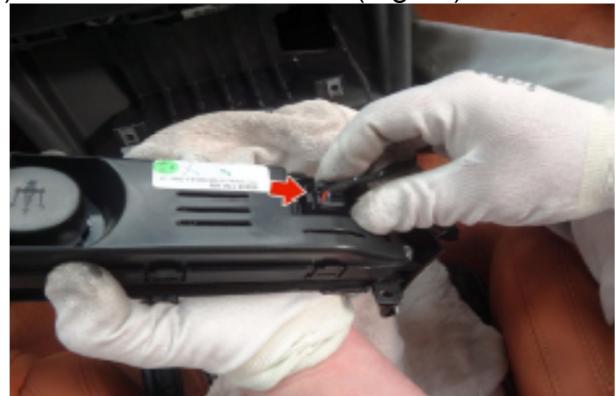
- Remove the a/c control panel (Fig.20) and the wire connector (Fig.21)

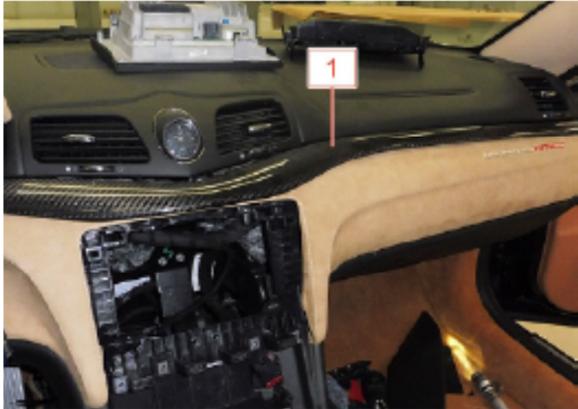
Fig.21

6. Remove (pull) the aesthetic moulding from the center of the dashboard (Fig.21).

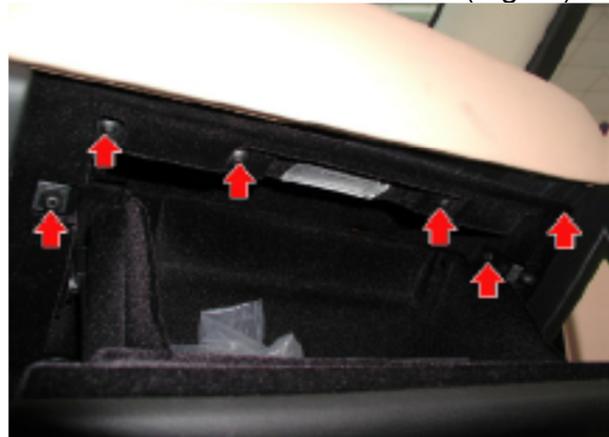
Fig.22

7. Open the glove box and remove the securing screws (Fig.22).

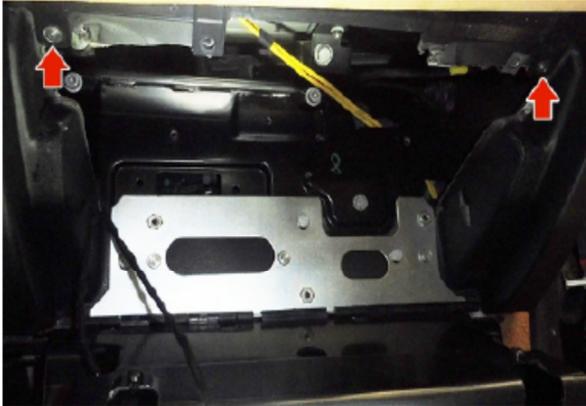
Fig.23

8. Remove the glove box frame screws (Fig.23).

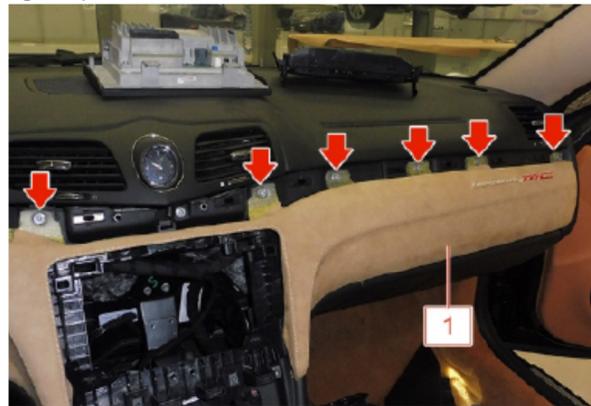
Fig.24

9. Remove the central dash trim panel (Fig.24)

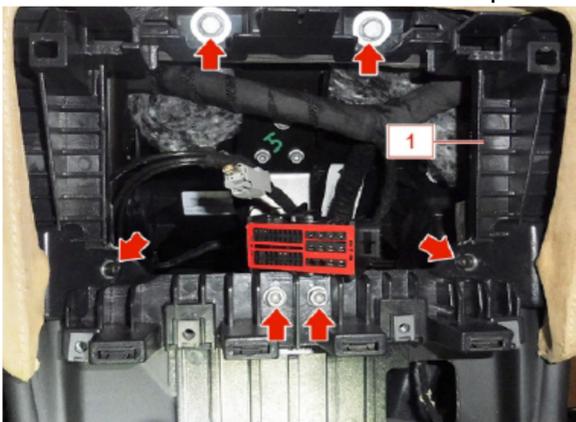
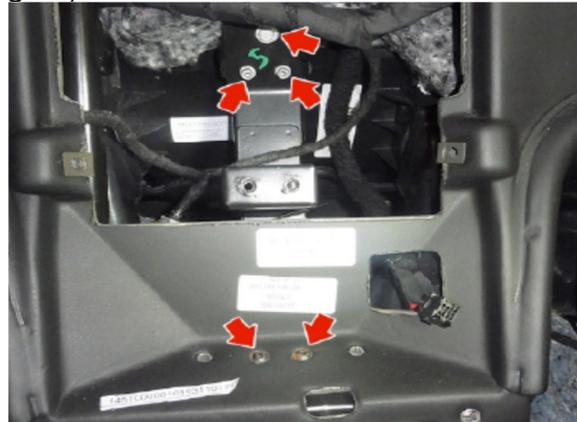
10. Remove the MTC mounting frame (Fig.25) and remove the bracket (Fig.26).

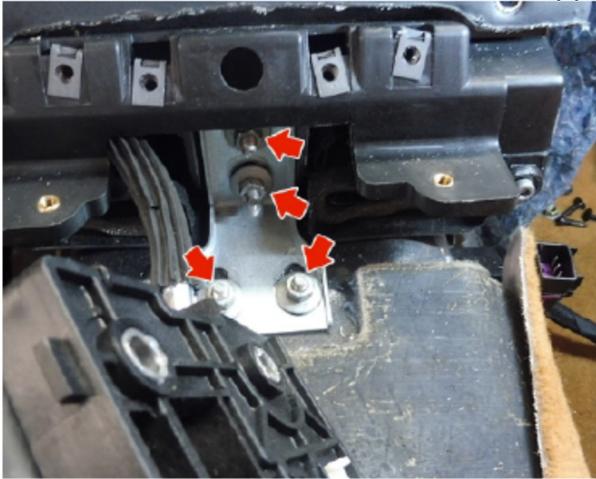
Fig.27

11. Remove the central dash lower support bracket (Fig.27)

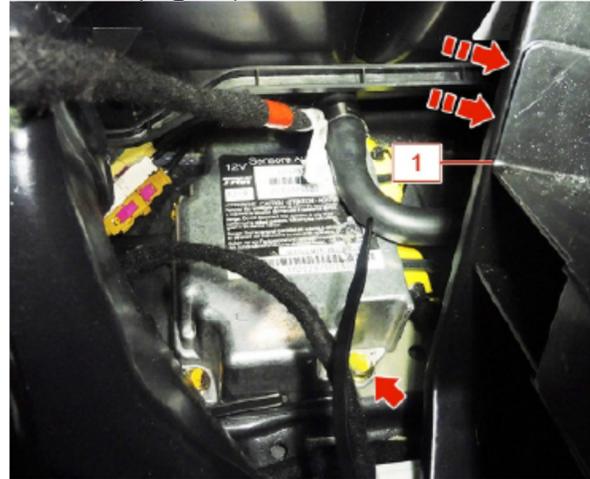
Fig.28

12. Slide the bracket mount over to the side to gain access to the air bag ecu mounting nuts as shown in Fig.28.

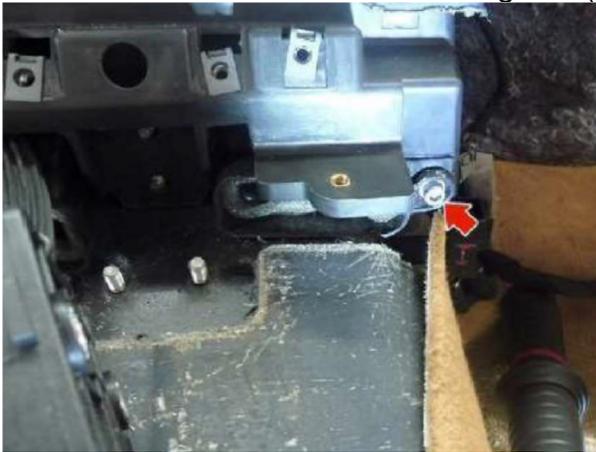
Fig.29

13. Remove the lower r/s mounting bolt (Fig.29).

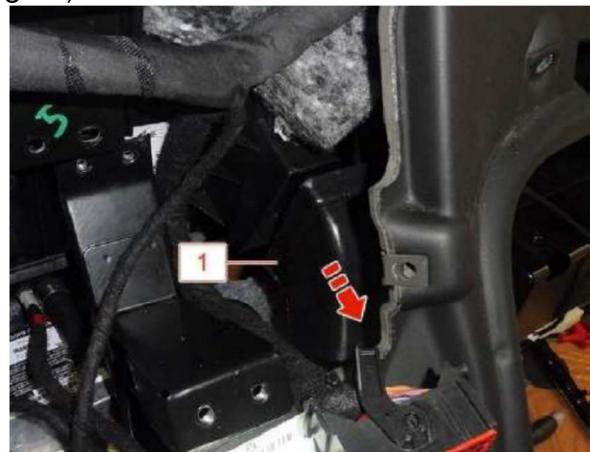
Fig.30

14. Slide the r/s air duct union down away from the housing (Fig.30).

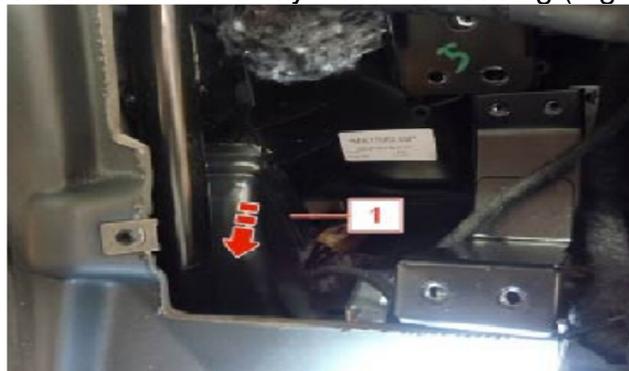
Fig.31

15. Slide the l/s air duct union down away from the housing (Fig.31).

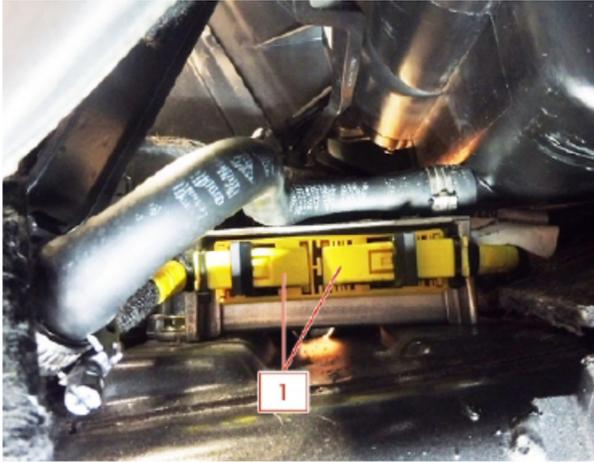
Fig.32

16. Unlock the safety locks and disconnect the wire connectors from the air bag control unit (Fig.32).

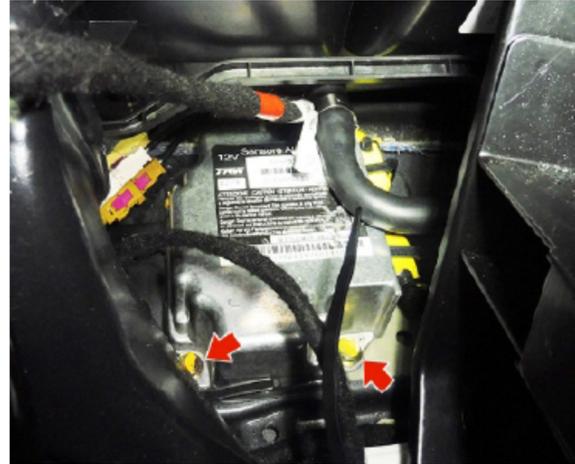
Fig.33

17. Remove the lower mounting screws from the air bag control unit (Fig.33).
18. Remove the upper mounting nuts from the air bag control unit (Fig.33).
19. Install the new air bag control unit by following the instructions in reverse order.
20. Tighten the fastening screws to a torque of 10 N·m (7.4 ft·lbf)
21. Proceed to the Initialization procedures in Attachment "C" of this bulletin.

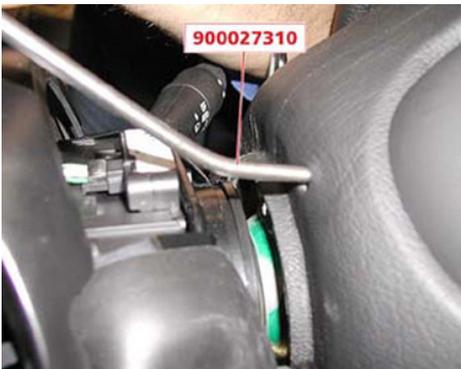
Fig.1

1. When replacing the Airbag Node, it is necessary to carry out the initialization procedure listed below after performing a Proxy Alignment.
2. To perform the initialization procedure it is necessary to disconnect the driver side, passenger side and Side Airbag electric connections located under the front seats.
3. Remove the steering wheel airbag using special tool 900027310. There are two holes behind the steering wheel. Unclip the airbag using the special tool and then disconnect the electrical connectors from the airbag (Fig.1).

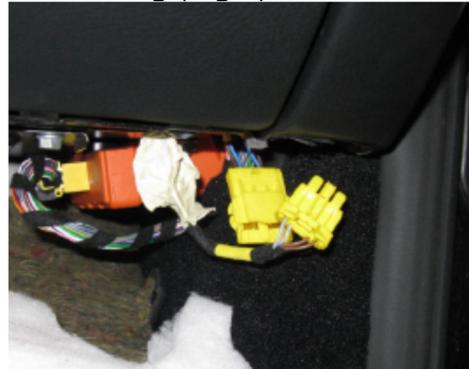
Fig.2

4. Disconnect the electric connector of the passenger side Airbag module (Fig.2).

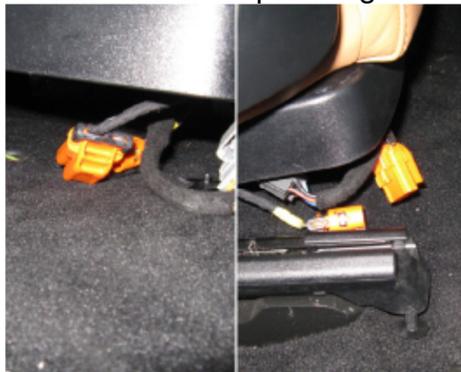
Fig.3

5. Disconnect the electrical connections of the driver and passenger - Side Air Bag Modules located under the front seats (Fig.3).
6. Using the MDEVO, select the vehicle type; in the “CLASS” menu, select “SAFETY” and in the “SYSTEM” menu, select “NAB -AIR BAG NODE - TRW”.

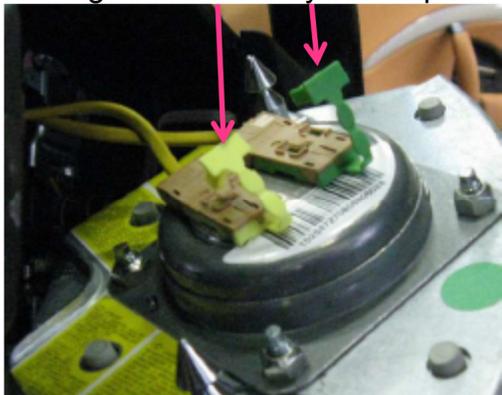
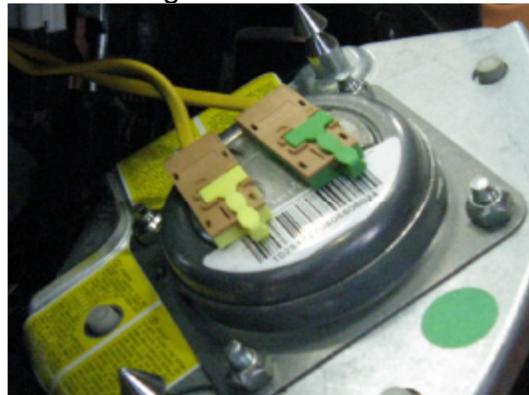
7. Select "CYCLE" in the "TEST" menu.
8. The initialization cycle prompts you to check whether the wiring Compliance label is present or not, and then shows the initial conditions to which the vehicle must be at to continue. **Press the skip test button at the bottom of the screen.**
9. The diagnostic equipment performs the first test on the driver and passenger side airbag. During this phase, the diagnostic equipment must detect faults with both airbags since the connectors are disconnected.
10. Then you are prompted to connect the two connectors of the driver side airbag leaving the Secondary Lock open as shown in Fig.4.

11. The system will now test the two lines of the driver side airbag.
12. If the test of line 1 is successful, you will be prompted to close the Yellow Line 1 Secondary Lock (the Yellow one in Fig's.4 and 5).
13. The same test will be performed on line 2, after which it will be necessary to close the Green Secondary Lock (the Green one in Fig's.4 and 5).
14. After the driver side Airbag diagnosis, reinstall the airbag onto the steering wheel.
15. The system will automatically move to the passenger airbag and it will prompt you to connect the dummy connector, Special Tool p/n: 900028133 (Fig.6) to the passenger airbag wire connector (Fig.7).
