2016 MX-5 Undercover welding Concern Safety Recall 3619F

B. REPAIR PROCEDURE: Front cross member under cover Removal/Installation

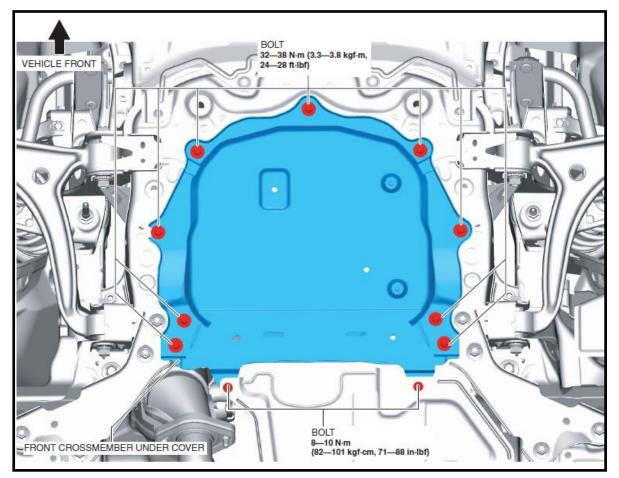
- 1. Lift up the vehicle.
- 2. Remove bolts.

- 3. Remove the front cross member under cover.
- 4. Install new under cover in the reverse order of removal.
