Service Bulletin

19-081

Safety Recall: Takata Driver's Airbag Inflator

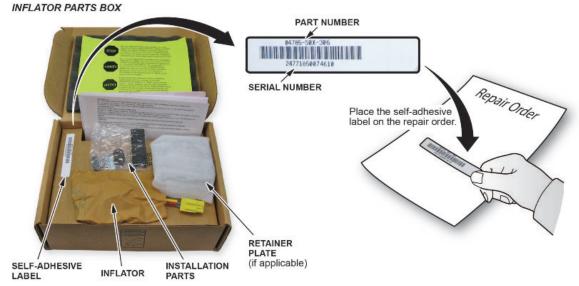
- 6. Peel the label located inside the inflator box from its backing, and attach it to the RO. For the warranty claim to be paid, the **replacement inflator part number that you received** must be included in the warranty claim.

- The replacement part number is printed on the top part of the label and the serial number is printed on the bottom. Make sure you attach the label to the RO and give it to the warranty clerk.
- There may also be a colored sticker located in the kit; ignore it because it is not used.
- Not all inflator kits have a label included. In those cases, write the serial number and part number from the side
 of the inflator box on the RO. The part number always starts with 047.

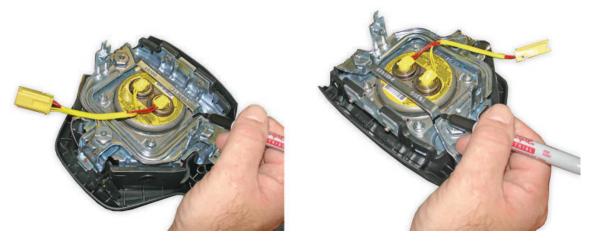
7.1. Using a marker, draw a line on the horn plate as shown.

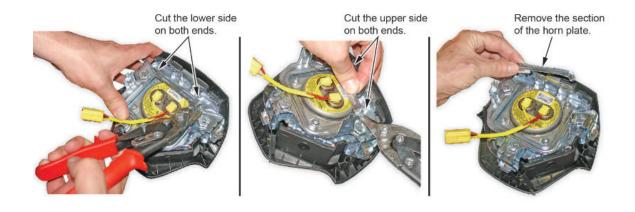
7.2. Using the snips, cut along the line drawn.

Always use sharp snips. If they are dull and you twist or wiggle them back and forth, you may warp the horn plate, which would require a new airbag module.

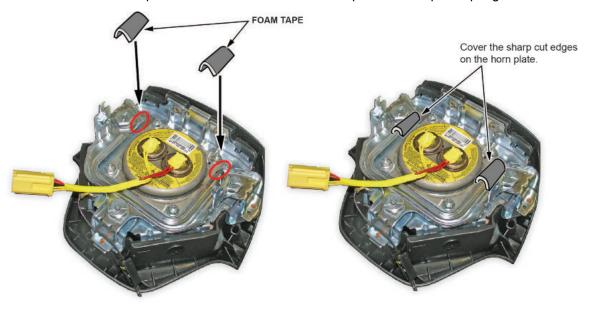
7.3. Take the felt tape and cut it into two pieces. Apply to the cut surface for protection.

- Do not file the metal edges.
- Make sure the felt tape does not interfere with the horn plate or horn plate springs.

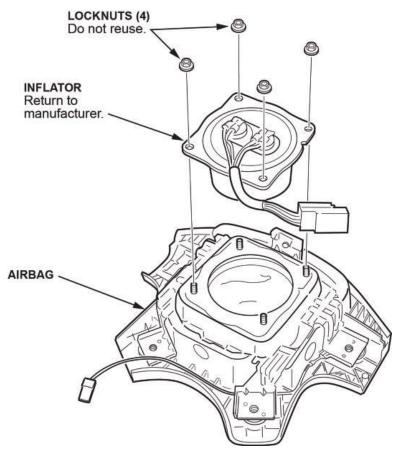
8. Using needle-nose vise grips or a 3/8 in. 6-point socket, remove the four locknuts from the inflator. The locknuts will not be reused.

Do not remove the inflator from the airbag until you complete step 9.

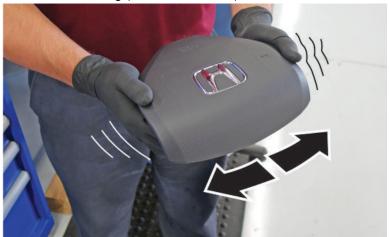
10. Turn over the airbag (inflator side down), and shake it to remove any debris from the inflator opening.

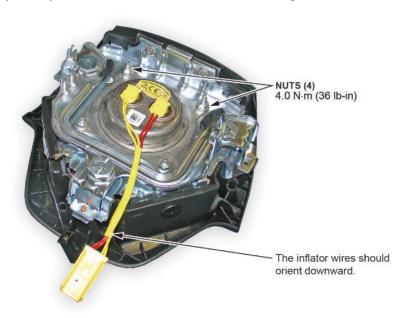
11.1. Insert the airbag inflator into the opening.

Make sure the inflator wires are positioned toward the bottom of the airbag. If you install the inflator incorrectly, you may not be able to reconnect the SRS airbag harness.

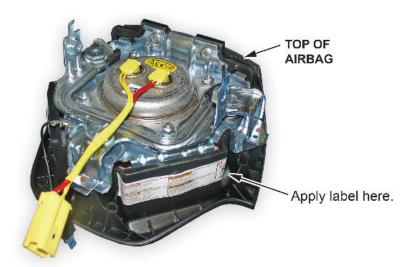
11.3. If the inflator kit came with a label, attach it to the airbag assembly as shown.
