<b>REFERENCE:</b>	Nova Bus Manuals
<b>SECTION:</b>	12: Passenger Seats
<b>RS N°:</b>	MQR 7621-1275
<b>EFFECTIVE IN PROD.:</b>	LC67(2019SE)
<b>TC RECALL N°:</b>	2019-332
<b>NHTSA RECALL N°:</b>	19V511

<b>SUBJECT:</b>	Cantilever-type passenger seat anchor rails
<b>JUSTIFICATION:</b>	Hardware used to secure some cantilever seats may not have been properly tightened.

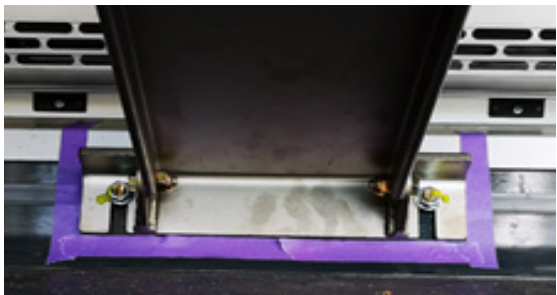
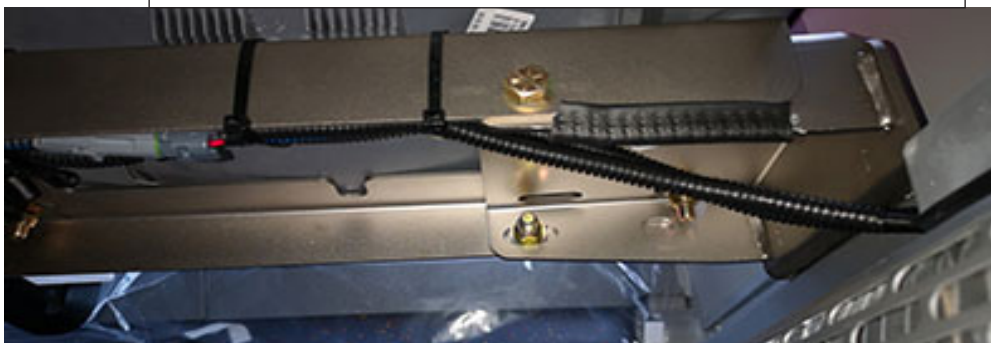
Figure 2 - Steps to do Before Seat Removal

a - Place tape on each side of the lower anchor bracket or brackets. Place tape on the wall to align with the middle of the top support bracket.

Middle of the top support bracket

b - Typical electrical harness to disconnect and remove

- 1.2. For all cantilever-type two passenger seats with no stanchion affixed to the backrest, follow steps a-q to replace the upper support bracket
  - a. Place tape on each side of the lower anchor bracket. Place tape on the wall to align with the middle of the top support bracket. See Figure 2.
  - b. If required, disconnect any electrical harness connected to an electrical device on the seat frame and remove the tie wraps. See Figure 2.
