REFERENCE:	Nova Bus Manuals
SECTION:	12: Passenger Seats
RS N°:	MQR 7621-1275
EFFECTIVE IN PROD.:	LC67(2019SE)
TC RECALL N°:	2019-332
NHTSA RECALL N°:	19V511

SUBJECT:	Cantilever-type passenger seat anchor rails
JUSTIFICATION:	Hardware used to secure some cantilever seats may not have been properly tightened.

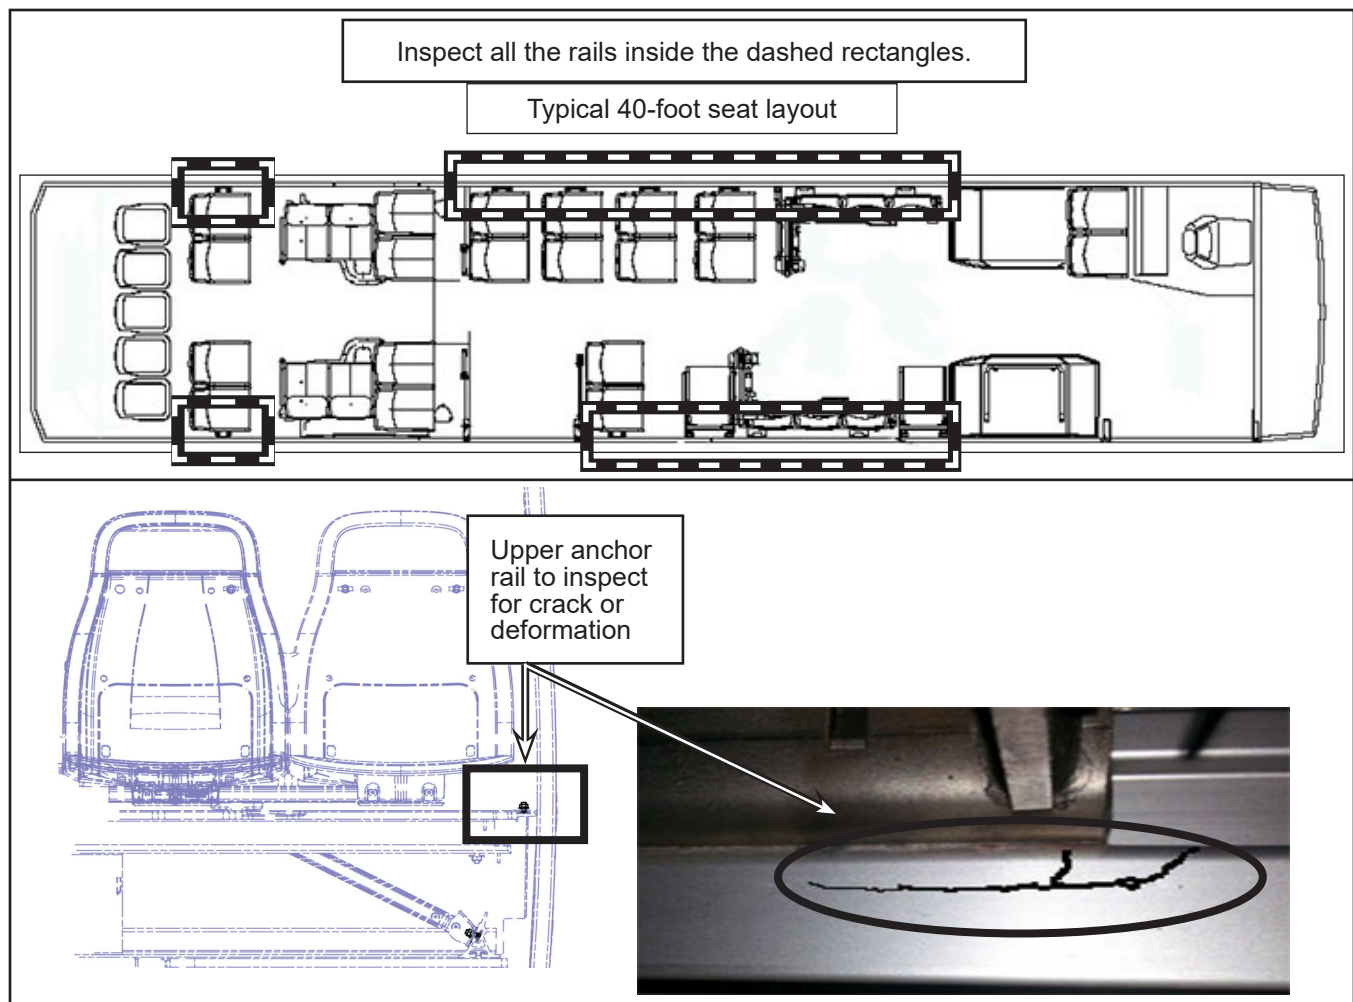
Figure 1 - Inspection Seats' Upper Rail

- 1.1. Visually inspect all the upper anchor rails located between the front wheelhouses and the rear of the vehicle for any cracks and/or deformities. See Figure 1.
 - a. If any cracks and/or deformities are visible on the top anchor rails, go to step 2.1. If no defect are found after inspection, proceed with the next step of the level 1 procedure

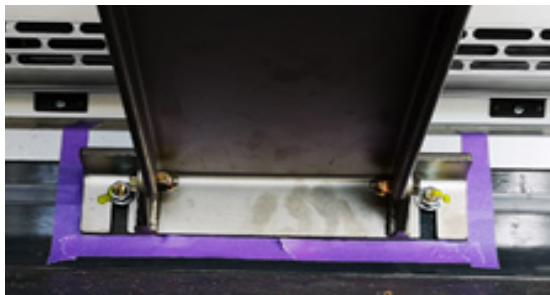
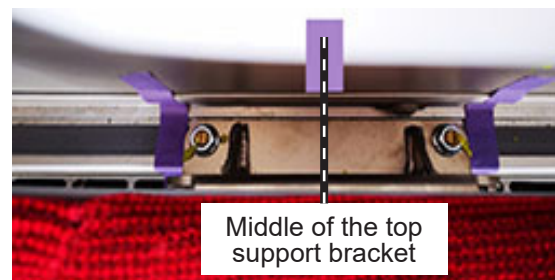
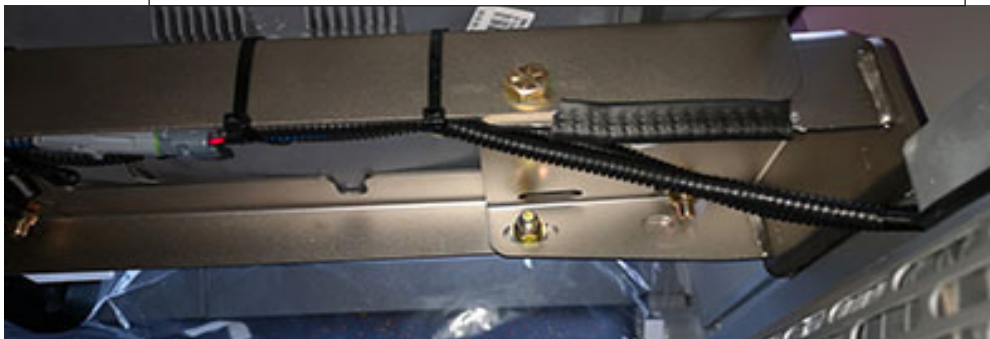
Figure 2 - Steps to do Before Seat Removal

a - Place tape on each side of the lower anchor bracket or brackets. Place tape on the wall to align with the middle of the top support bracket.

b - Typical electrical harness to disconnect and remove

- 1.2. For all cantilever-type two passenger seats with no stanchion affixed to the backrest, follow steps a-q to replace the upper support bracket
 - a. Place tape on each side of the lower anchor bracket. Place tape on the wall to align with the middle of the top support bracket. See Figure 2.
 - b. If required, disconnect any electrical harness connected to an electrical device on the seat frame and remove the tie wraps. See Figure 2.
