REFERENCE:	Nova Bus Manuals
SECTION:	12: Passenger Seats
RS N°:	MQR 7621-1275
EFFECTIVE IN PROD.:	LC67(2019SE)
TC RECALL N°:	2019-332
NHTSA RECALL N°:	19V511

SUBJECT:	Cantilever-type passenger seat anchor rails
JUSTIFICATION:	Hardware used to secure some cantilever seats may not have been properly tightened.

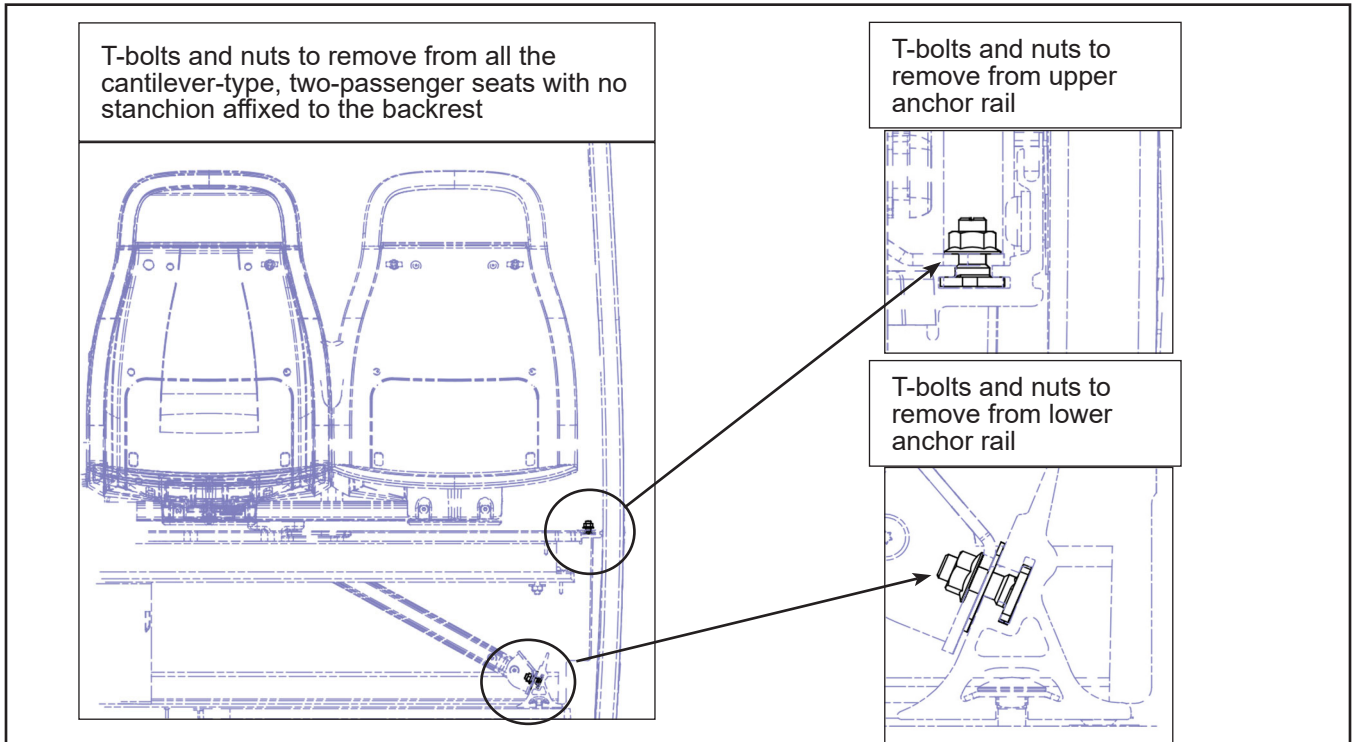
Figure 3 - T-bolts and Nuts to remove

- c. Remove the cantilever-type two passenger seats with no stanchion affixed to the backrest from the seat anchor rail. Remove all T-bolts and nuts from the upper and lower anchor rails. Dispose of all the removed T-bolts and nuts. See Figure 3.

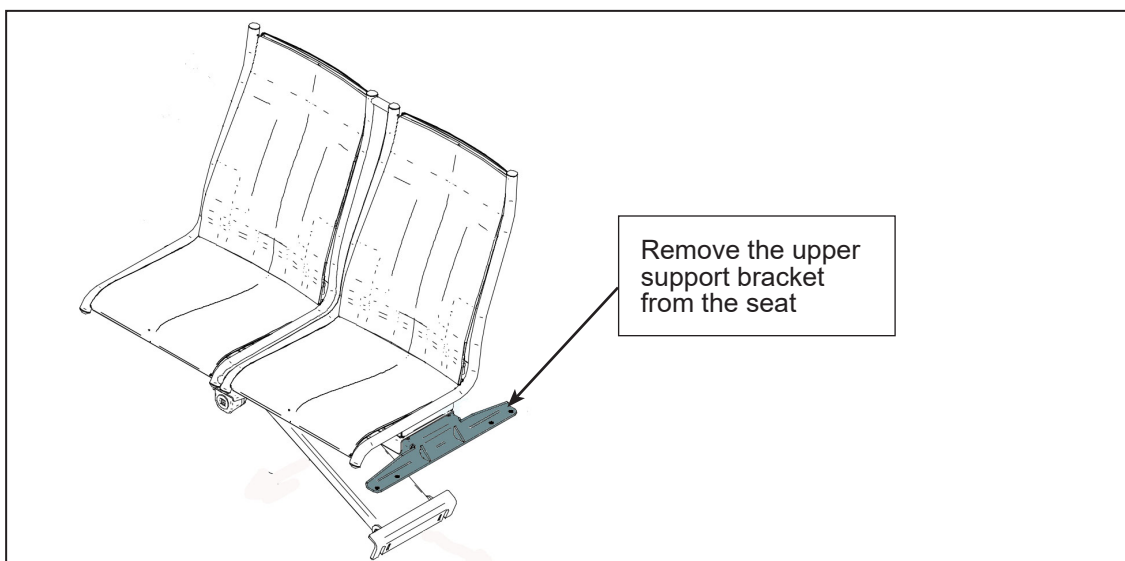
Figure 4 - Typical Upper Support Bracket to Remove

- d. Remove the upper support bracket from all the removed cantilever-type seats. Retain the hardware. See Figure 4.

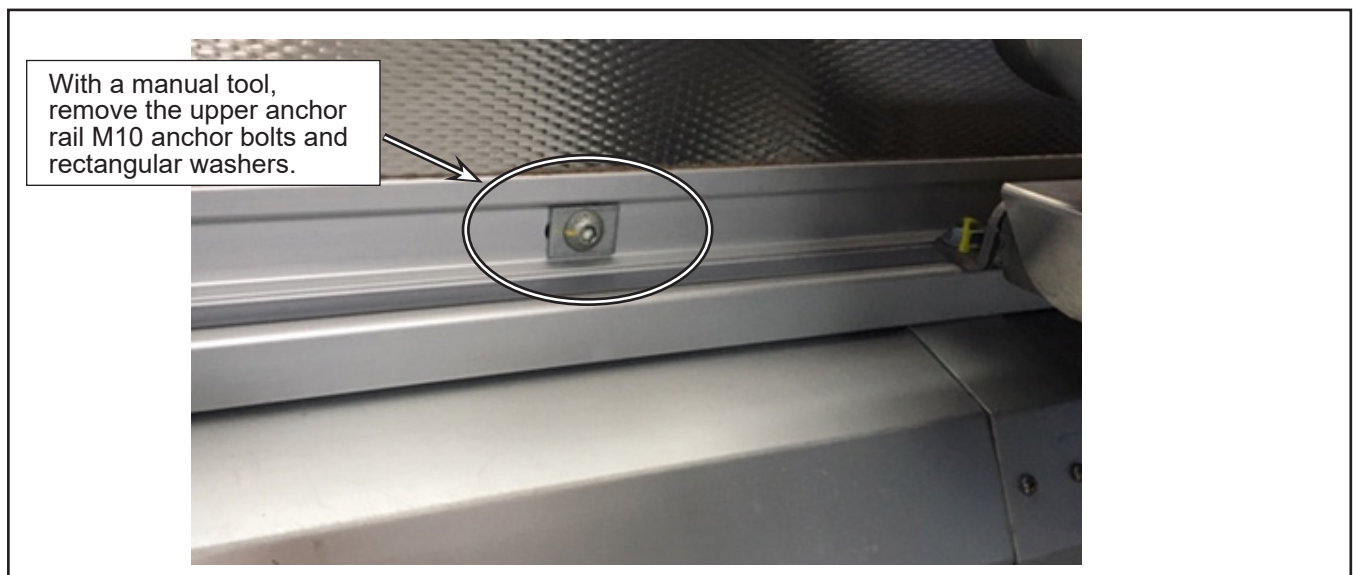
Figure 12 - M10 Bolts and Rectangular Washers to Remove

- h. With a manual tool remove the top anchor rail M10 anchor bolts and rectangular washers. Be careful not to strip the wall rivnuts while removing the anchor bolts. Discard the bolts and retain the rectangle washer. See Figure 12.
- i. Remove the upper anchor rail by pulling the bottom of the rail toward the center of the vehicle. Dispose of the removed anchor rail.
