Keystone RV Company

SAFETY ADVISORY # 19-357

Hampton – Sunset Breakaway Wiring

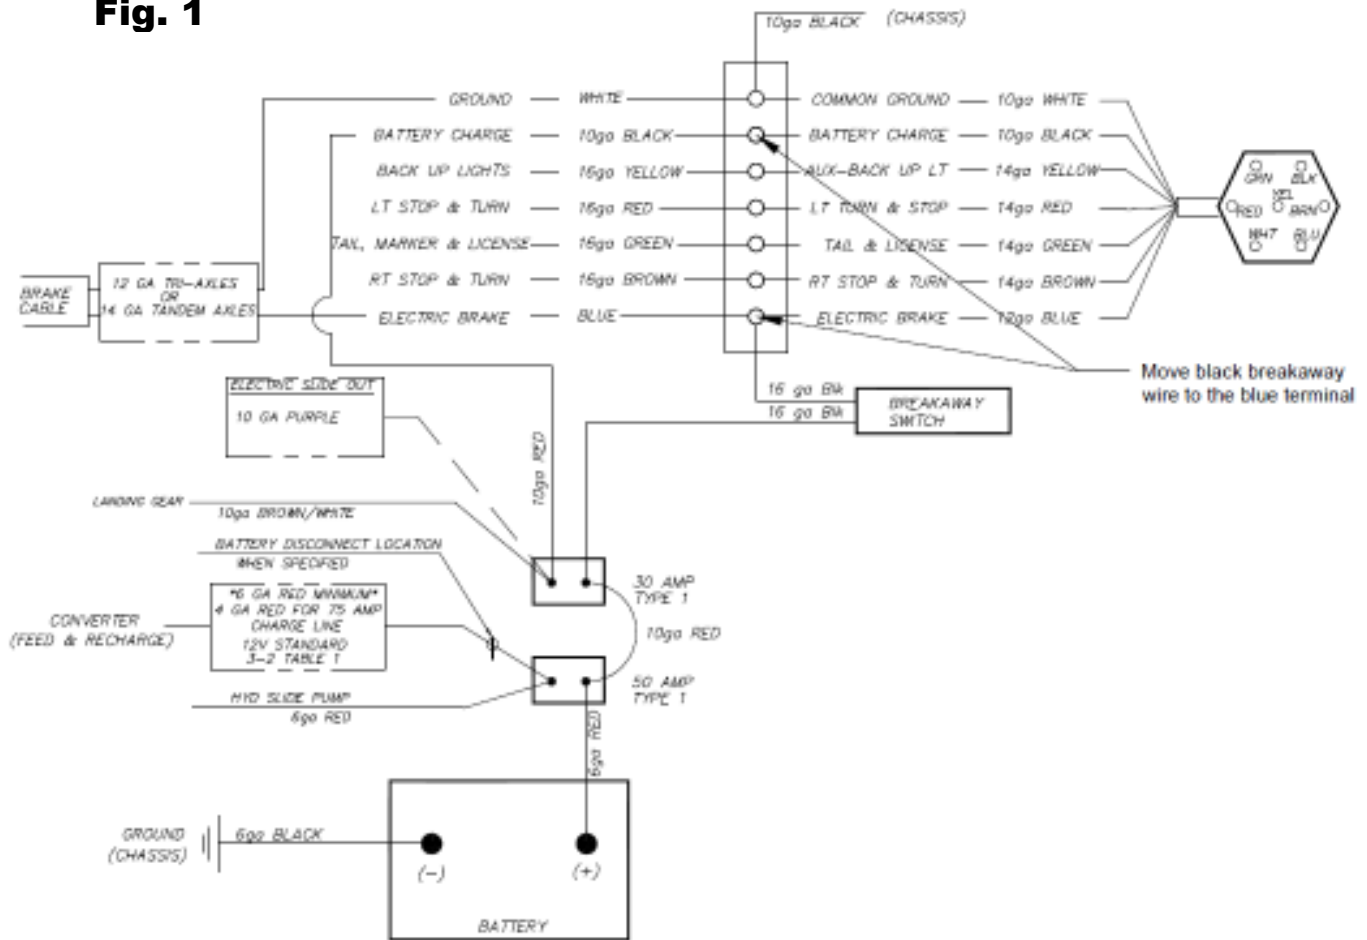
Fig. 1

Remove the cover to the Bargman 7-way distribution box and inspect the installation of the breakaway wire. See Figures 1 & 2.

ELECTRICAL WIRING - BARGMAN CORD

If the breakaway wire is connected to the black charge line, remove it and install it on the blue brake wire.
