Safety Recall Notice Service Bulletin 508949 Rev. B

NHTSA Recall #: 19V546

Seat Solenoid Timer Installation Kit 508947KS

Applicable for Ford MXV With Flip n Go Seat
Shipped Before June 10, 2019

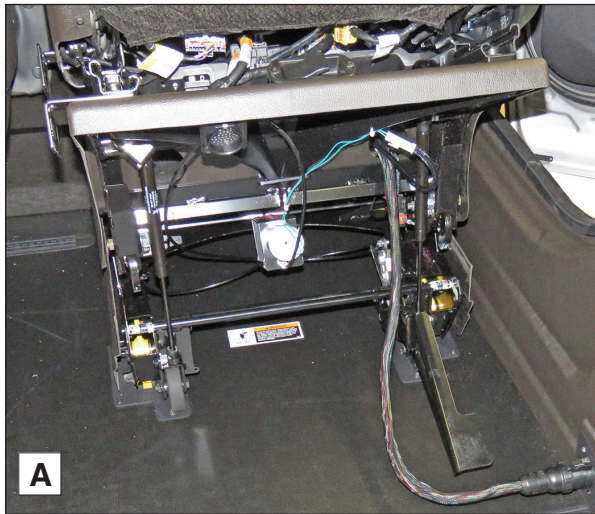
1. Tilt seat forward. See Photo A.

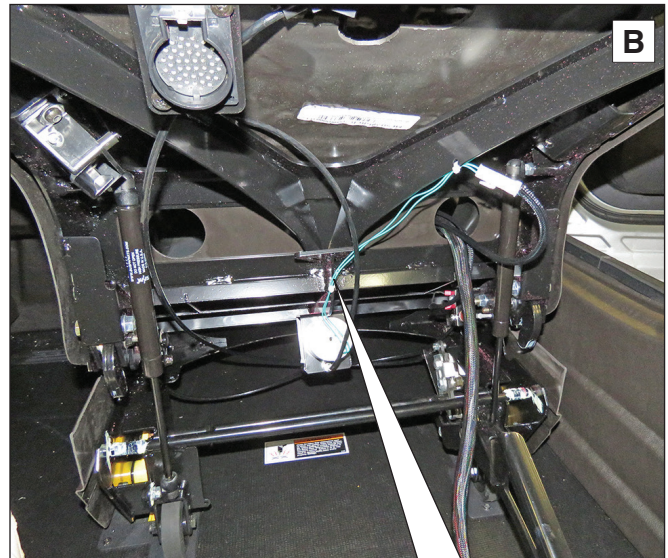
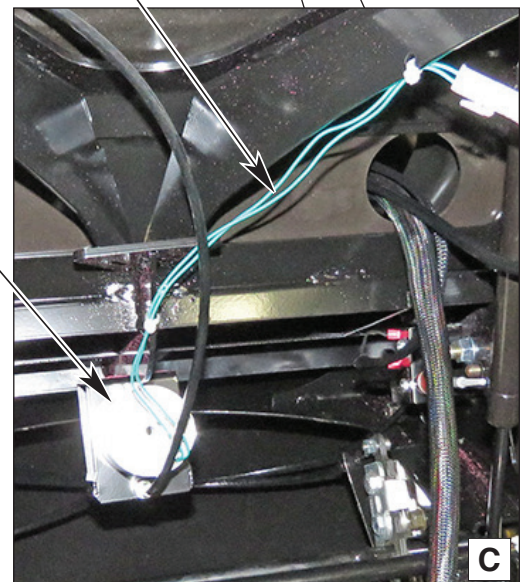
2. Inspect seat solenoid wiring for damage, wear, or
any abnormal condition. See Photos B and C.

If condition above is observed, contact Vehicle
Aftersales at 1-877-272-8633, Option 3.

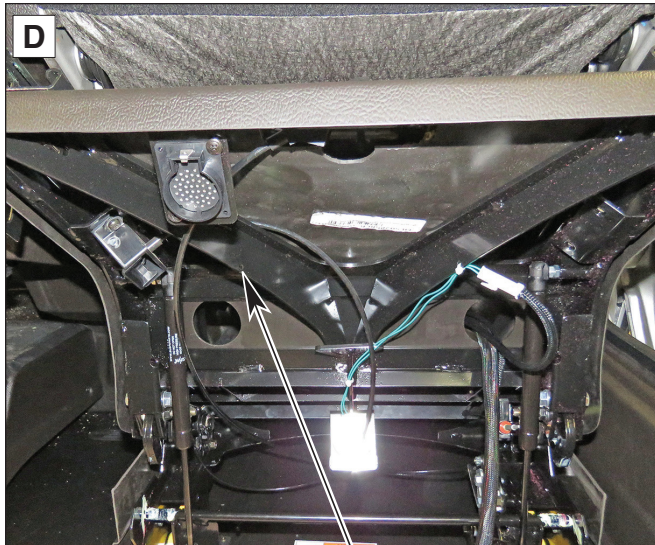
Existing Hole

3. Locate existing hole shown in Photo D.

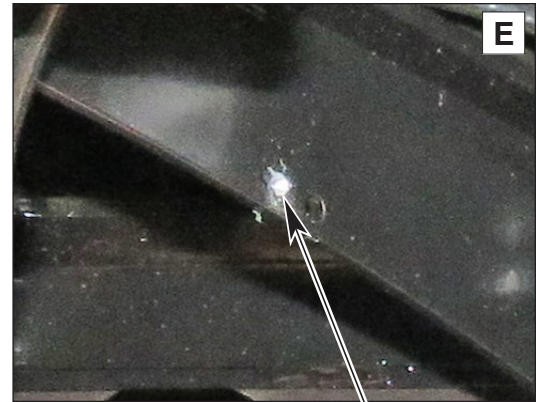
9/32" Hole

4. Drill a 9/32" approximately 1/2" from existing hole as shown in Photo E.

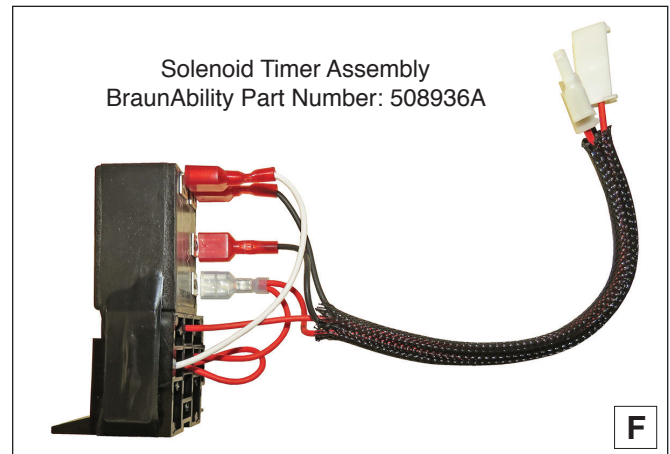
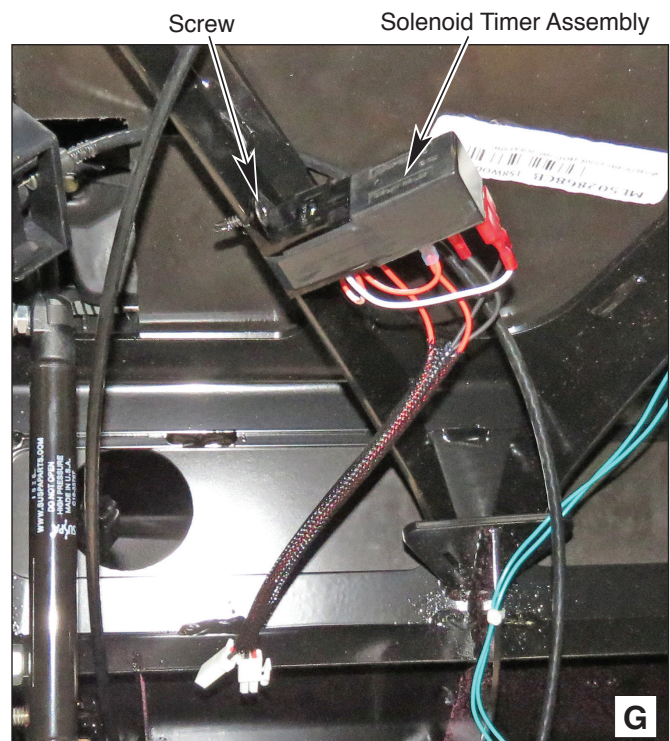
5. Secure solenoid timer harness assembly to underside of seat using hole drilled in Step 4 and screw included in kit. See Photos F and G.

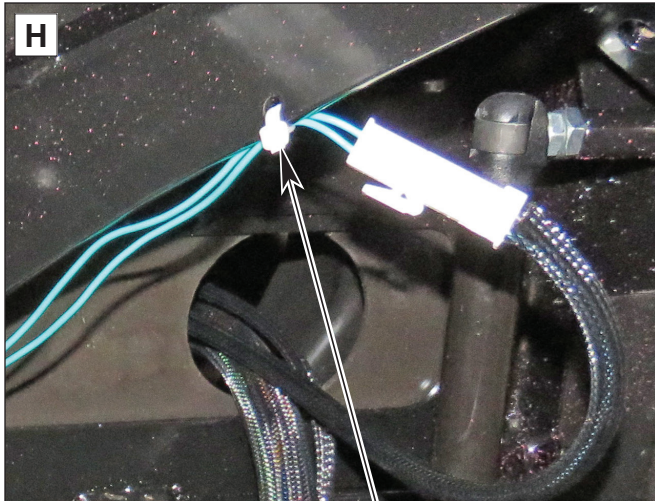
Cable Tie

6. Remove cable tie, shown in Photo H, securing solenoid wires to underside of seat.

8. Secure harness to underside of seat using cable tie included in kit. Refer to Photo H.

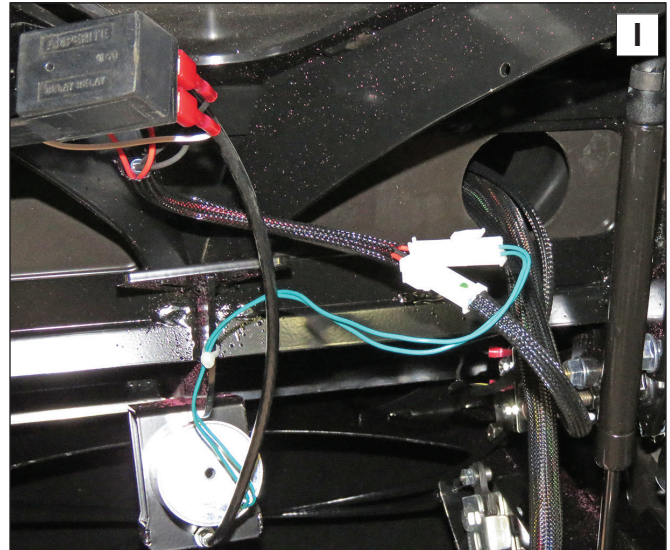
7. Connect solenoid timer assembly in-line as shown in Photo I.

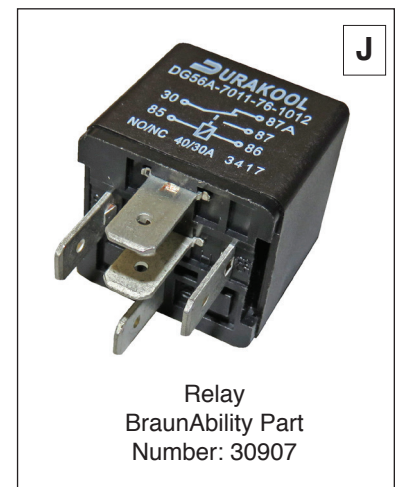
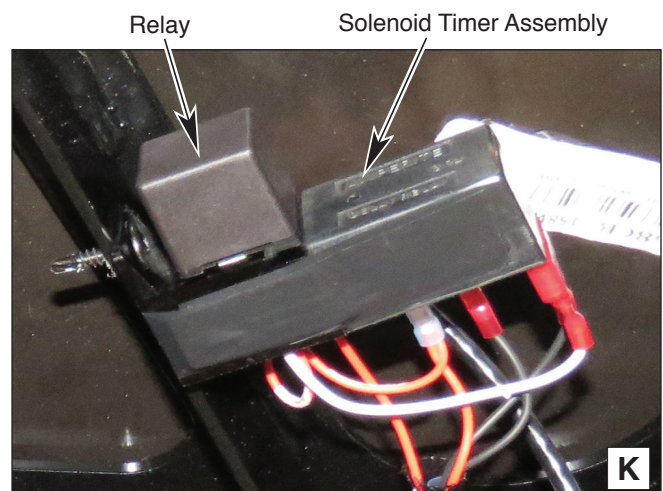
9. Connect relay, included in kit, to solenoid timer assembly. See Photos J and K.

Relay
BraunAbility Part
Number: 30907
