2019 Mazda3 - Interior Rearview Mirror Can Suddenly Detach - Safety Recall 3919G

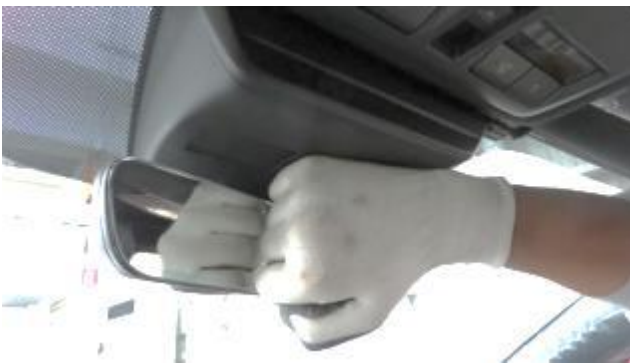
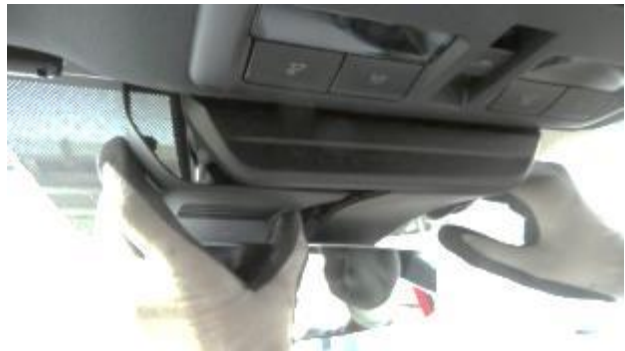
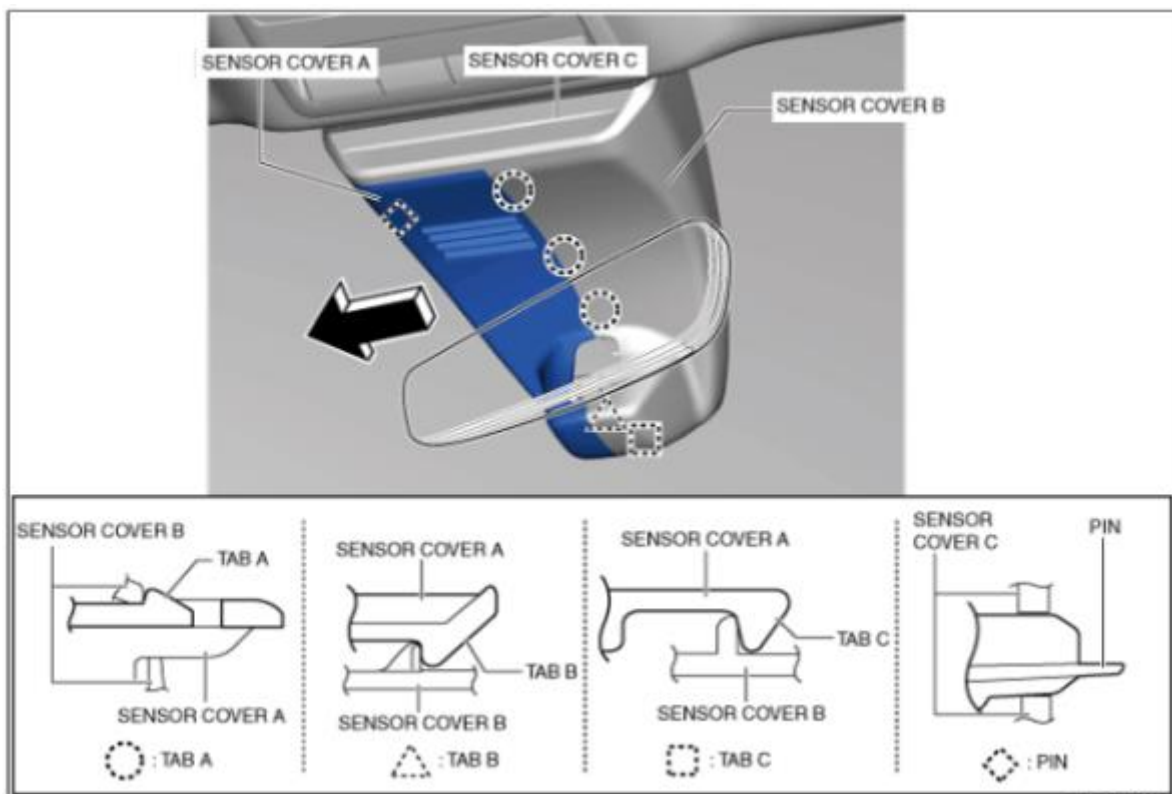
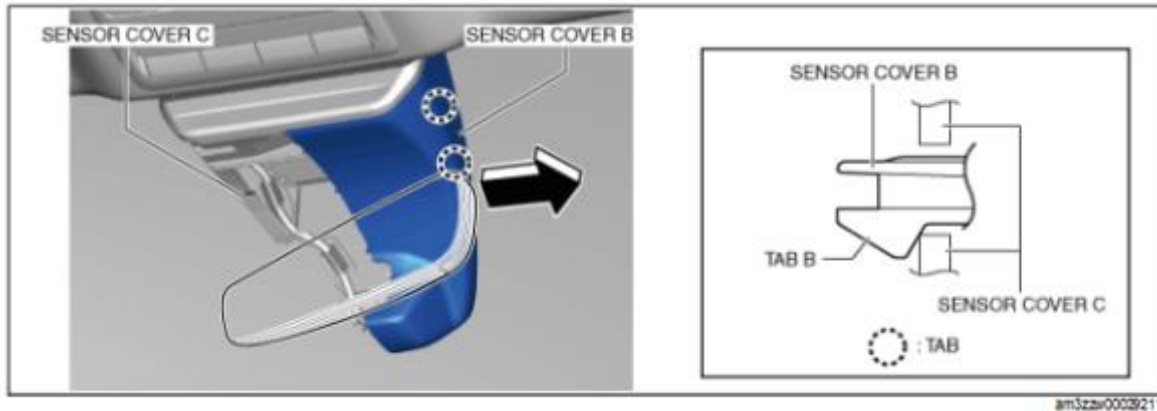
1. Hit the sensor cover at center line lightly and remove the sensor cover when the gap is visible. Slide the sensor cover in parallel and remove.

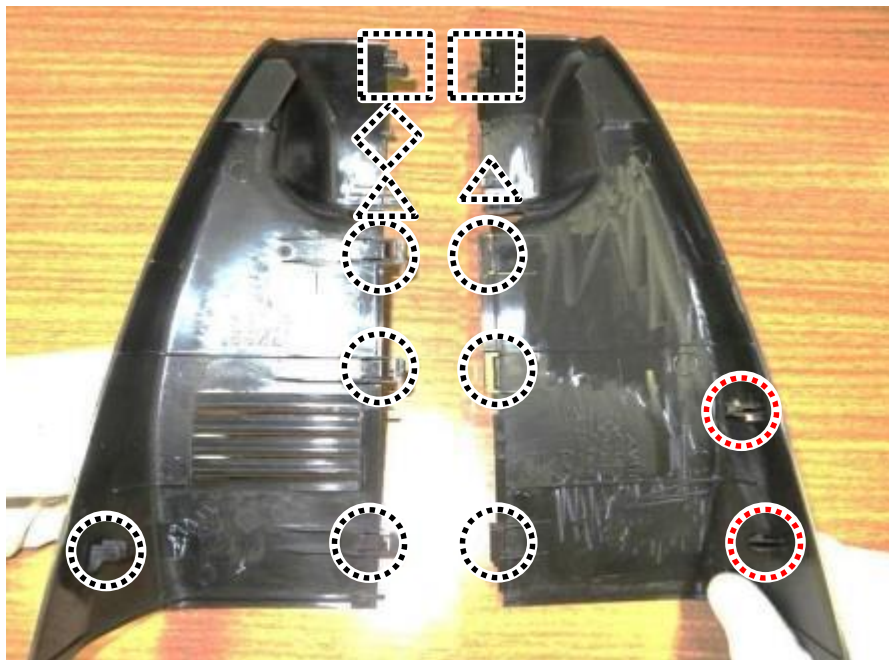
➤ Right and left

2. Confirm all fitting tabs of the sensor cover are secure.

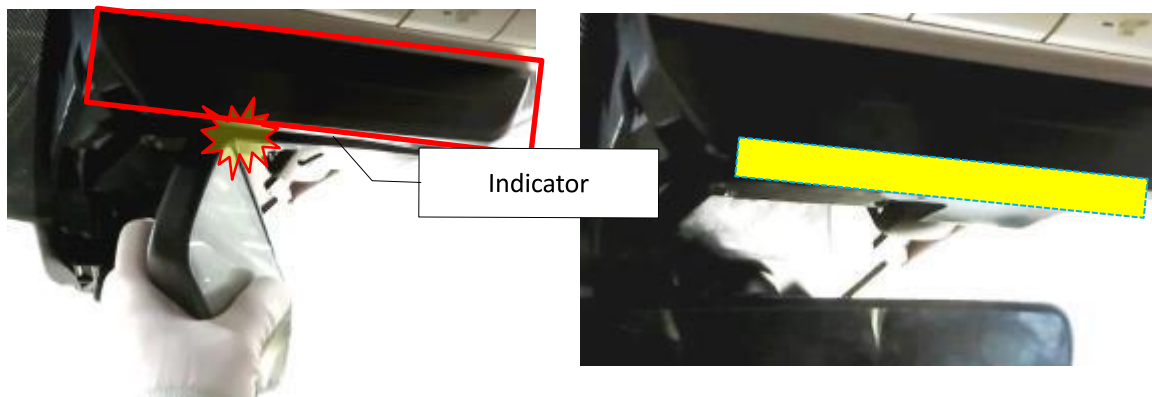
3. Protect the indicator with masking tape to avoid possible scratches. It is possible to hit the indicator when removing the inner mirror.

BE CAREFUL! IT HAS BEEN FOUND THAT EXCESSIVE FORCE DURING REMOVAL OF THE MIRROR IS CAUSING THIS CHIPPING.

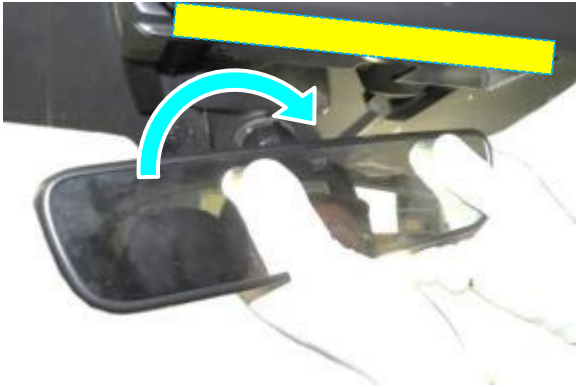
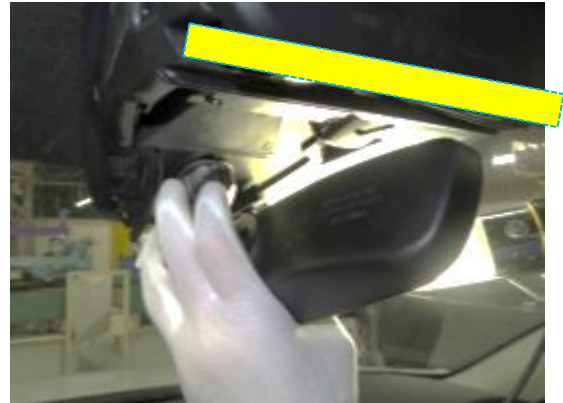
4. Turn the mirror (shown the picture below) about 60 degree then remove the inner mirror.

Note : Hold at inner mirror arm and turn whole inner mirror for easy removal. (shown the picture below.)

BE CAREFUL! EXCESSIVE FORCE WILL DAMAGE THE MIRROR BASE!

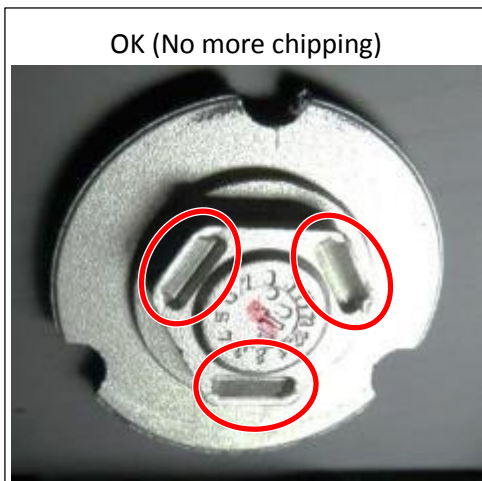
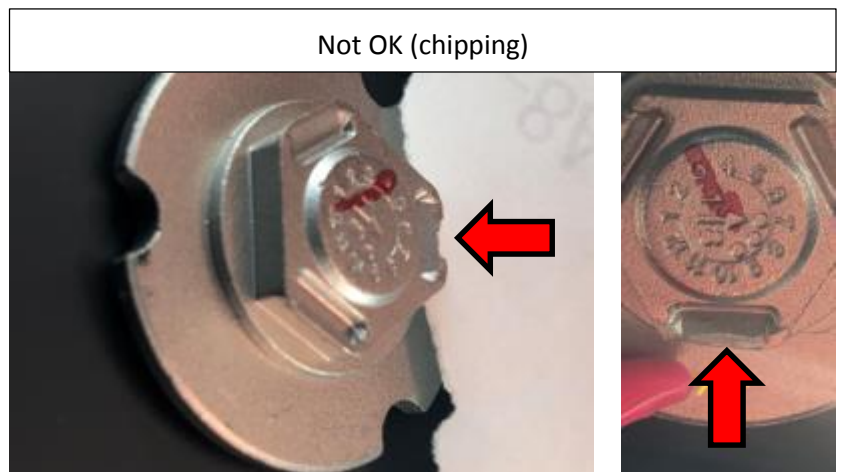
5. Confirm the mirror base is secure.

Caution : If there are chips at any of three mirror base slit (red circle), the front windshield must be replaced. (Mirror base is not replaced as a single part.)

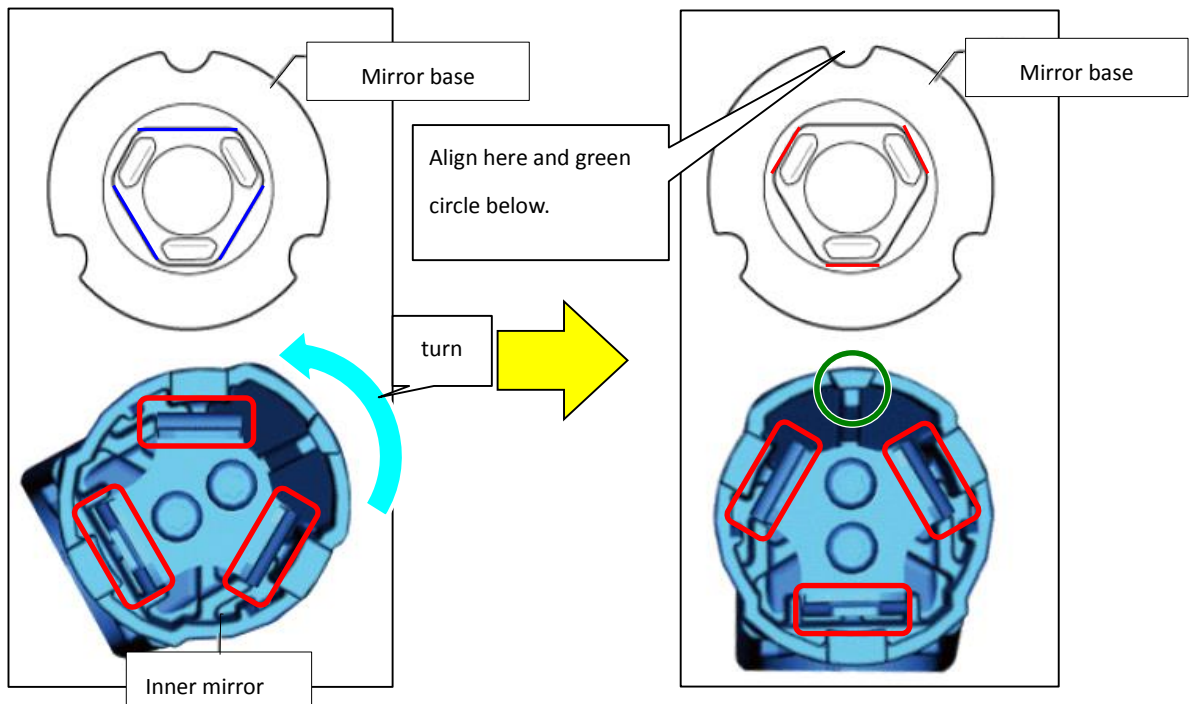
Note: Align the claws of the inner mirror (square in the figure below) with the long three sides (blue) of the six sides of the inner mirror base hexagon. Rotate about 60 degree and fit the claws of the inner mirror with the three short sides (red) of the slit.

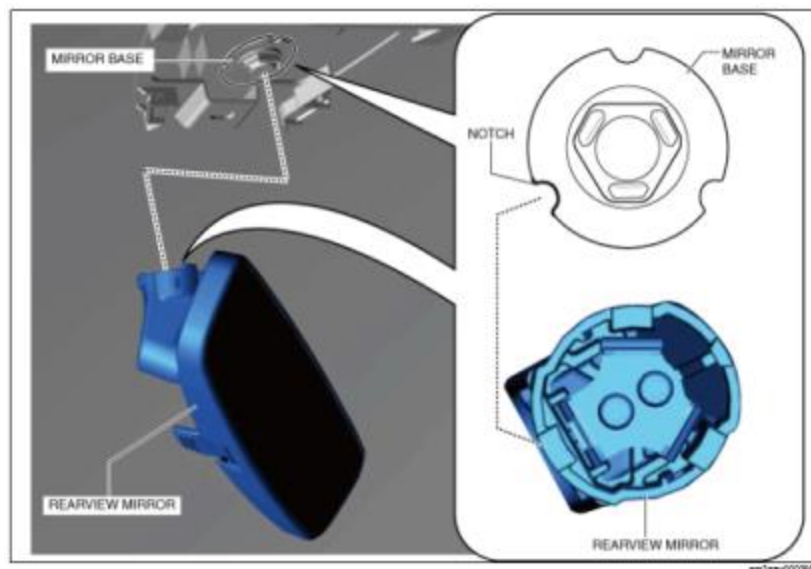
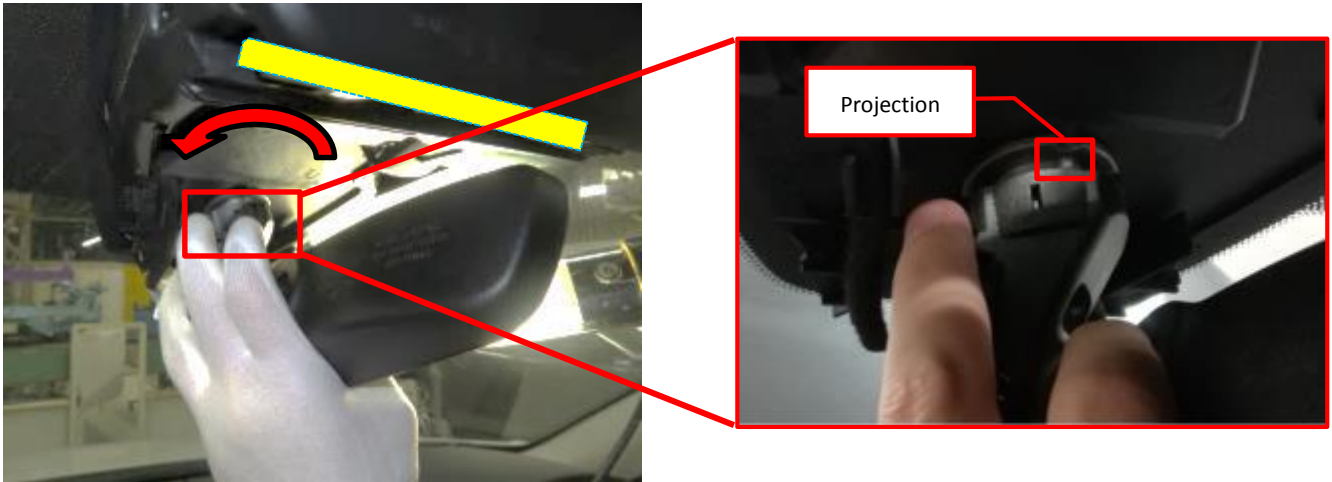
1. Align the projection of the inner mirror at the notch of the mirror base then turn the inner mirror about 60 degree to mount.

Point : After aligning the projection with the notch, turn it along the inner mirror base for easy installation.

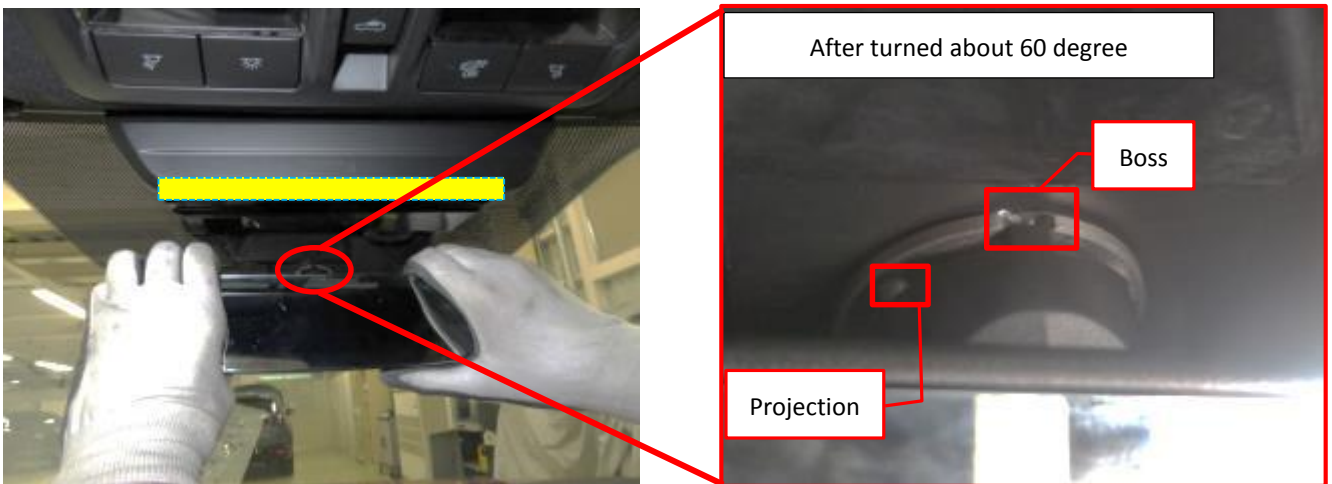
2. Make sure the inner mirror is facing the front and boss is in the red circle position.

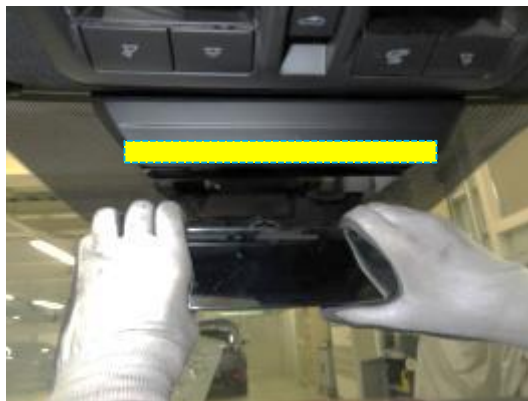
3. Make sure there is no freeplay on the mirror base mounting part.

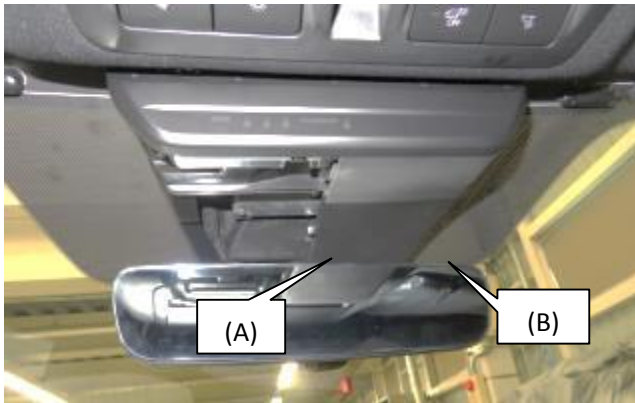
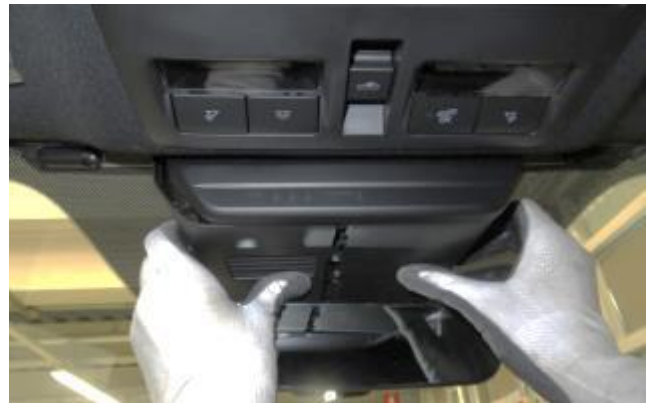
4. Remove the protective masking tape on the indicator.
5. After making sure the tabs are not damaged on the center cover, re-install these covers.

Caution : If the cover is scratched or damaged, replace them.

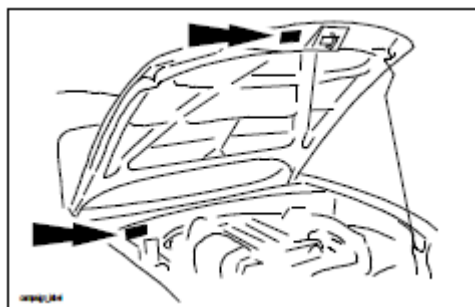
2. Affix it to the hood or bulkhead as shown:
