2019 Mazda3 - Interior Rearview Mirror Can Suddenly Detach - Safety Recall 3919G

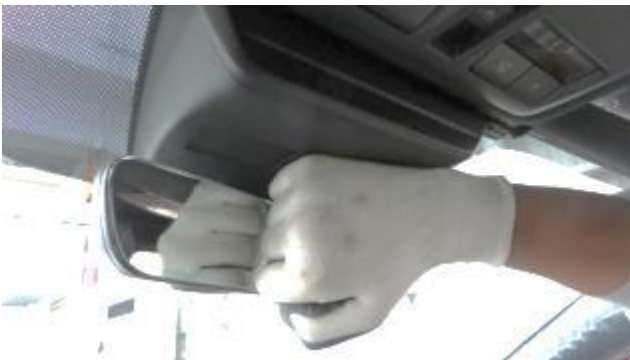
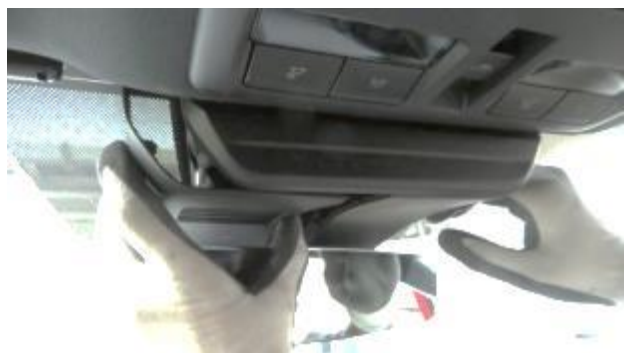
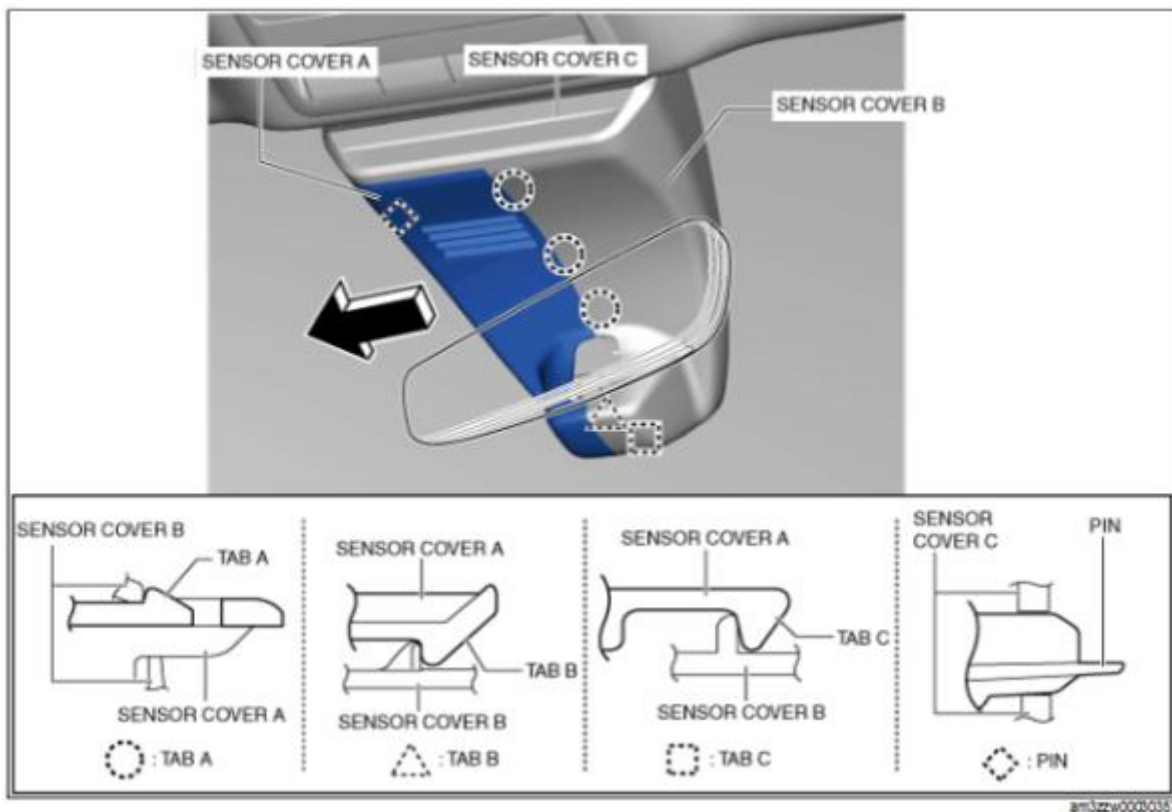
1. Hit the sensor cover at center line lightly and remove the sensor cover when the gap is visible. Slide the sensor cover in parallel and remove.

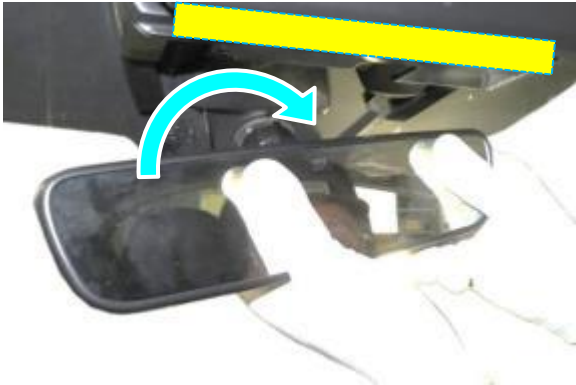
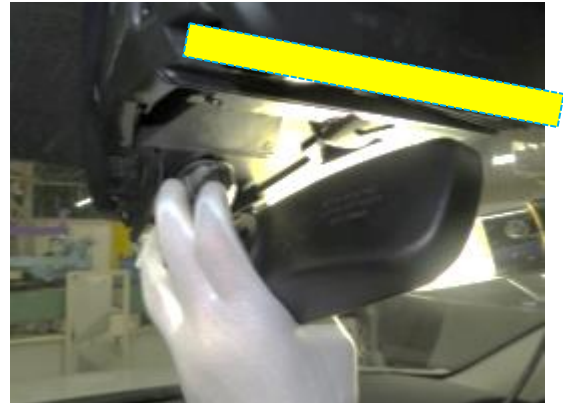
4. Turn the mirror (shown the picture below) about 60 degree then remove the inner mirror.

Note : Hold at inner mirror arm and turn whole inner mirror for easy removal. (shown the picture below.)

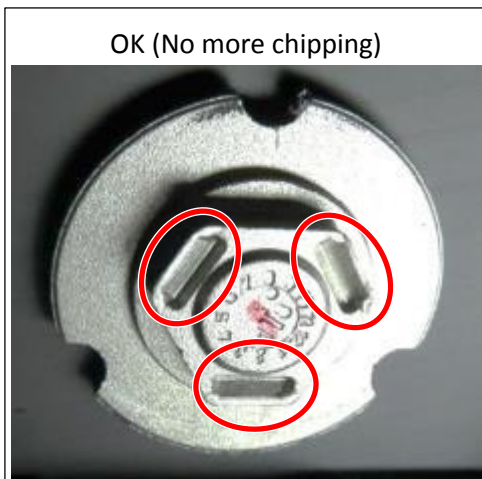
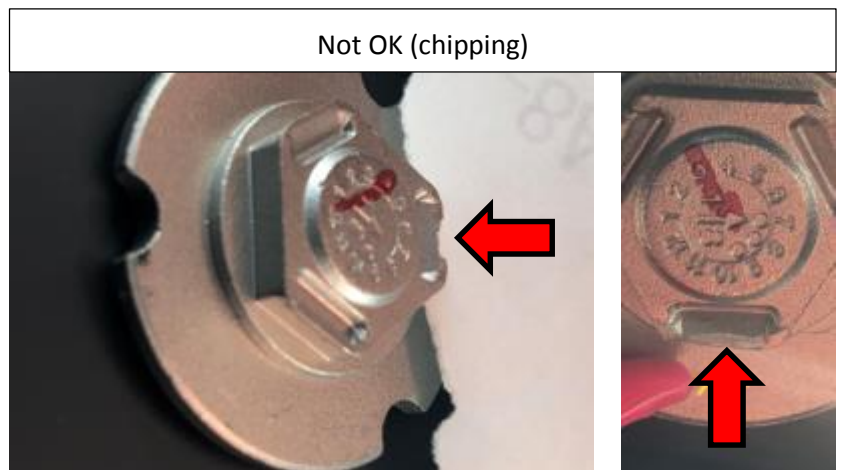
5. Confirm the mirror base is secure.

Caution : If there are chips at any of three mirror base slit (red circle), the front windshield must be replaced. (Mirror base is not replaced as a single part.)

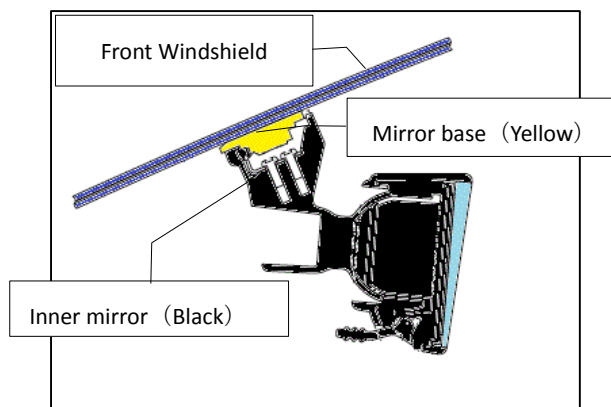
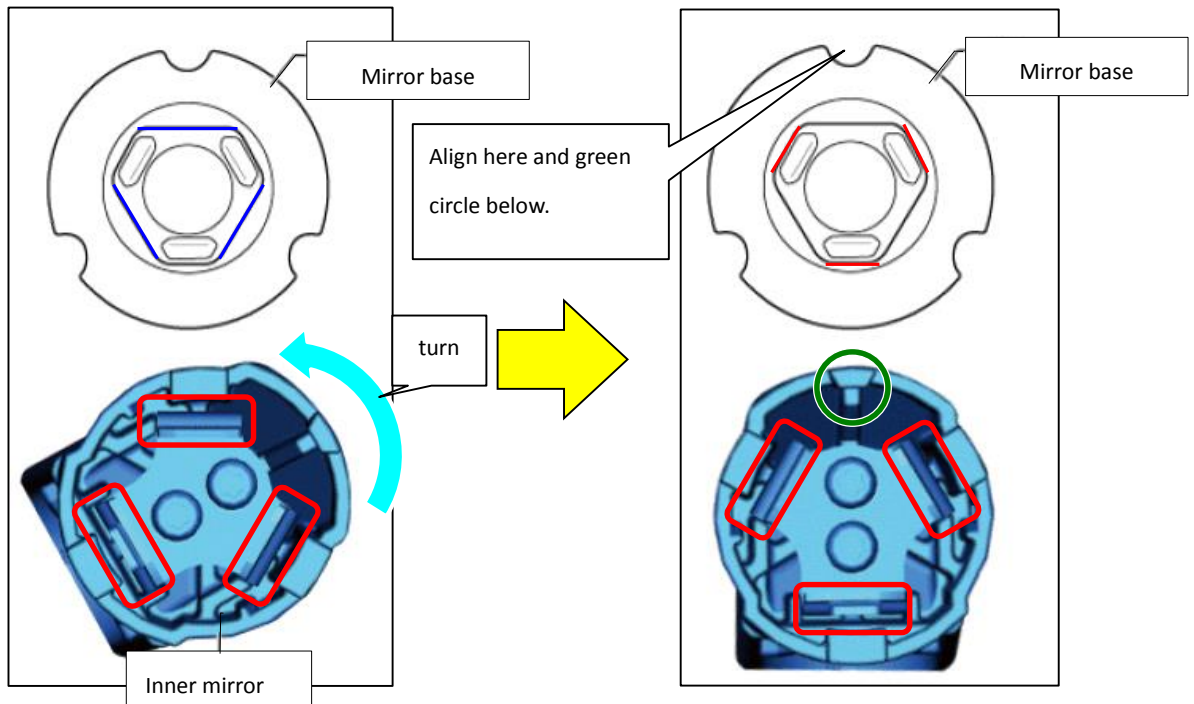
- Cut image

Note: Align the claws of the inner mirror (square in the figure below) with the long three sides (blue) of the six sides of the inner mirror base hexagon. Rotate about 60 degree and fit the claws of the inner mirror with the three short sides (red) of the slit.

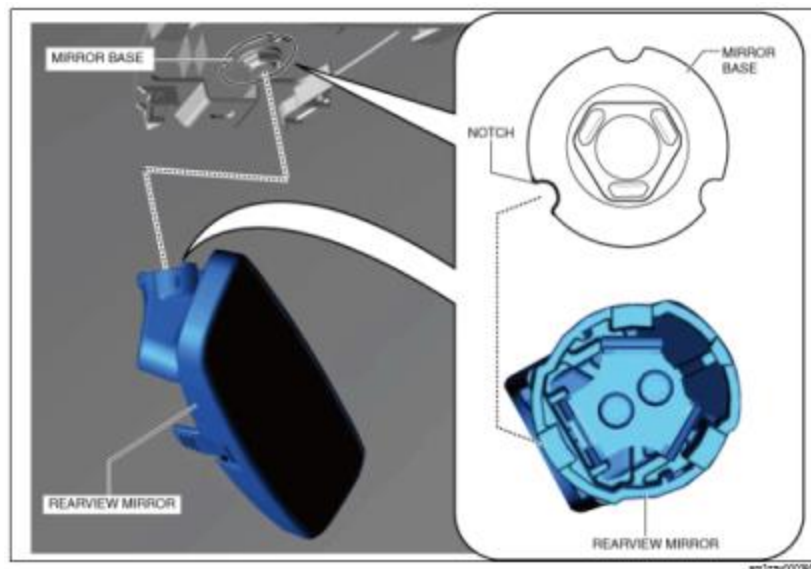
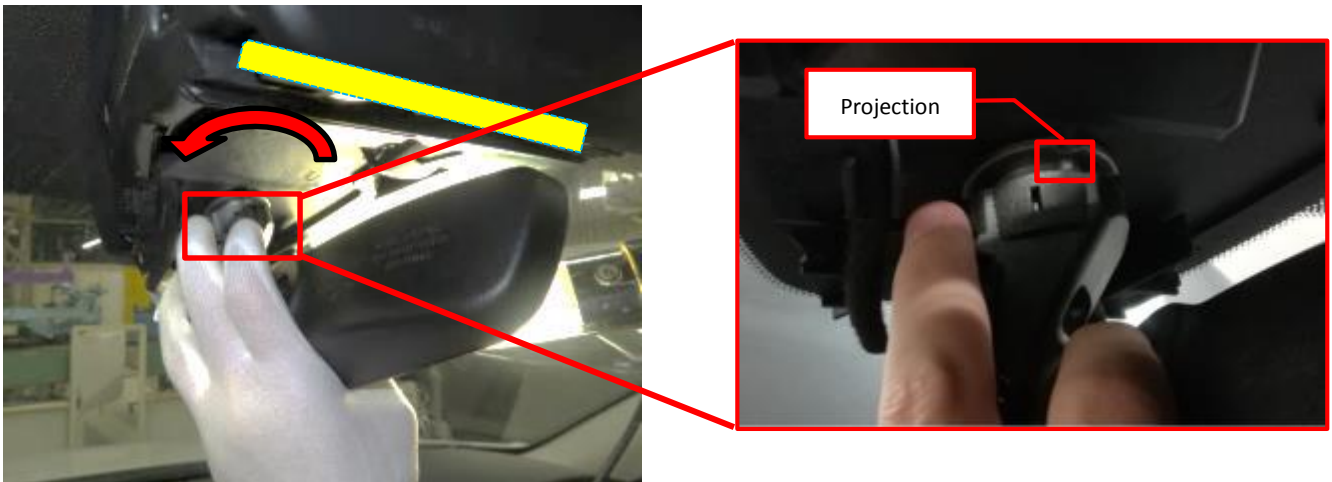
1. Align the projection of the inner mirror at the notch of the mirror base then turn the inner mirror about 60 degree to mount.

Point : After aligning the projection with the notch, turn it along the inner mirror base for easy installation.

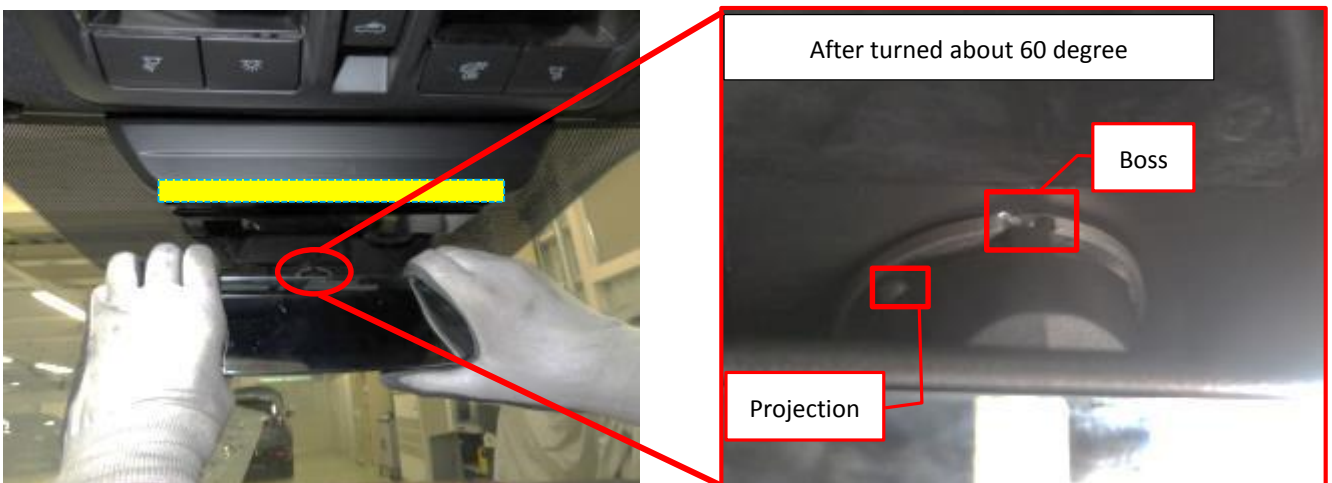
2. Make sure the inner mirror is facing the front and boss is in the red circle position.

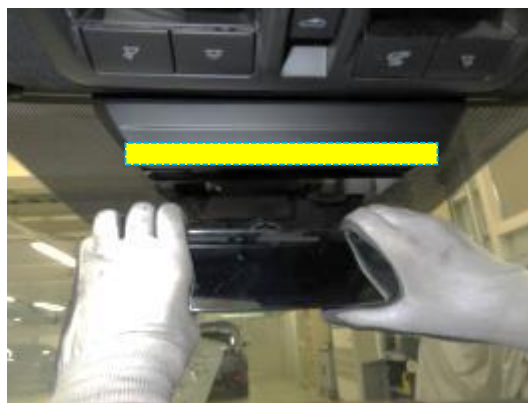
3. Make sure there is no freeplay on the mirror base mounting part.

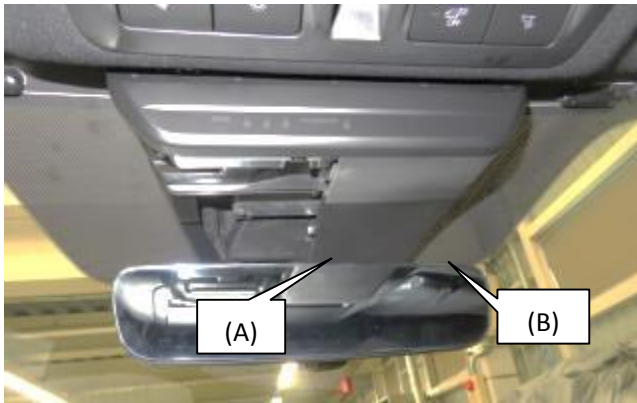
4. Remove the protective masking tape on the indicator.
5. After making sure the tabs are not damaged on the center cover, re-install these covers.

Caution : If the cover is scratched or damaged, replace them.

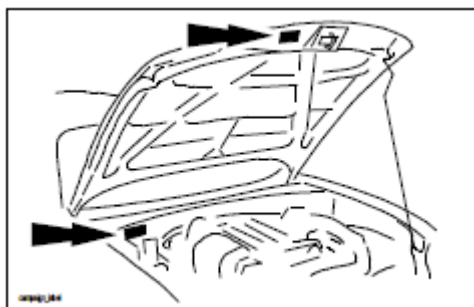
2. Affix it to the hood or bulkhead as shown:
