TO: Mercedes-Benz Dealer Principals, General Managers, Sales Managers, Service Managers, Parts Managers	FROM: Gregory Gunther, Department Manager, Vehicle Compliance and Analysis, Engineering Services
RE: <b>Recall Campaign Launch Notification</b> <b>Replace Passenger Airbag</b> <b>MY18-19 231 (SL-Class)</b>	DATE: December 6, 2019

**Recall Campaign Launch Notification**

Replace Pass Airbag

SUBJECT: **Model SL-Class vehicles (231 platform)**  
**Model Years 2018-2019**  
**Replace front passenger airbag**

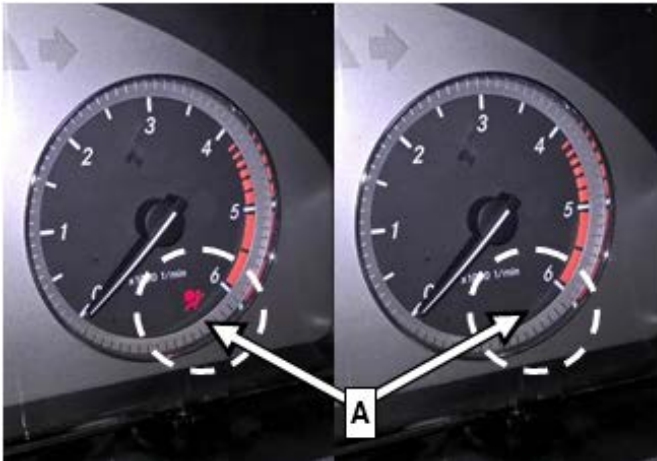
Figure 1

2. Turn the transmitter key in the electronic ignition lock to **position 1** and check whether the airbag indicator lamp (A, figure 1 **or** 2) goes off and stays off after several seconds.

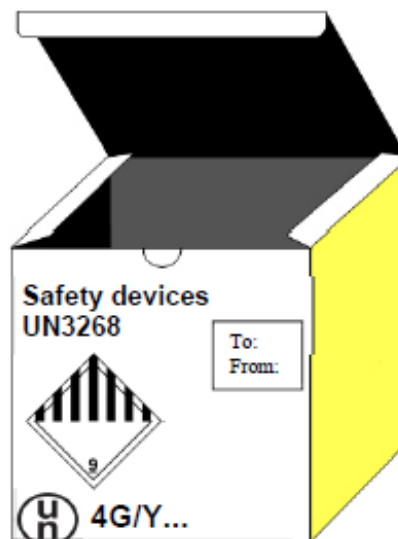
- Carefully open received box and remove new airbag. Keep box intact & save all contents!
- Place used airbag into replacement airbag box, re-using any packaging material (e.g., cardboard inserts) used for the new airbag. Package as the new airbag was packaged.
- Use plastic adhesive tape 50 mm wide to secure the box closed. Do not obscure labels or text on the box with the tape.
- Ensure that the 4G fiberboard box is not ripped or damaged.

- A Class 9 Miscellaneous label must be clearly visible on one side of the box.

- The following words ("marking") must also be clearly visible on the same side of the box as the Class 9 label:  
**Safety devices**  
**UN3268** (font size must be  $\geq \frac{1}{2}$  inch)
- Affix "To/From" address label to same or adjacent packaging face as the hazardous markings/labels.
- The UN 4G code preprinted near the bottom edge of the box must also be clearly visible.

- Note:** The Packing Group and the EX# are no longer required to be printed on the HAZMAT bill of lading.
- Package example:**

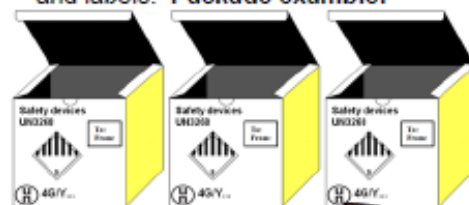
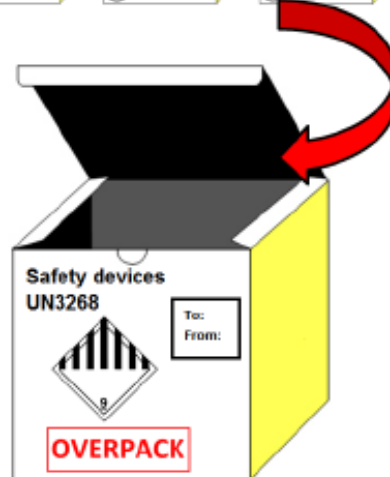
- Package each airbag in a separate UN spec box prepared with the labels/markings described above.
- Place each individual airbag box inside a larger non-UN spec box to keep the shipment together.
- This larger box is called an "OVERPACK."

- The OVERPACK must have the identical markings and label as the boxes contained inside.
- The OVERPACK must have the "OVERPACK" statement on the same face as the hazard markings and labels. **Package example:**
