TECHNICAL INSTRUCTIONS

SAFETY (NONCOMPLIANCE) RECALL K0N

BACKUP CAMERA DISPLAY MAY NOT OPERATE

CERTAIN 2019 MODEL YEAR RAV4 / RAV4 HV

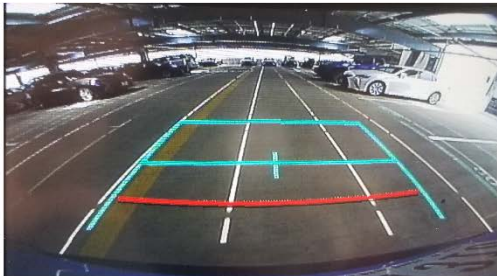
INSPECTION METHOD		
<p>1. INSPECT BACKUP MONITORING SYSTEM FUNCTION</p> <p>a. Turn the IG ON b. Shift the vehicle into Reverse</p>		<p>ACTIONS TO TAKE</p>
<p>OK Backup camera is functional</p> <div style="display: flex; align-items: center;">

</div> <p>*Home screen is used as an example.</p>	<p>No further action required. Campaign Complete</p>	
<p>NG No response</p> <div style="display: flex; align-items: center;">

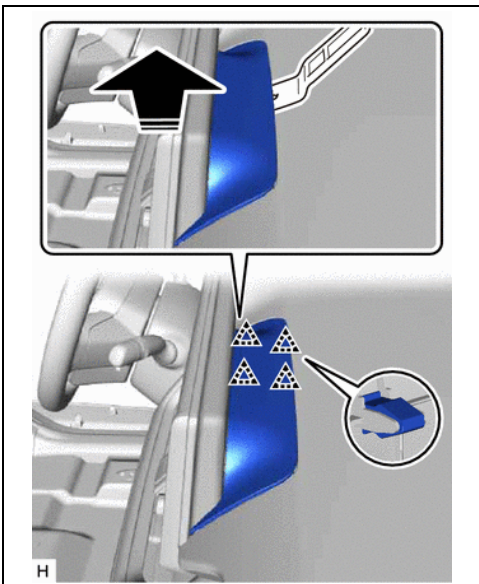
1. REMOVE CENTER UPPER INSTRUMENT CLUSTER FINISH PANEL

- a. Ensure the IG is OFF
- b. Using moulding remover B, detach the clips

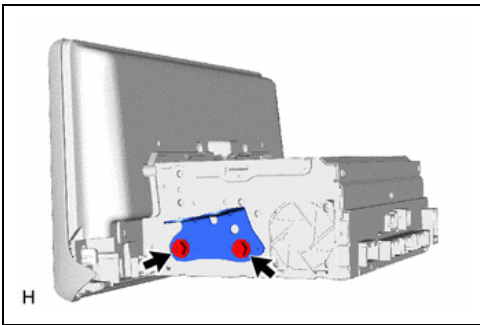
3. **INSTALL THE *NEW* RADIO AND DISPLAY RECEIVER ASSEMBLY WITH BRACKET**

- a. Install the No.1 radio receiver bracket with the 2 screws

Torque: 27 in.lbf (3 Nm, 31 kgf-cm)

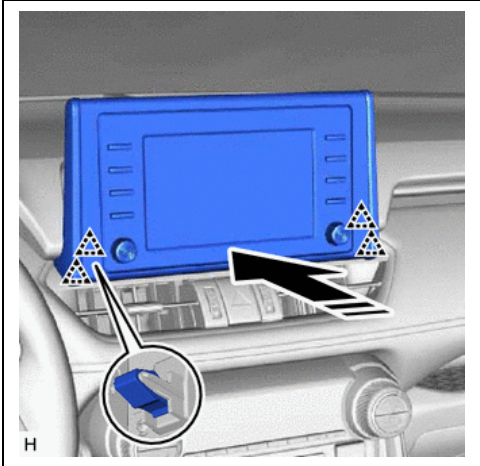
- b. Install the No.2 radio receiver bracket with the 2 screws
Torque: 27 in.lbf (3 Nm, 31 kgf-cm)

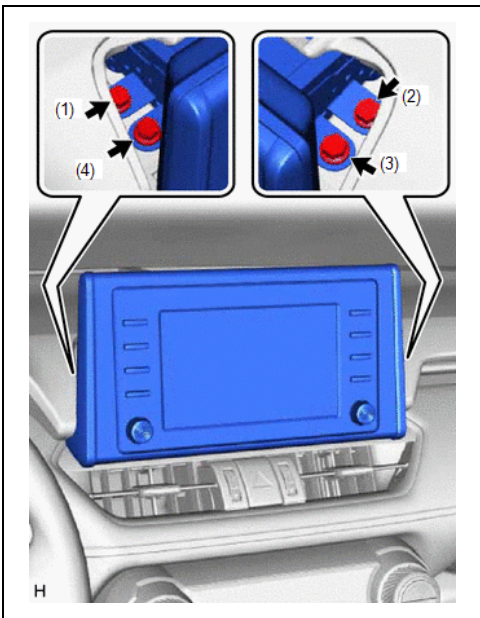
- c. Connect each connector
- d. Attach the clip to install the **NEW** radio and display receiver assembly with bracket

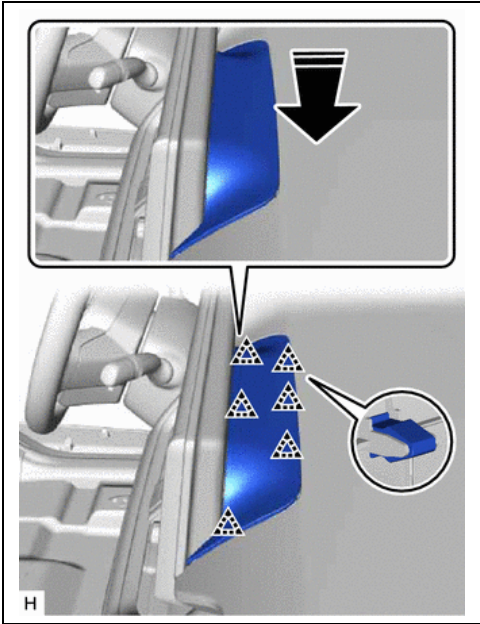
- e. Install the 4 bolts in the order shown in the illustration
Torque: 9 ft.lbf (12 Nm, 122 kgf-cm)
