Mercedes-Benz

Campaign No. 2019080010, September 2019

SUBJECT: **Model GLA-Class vehicles (156 platform)**
Model Years 2018-2019
Check rear middle seat belt, correct if necessary

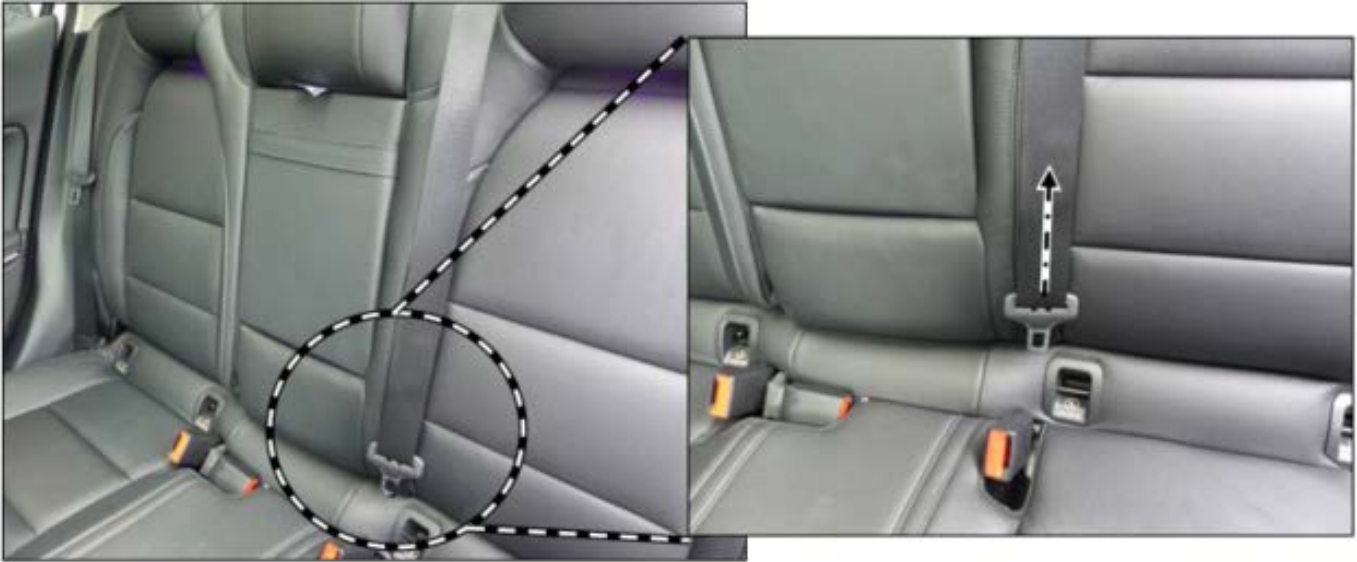
Figure 1

1. Check whether seat belt end fitting of center rear seat belt is attached correctly.

1.1. Grasp seat belt strap of center rear seat belt in area of rear seat cushion and rear seat backrest and pull away from rear seat (**Figure 1**).

i It is possible that the seat belt end fitting of the center rear seat belt is not attached and is just jammed.
