GROUP  
**Safety Recall Campaign**

MODEL  
**2020MY  
Telluride (ON)**

NUMBER  
**SC181 (Rev 1, 09/05/2019)**

SUBJECT: SEAT BELT INSPECTION  
AND/OR REPLACEMENT (SC181)

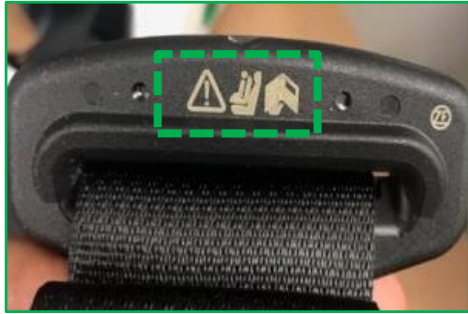
**✓OK**

Locate the seat belt assemblies outlined in this bulletin to identify the laser markings shown below and verify if the vehicle is affected: No Good (NG). If so, replace the seat belt assembly part(s) with the correct (OK) seat belt assembly part(s) found on the parts table, page 6.

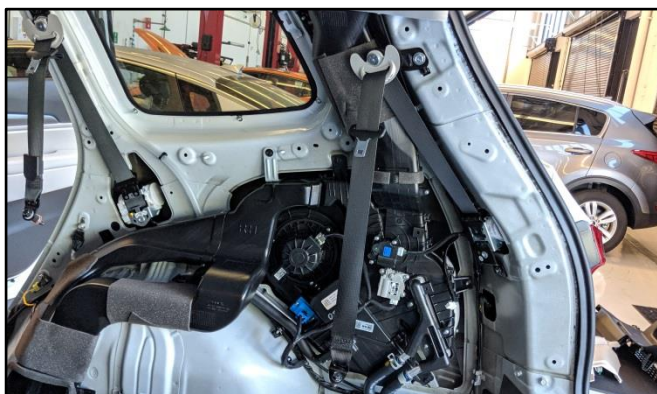
**Replacement Procedure – Rear Seat(s) 2<sup>nd</sup> and/or 3<sup>rd</sup> row Seat Belt(s):**

1. Replace the passenger seat belt by referring to “Body (Interior and Exterior) → Rear Seat Belt → Rear Seat Belt Retractor → Repair procedures” chapter in the applicable Shop manual on KGIS.
