GROUP
Safety Recall Campaign

MODEL
**2020MY
Telluride (ON)**

NUMBER
SC181 (Rev 2, 04/22/2019)

SUBJECT: SEAT BELT INSPECTION
AND/OR REPLACEMENT (SC181)

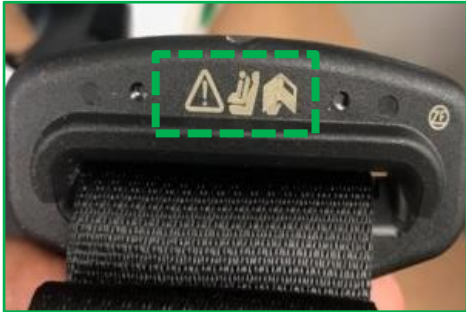
✓OK

Locate the seat belt assemblies outlined in this bulletin to identify the laser markings shown below and verify if the vehicle is affected: No Good (NG). If so, replace the seat belt assembly part(s) with the correct (OK) seat belt assembly part(s) found on the parts table, page 6.
