Retail Instructions to INSPECT THE LOWER STEERING SHAFT BOLT

Retail Instructions to INSPECT THE UPPER STEERING SHAFT BOLT

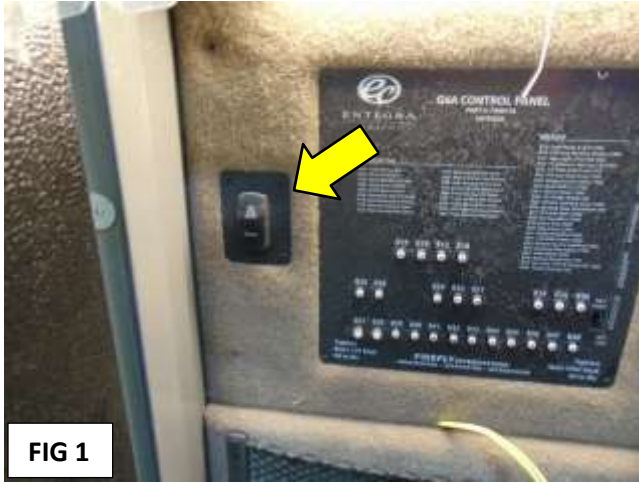
FIG 1:

- Turn the ignition ON (the engine does not need to be running)
- Make sure there is an unobstructed area 3 feet in front of the motorhome.
- Open the generator compartment using the switch (arrow) inside the driver side front electrical compartment. Press and hold the switch until compartment is fully extended.

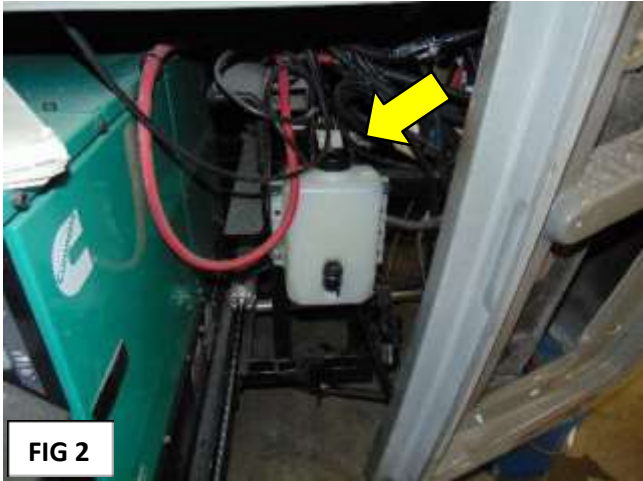
FIG 2:

- The steering shaft bolt is located on the right side of the generator behind the washer fluid bottle (arrow).

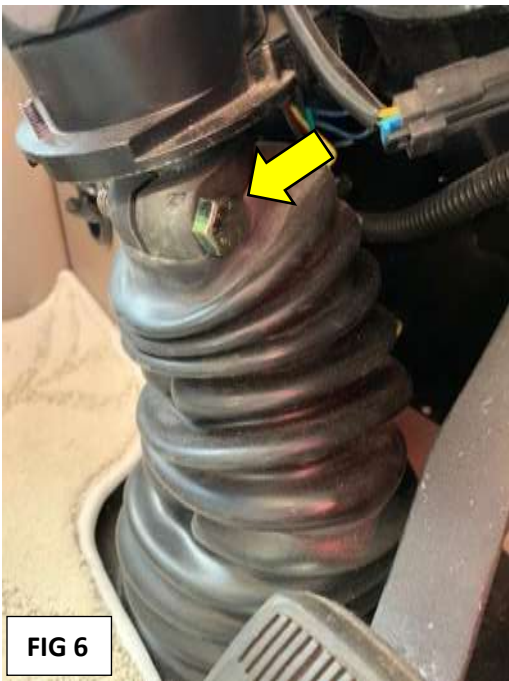
FIG 6:

- Upper steering shaft bolt is located on the steering column, beneath the steering wheel and under the large rubber boot.
- Lower the rubber boot on the steering column to see the bolt.

The bolt threads visible in Fig 5 AND 6 (for ***Upper and Lower bolts***) must be at least two threads past the nut for the locking feature to be engaged, to ensure your safety to travel to a Dealer to have the bolt/s properly torqued at 45 ft. lbs.

If there are less than two threads showing past the nut, you must tighten with a 5/8" wrench on the bolt side / 11/16" on the nut size, till at least two threads are past the nut. **This must be completed prior to moving your motorhome.**
