**SUBJECT: NEW VEHICLE DEMONSTRATION / DELIVERY HOLD**

**Compliance Recall 19C07 – Supplement #4**

Certain 2018-2020 Model Year Escape, Explorer, F-150, Superduty, Expedition and Aviator Vehicles Equipped with Manual Reclining Seats

Manual Recliner Seat Inspection

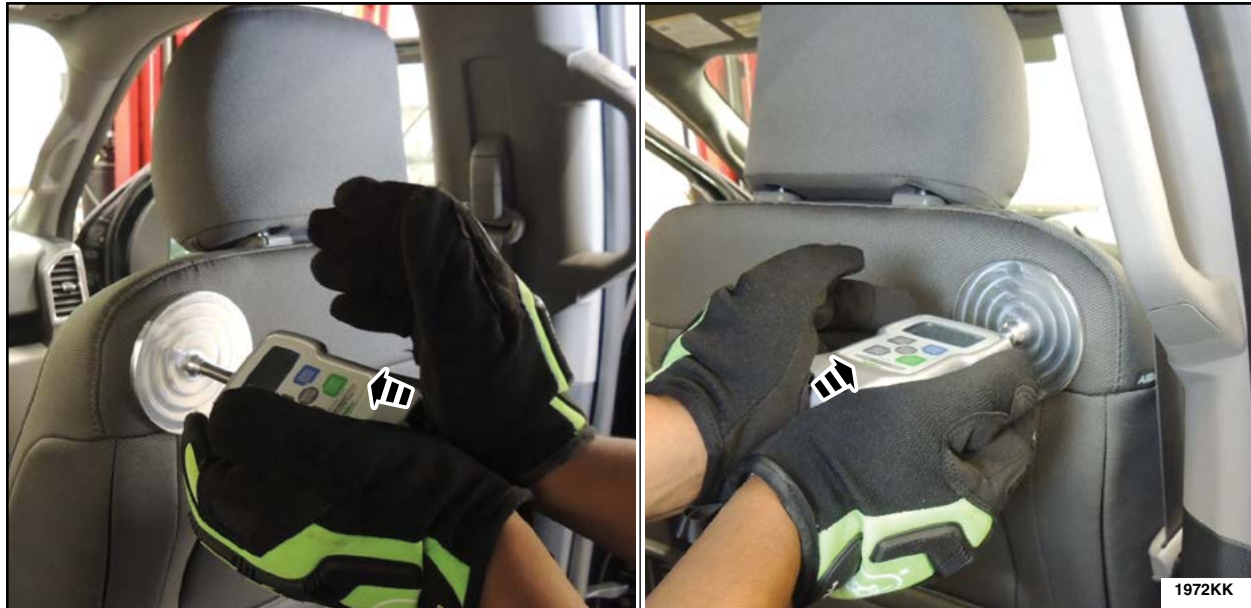
**FIGURE 1**

**NOTICE:** Do not exceed 950N (0.950kN) force, damage to the seat back could occur.

**NOTE:** Zero out the Force Gauge between each measurement.

Yes - This seat has failed inspection and will require replacement. Reference Attachment VI for repair procedure and Dealer Bulletin for parts ordering information.

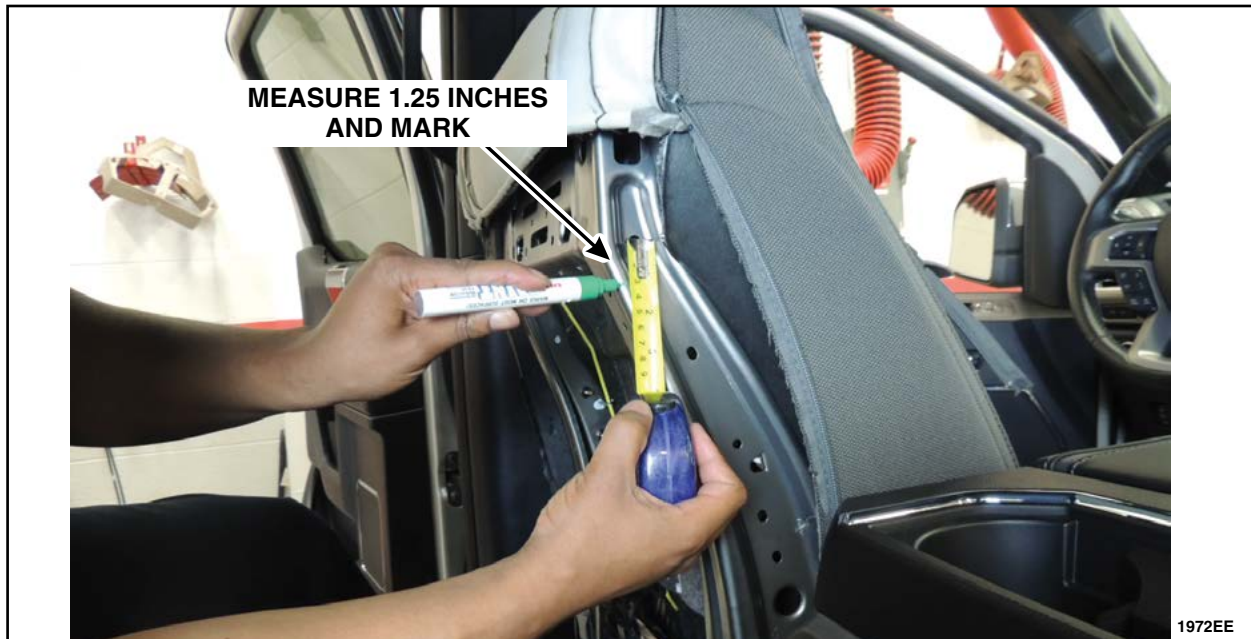
FIGURE 5

6. Measure 1.25 inches (32mm) down from the center of the upper attachment hole shown and mark frame as shown in Figure 5.

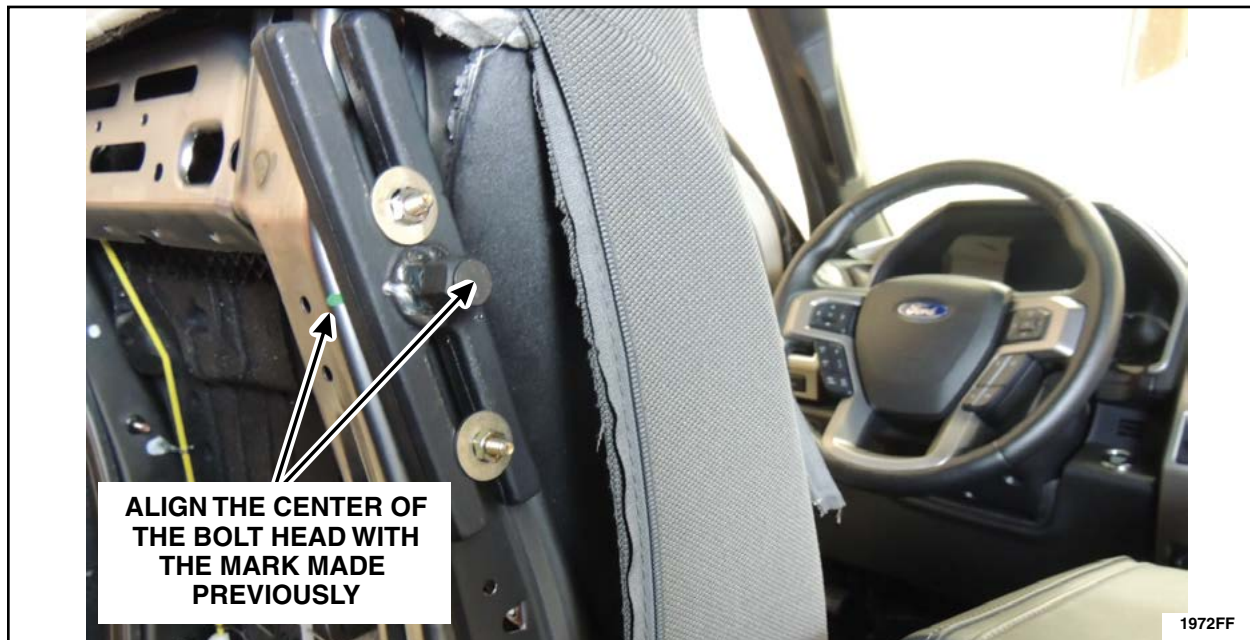
FIGURE 6

7. Install Torque Fixture onto the inboard side of the front seat backrest. See Figure 6.
  - a. Position a washer on the 6mm bolt, of suitable length, and install through the lower attachment hole.
  - b. Install a washer and nut onto the lower attachment bolt.
  - c. Position the Torque Fixture onto the lower attachment bolt between the frame and the outer washer.
  - d. Position a washer on the bolt and install through the upper attachment hole.
  - e. Install a washer and nut onto the upper attachment bolt.
  - f. Align the mark made on the backrest to the center of the Torque Fixture bolt.
  - g. Tighten down the Torque Fixture bolts and nuts so that the fixture can not move.

Yes - This seat has failed inspection and will require replacement. Reference Attachment VI for repair procedure and Dealer Bulletin for parts ordering information.

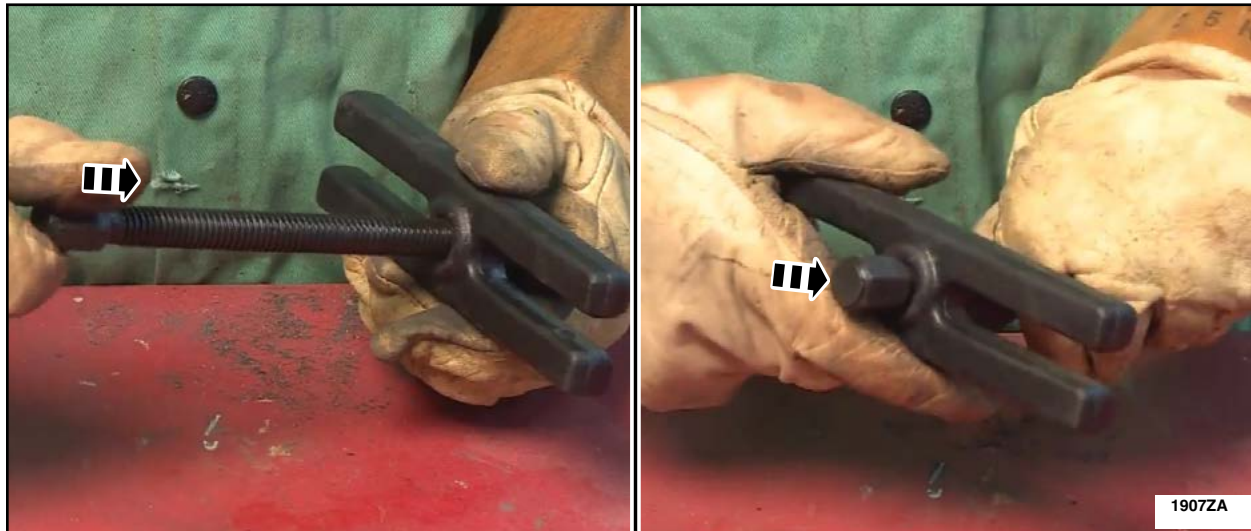
FIGURE 1

1. Screw the bolt fully into the H bar gear puller. See Figure 1.

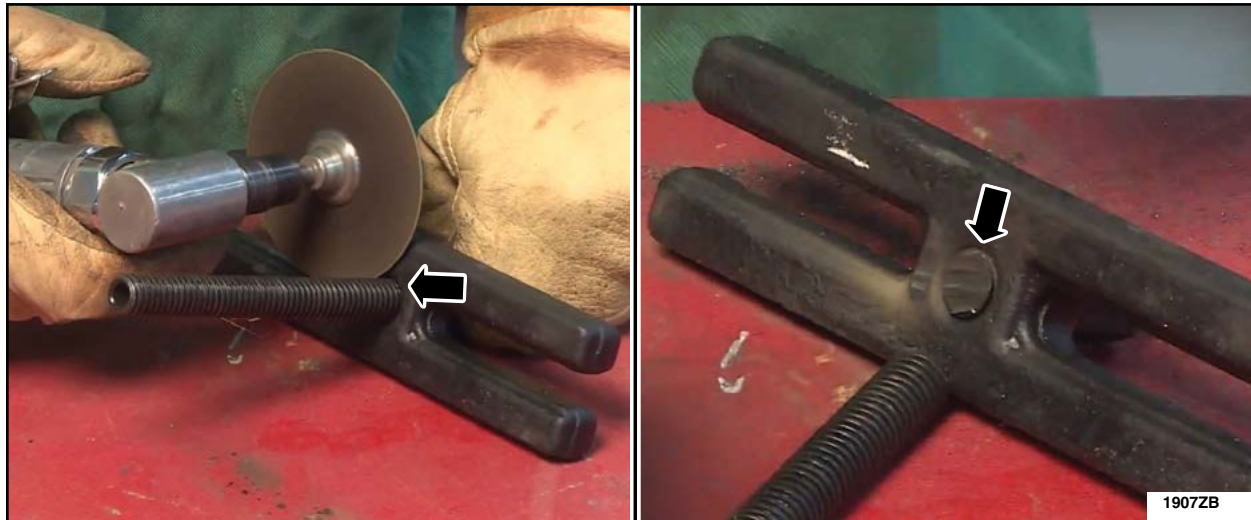
**FIGURE 2**

2. Use a cut off wheel to cut the excess bolt threads off the bottom end of the H bar tool, flush with the bottom of the H bar tool. See Figure 2.

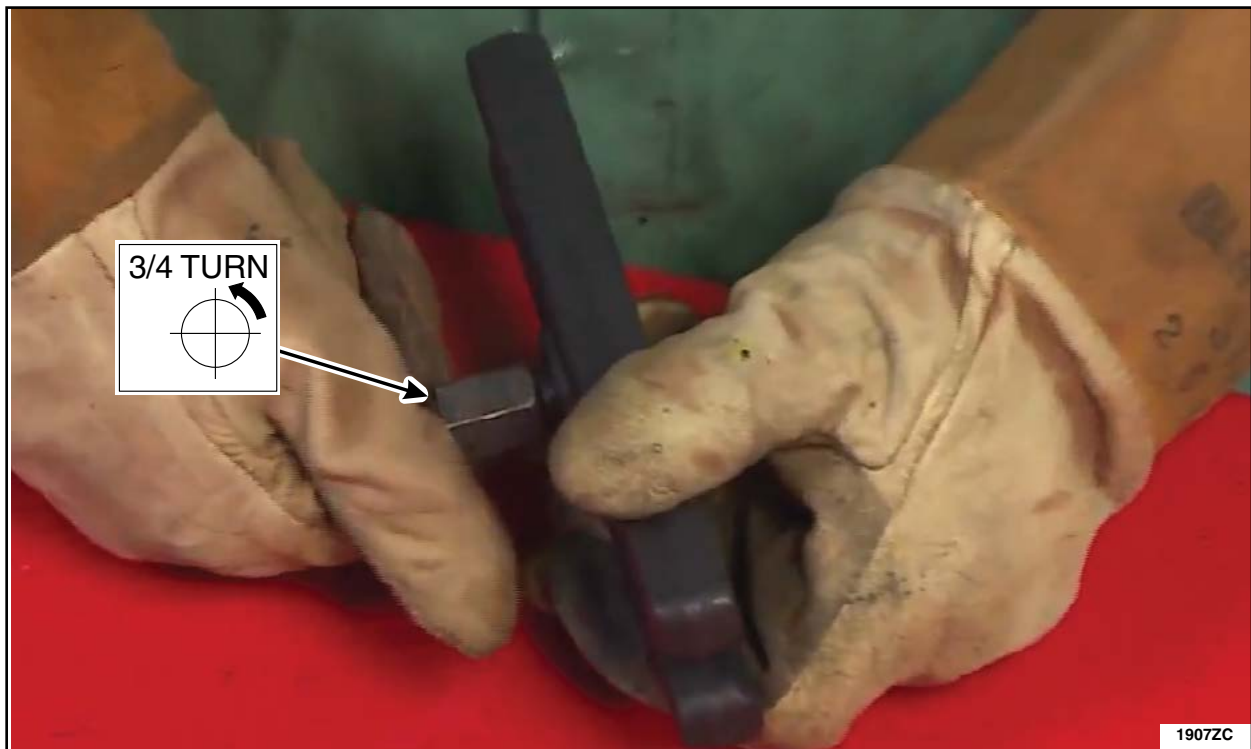
**FIGURE 3**

3. Back off the bolt head 3/4 of a turn to provide room for a good weld bead on both sides of the bolt threads (top and bottom). See Figure 3.

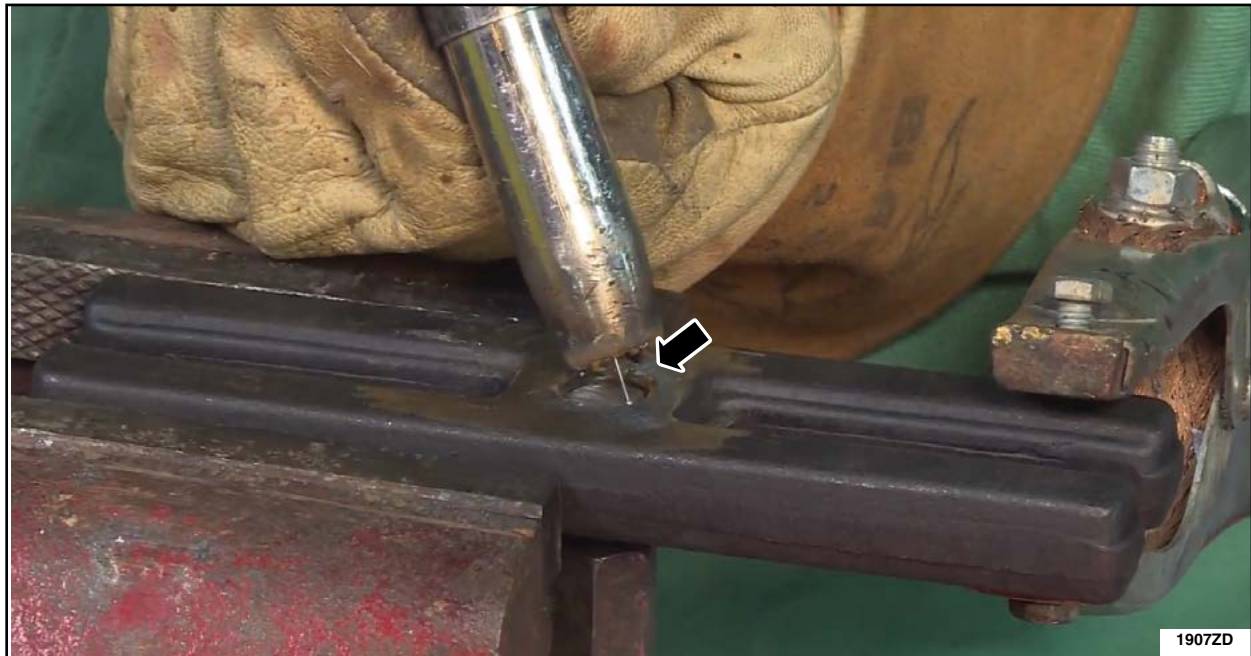
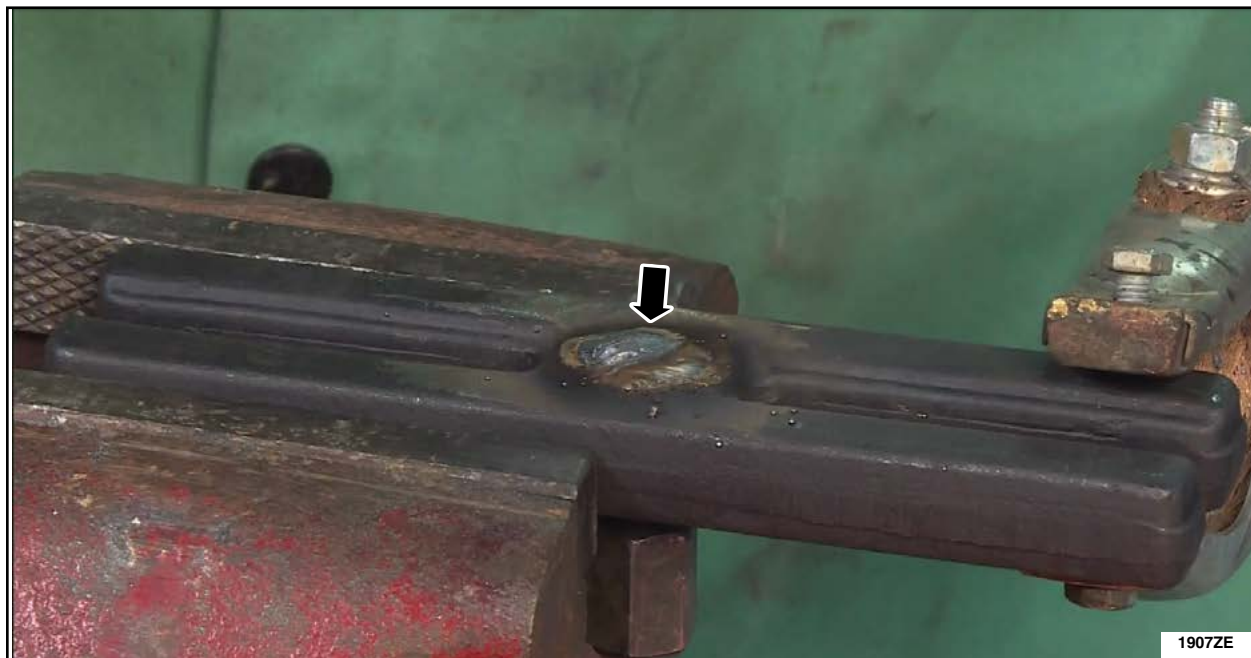
FIGURE 4a

4. Place the H bar tool in a vice. Weld bottom of the bolt threads to permanently secure the bolt in place. Ensure the weld is sufficient to withstand a large amount of torque. See Figures 4a and 4b.

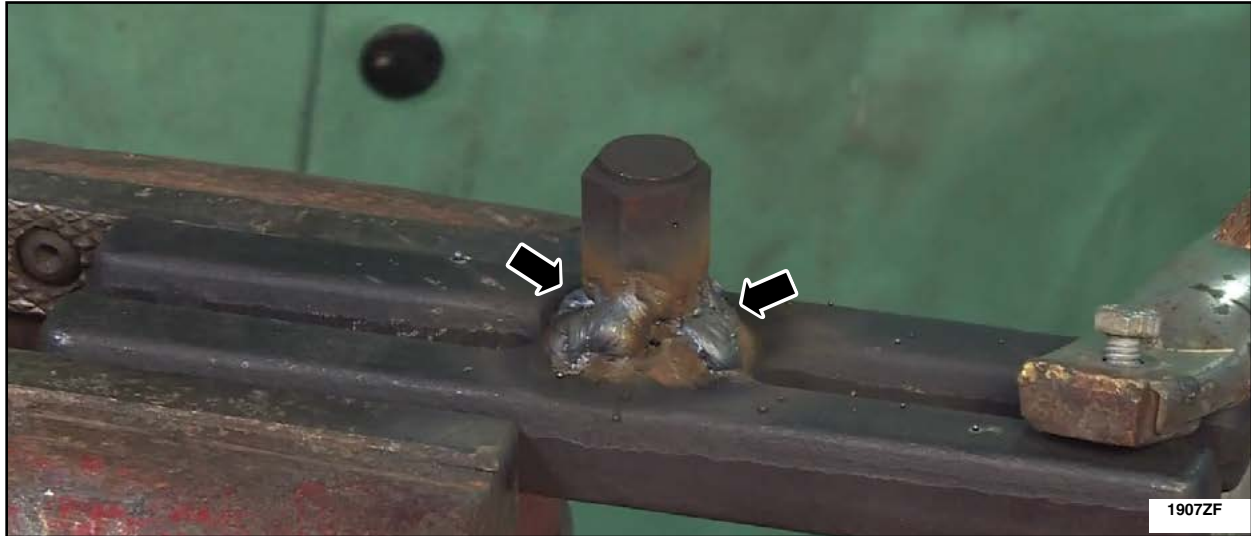
FIGURE 5

5. Turn the H bar tool over, bolt head side up and secure in the vice. Weld bolt threads to the H bar tool to permanently secure the bolt head in place. Again ensure the weld is sufficient to withstand a large amount of torque. See Figure 5.

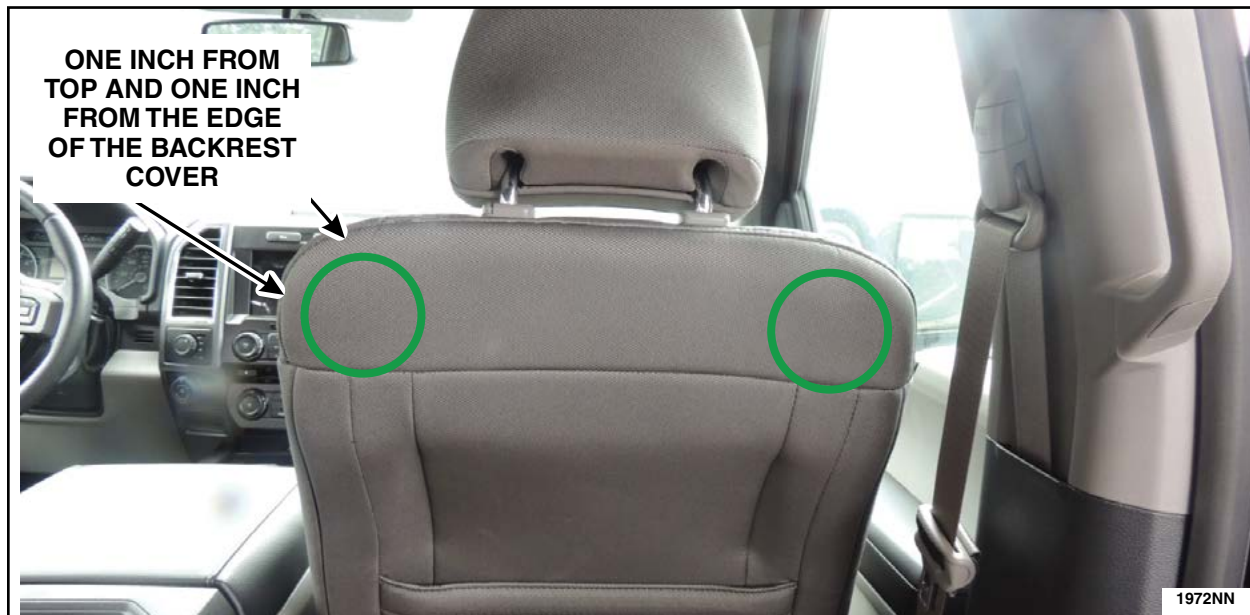
FIGURE 1

- b. Some Force Gauges will require reading the included instruction manuals in order to be able to select the correct units.
2. Ensure that the force plate is contacting the seat at the top corners. If the gauge is misplaced (too far in or too low), the seat frame may not be engaged and a proper reading will be difficult to obtain. See Figure 1.

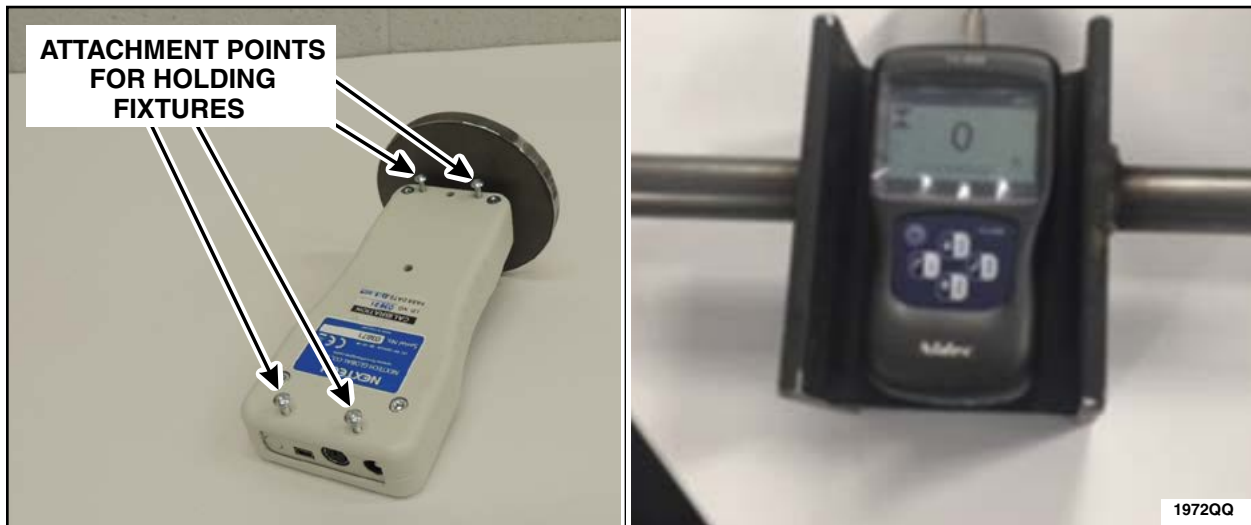
FIGURE 3

- a. Some dealer techs have fabricated simple holding fixtures that allow the tech to have better control of the Force Gauge. These holding fixtures range from a simple assembly of 2x4's to the use of C-Chanel or a small I-Beam with through holes drilled and handles welded on. See Figures 3 and 4.
