Product Safety Recall

N192268310 Engine Compartment Rail Stress Fracture

Release Date: September 2019

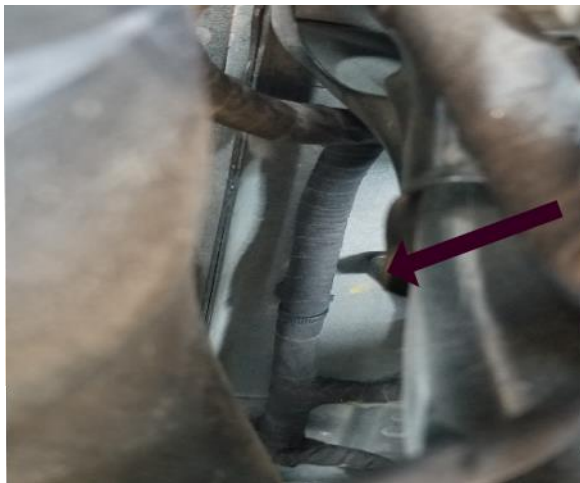
5401755

2. Locate the inspection area on the inner right front frame rail. This area runs from the bumper bracket (1) to the frame rail mounted upper tie bar bracket (2).

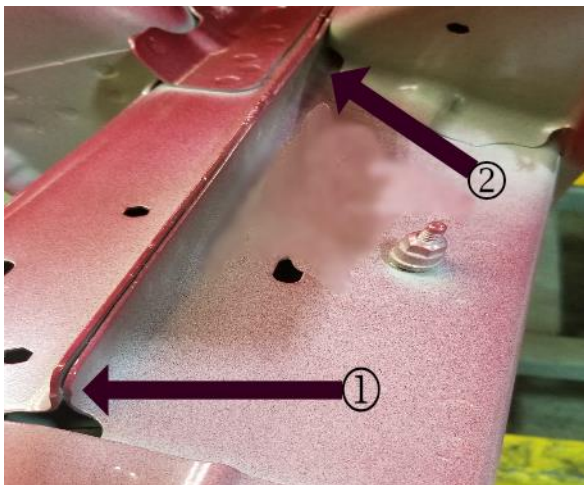
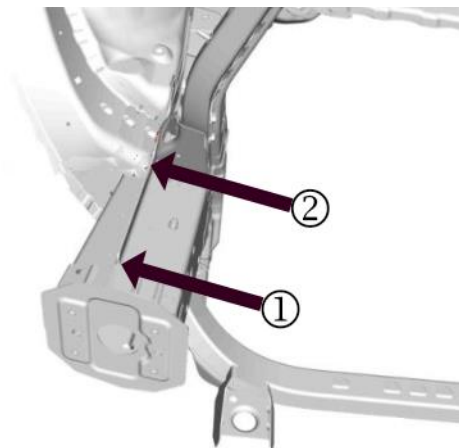
5401758

3. Use the ground stud for reference.

4. Using a bright light, visually inspect the frame rail where the weld flange meets the top horizontal surface of the frame rail from point (1) to point (2).

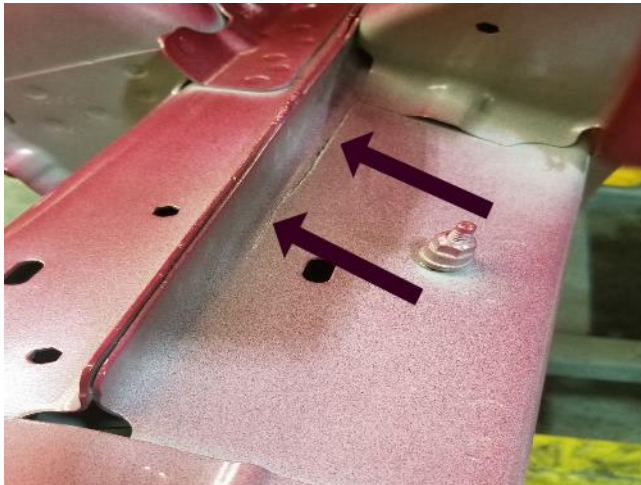
5401749

Crack example

5. Verify that there are no cracks, or indication of cracks in this area.
 - If **No Cracks Are Found**, reinstall the air cleaner assembly and return the vehicle to service.

- If **Any Evidence of Cracks Are Found during the inspection process you must perform the following steps:**
 - **Quarantine the vehicle.**
 - For US Dealers - Submit a Field Product Report (FPR) and Pictures using the Field Product Reporter App found in the Certified Service Mobile Tools (reference TSB 02-00-89-002). For Canadian Dealers - Submit a Product Information Report (PIR) and Pictures (reference TSB 10-00-89-006). Be sure to include the following information:
