CR180 – Breather valve kit part no.69929001A installation

1199 Superleggera Model Year 2014
 1299 Superleggera Model Year 2017
 1299 Panigale R Final Edition Model Year 2018
 Panigale R Model Year 2015-2017
 Safety Recall Bulletin SRV-RCL-19-002

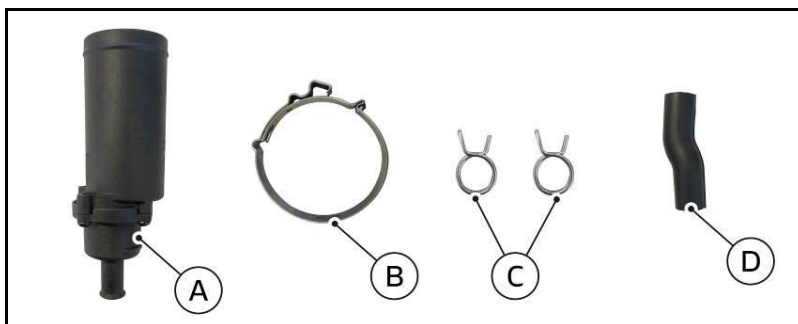
The kit part no.69929001A is made up of the following components:

Part no.	Reference	Description	Quantity
69929001A	A	Cyclone separator	1
	B	Click clamp	1
	C	Clamps	2
	D	Rubber hose	1

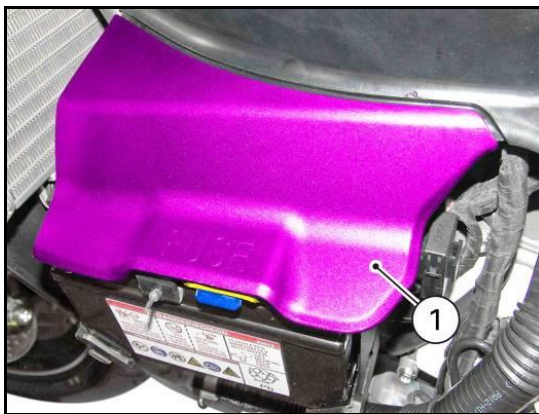
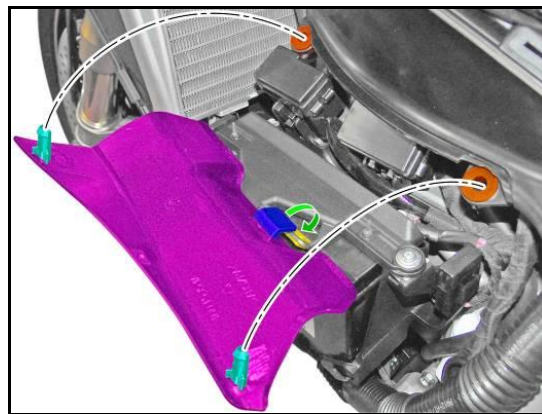
1. Position the vehicle on the rear paddock stand
2. Remove the LH side fairing (see Sec. 5: "Fairing installation – Fairing" of the Workshop Manual)
3. Remove the ignition switch cover (see Sec. 5: "Fairing installation – Headlight Fairing" of the Workshop Manual)
4. Remove both right and left air conveyer covers (see Sec. 5: "Fairing installation – Headlight Fairing" of the Workshop Manual)
5. Remove the battery cover (1)

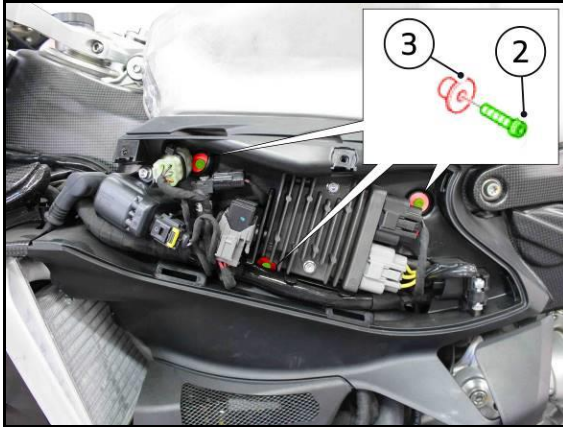
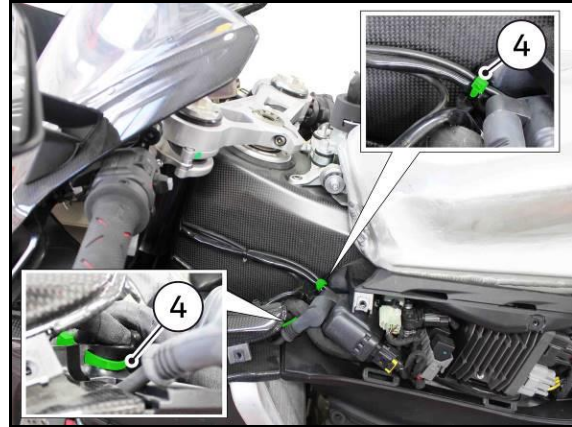
6. Remove the **3 M5x22 screws (2)** and the relevant **spacers (3)** securing the electrical components support
7. Remove the **2 big self-locking ties (4)**

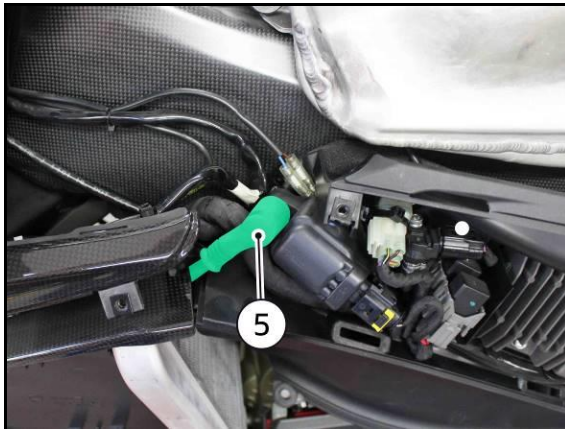
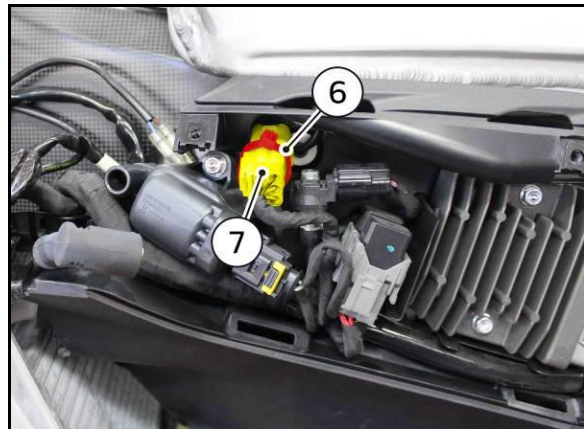
8. Disconnect the **spark plug cable (5)** from the horizontal cylinder coil
9. Remove the big self-locking **tie (6)** securing the ignition switch **connector (7)** to the electrical components support and disconnect the connector

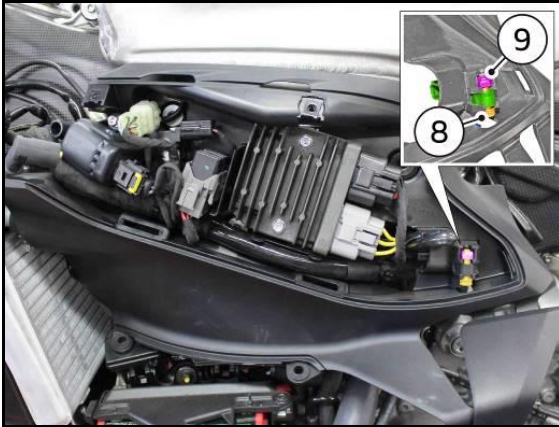
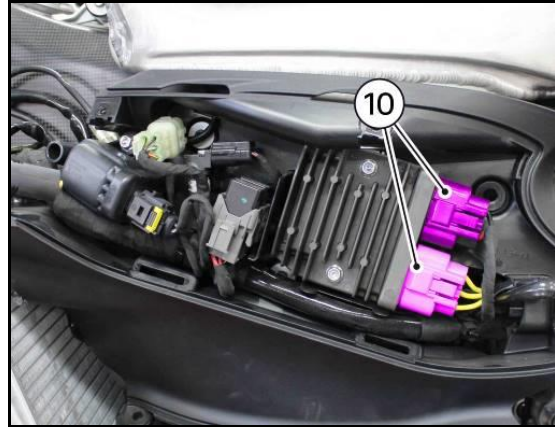
10. Remove the **M6x22 screw (8)** securing the pressure sensor to the electrical components support and slide **nut (9)** out
11. Remove the **2 connectors (10)** of the voltage regulator

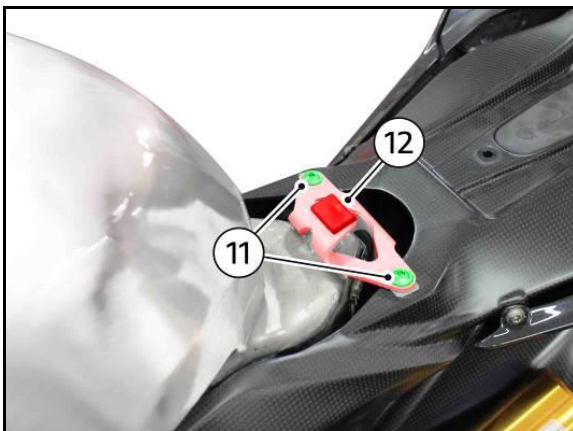
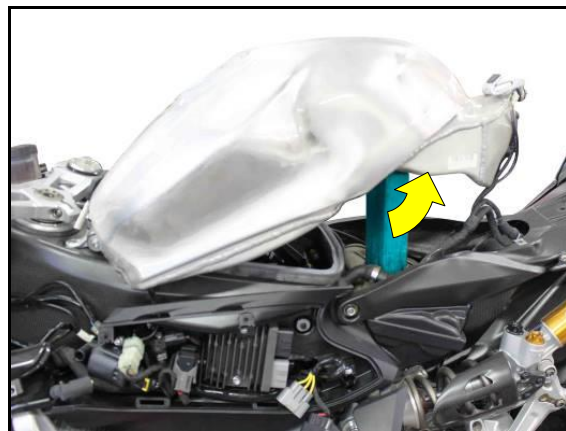
12. Remove the rider seat (see Sec.5: "Fairing installation – Seat" of the Workshop Manual)
13. Remove the **2 M6x14 screws (11)** that retain the fuel tank **bracket (12)** to the rear subframe
14. Lift the fuel tank and keep it lifted using a suitable support taking care not to damage components with the support or impinge the fuel tank into any other components, as shown in the figure

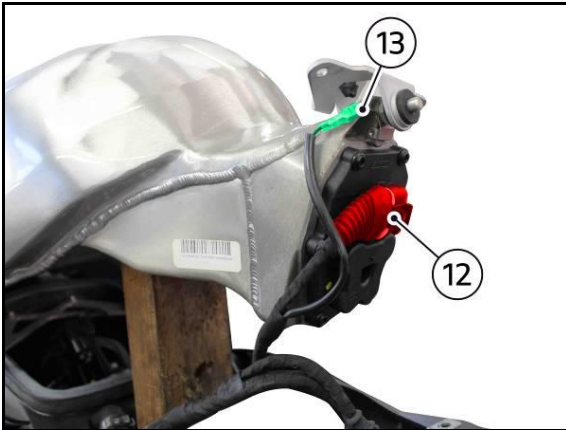
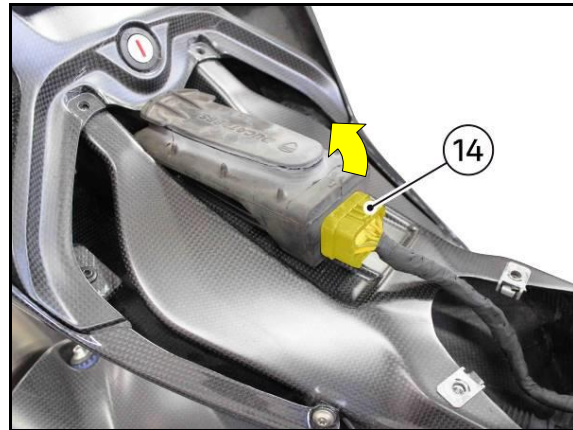
15. Disconnect fuel level sensor **connector (12)** and **ground cable (13)**

16. Release the BBS control unit from the rear subframe and disconnect **connector (14)**

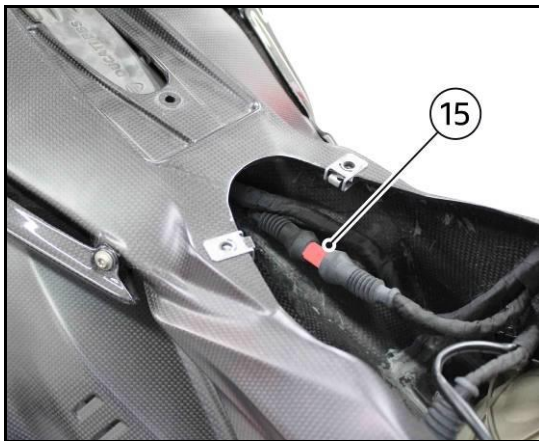
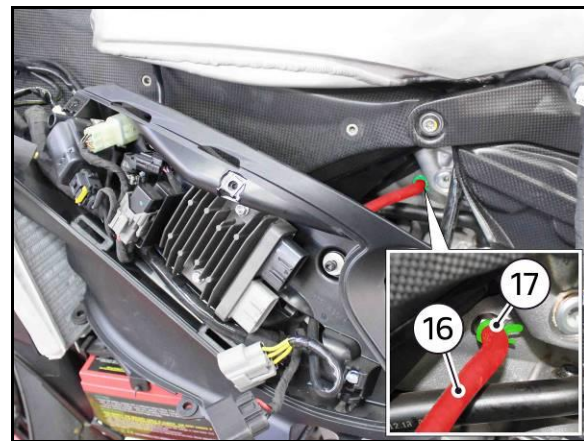
17. Disconnect the rear wiring **connector (15)**

18. Pull out the vertical head pressure sensor **hose (16)** by removing the **clamp (17)**

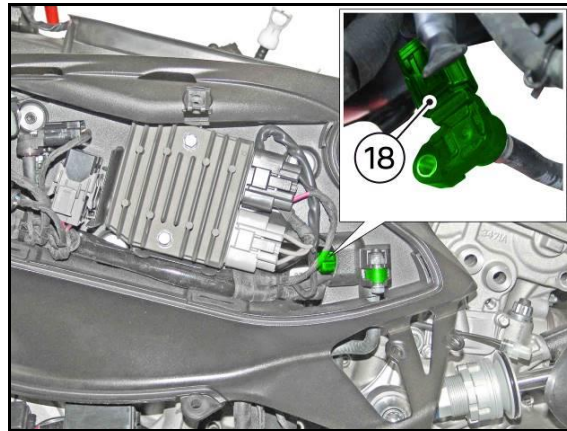
19. Disconnect vertical head pressure sensor connector (18)

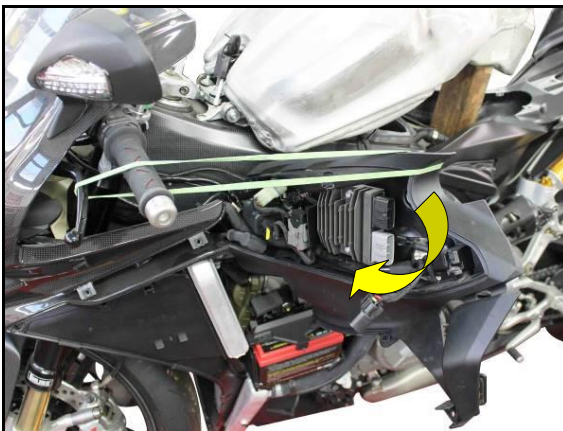
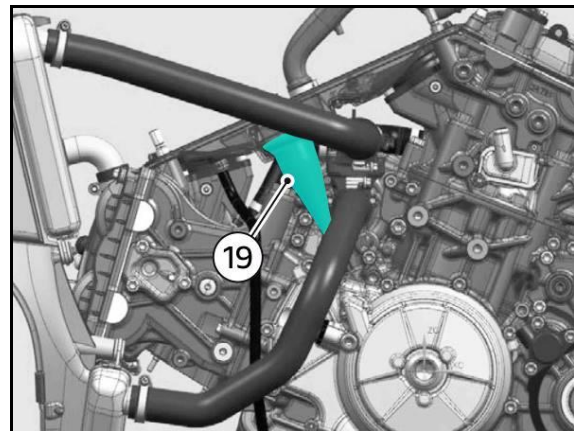
20. To access the cyclone hose (19), rotate the electrical components support towards the front side and fasten it with an elastic band, as shown in the figure

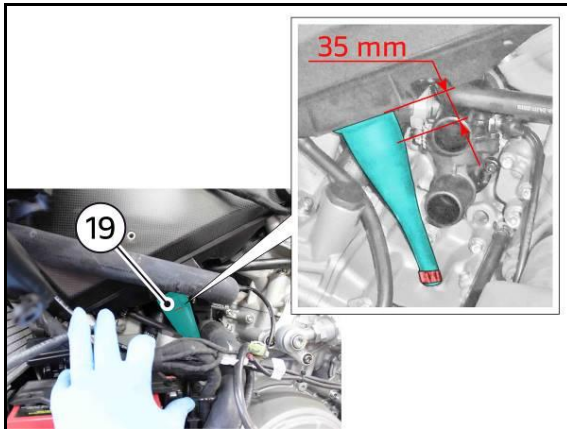
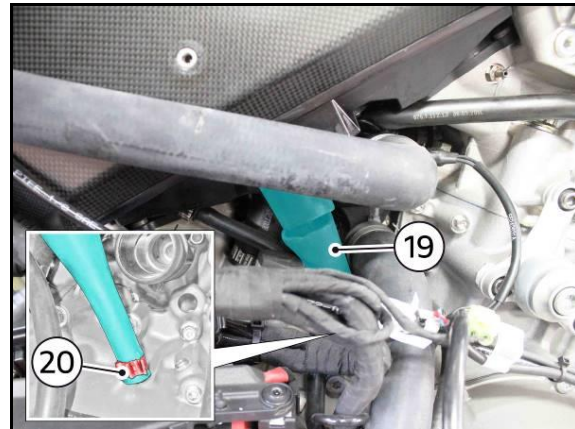
21. To install the Breather valve kit part no.69929001A it is necessary to modify the cyclone **hose (19)** installed on the vehicle.

Use a marker to make a mark on the cyclone **hose (19)** at a length of **35 mm** measured from the **Airbox bottom**; use a cutter or workshop scissors to cut the hose in correspondence of the mark previously made with the marker.

22. Remove the click **clamp (20)** and pull out the lower part of the cyclone **hose (19)** from the crankcase

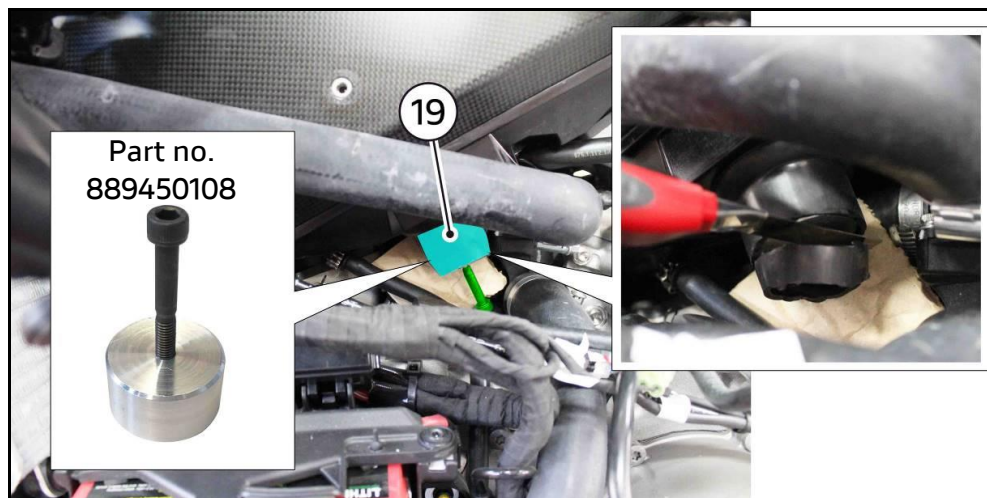
23. Take the tool part no.889450108, insert the buffer in the cyclone **hose (19)** driving it fully home and remove the excessive section of hose using a cutter.

During the trimming operation, protect the surrounding components around the cyclone hose to avoid damaging the coolant hoses

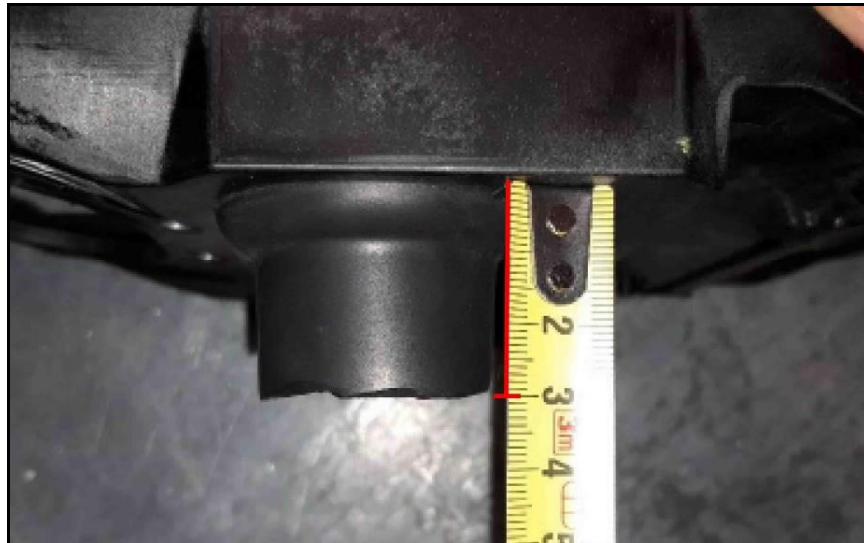
Check that the remaining length of the cyclone **hose (19)** is equal to approx. 30 mm and remove both the protection used and the tool part no.889450108.

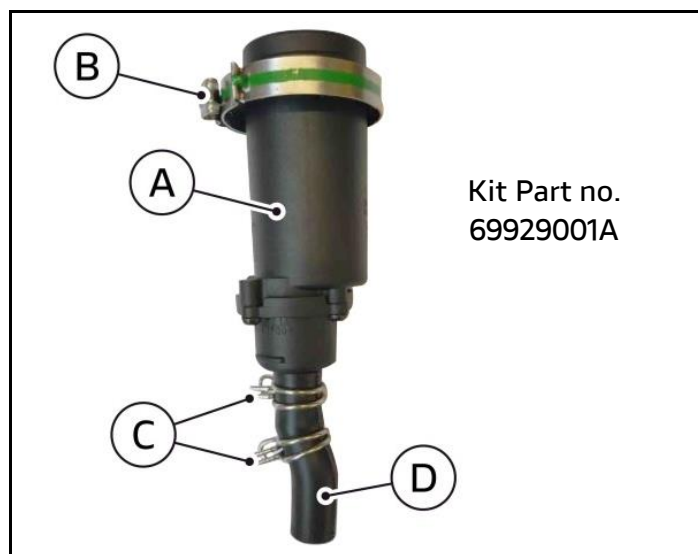
24. Take the kit part no.69929001A and assemble the **cyclone separator (A)**, the **click clamp (B)**, the **rubber hose (D)** and the **2 clamps (C)** as shown in the figure

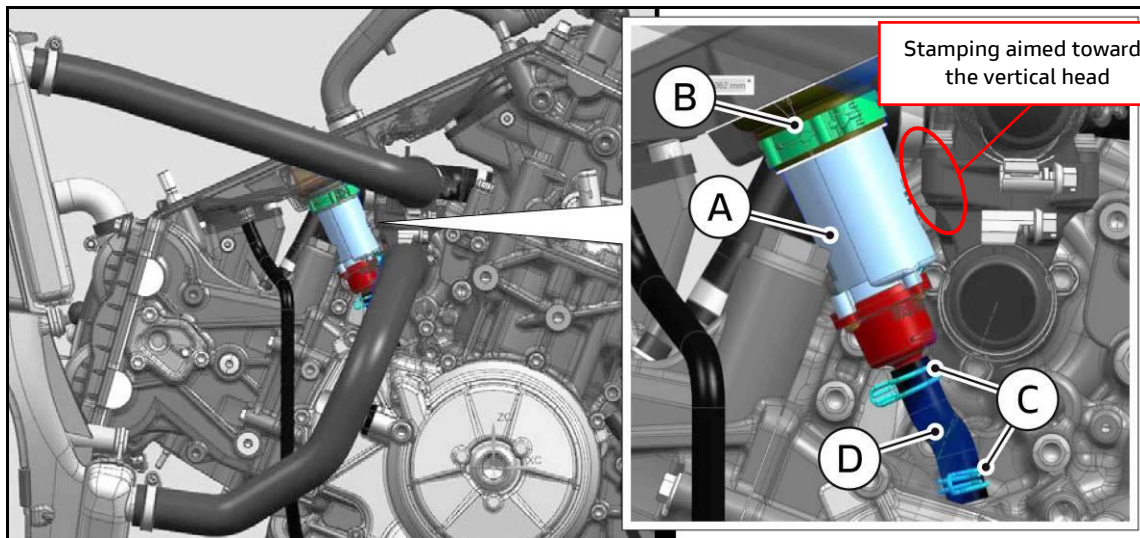
25. Install the **cyclone separator (A)** inside the cyclone hose aiming the stamping towards the vertical head, as shown in the figure. Fasten the cyclone separator using the **click clamp (B)**
26. Insert the terminal part of the **hose (D)** in the crankcase and aim the **2 clamps (C)** as shown in the figure

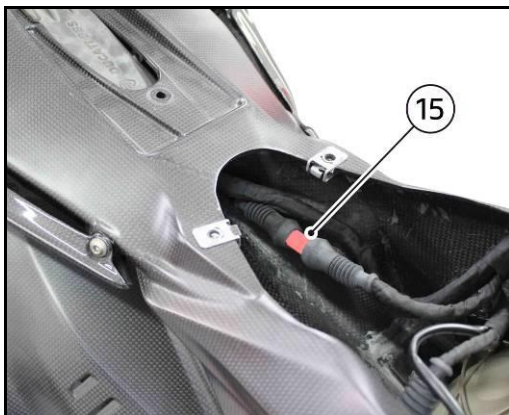
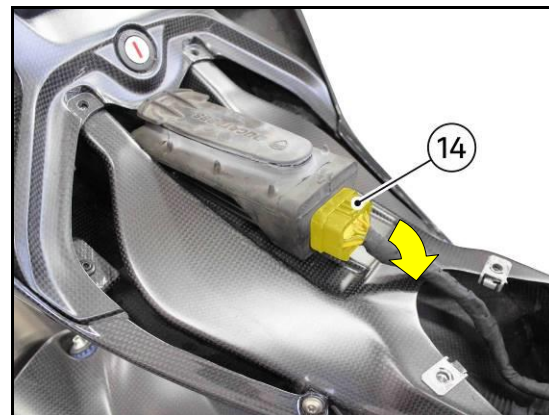
27. Remove the elastic band used to rotate the electrical components support
28. Connect the rear wiring **connector (15)**
29. Connect **connector (14)** and reposition the BBS control unit inside the rear subframe

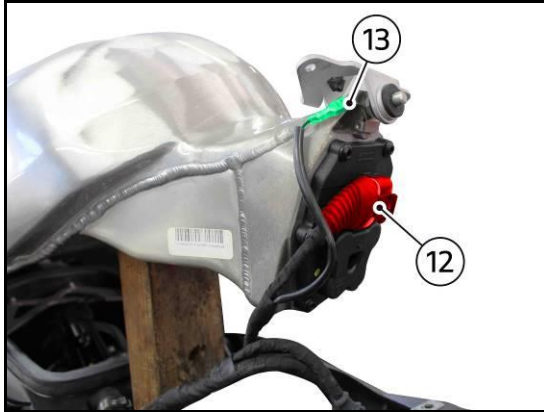
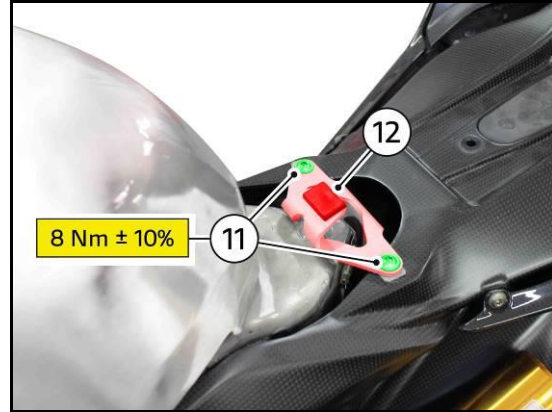
30. Connect fuel level sensor **connector (12)** and **ground cable (13)**

31. Remove the fuel tank support and fit **bracket (12)** tightening **2 M6x14 screws (11)** to **8 Nm \pm 10%**

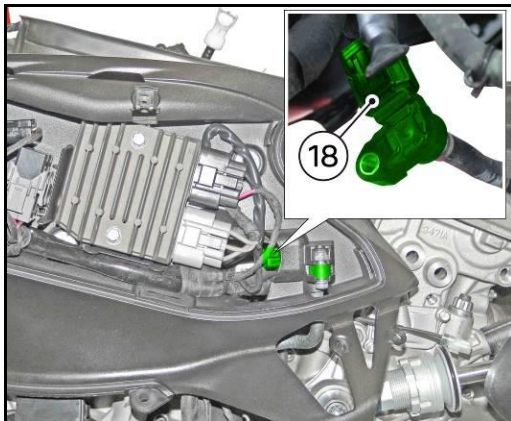
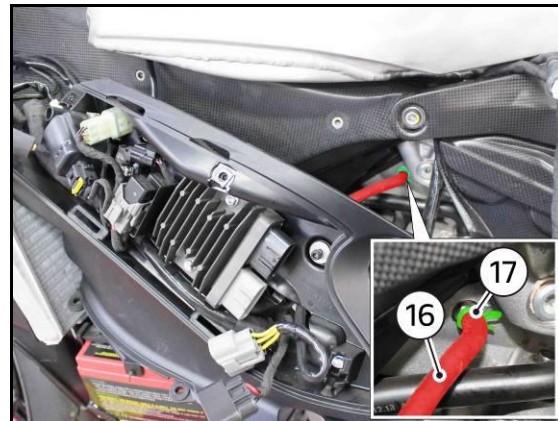
32. Connect vertical head pressure sensor **connector (18)**

33. Connect the vertical head pressure sensor **hose (16)** and fasten it with **clamp (17)** aiming it as shown in the figure

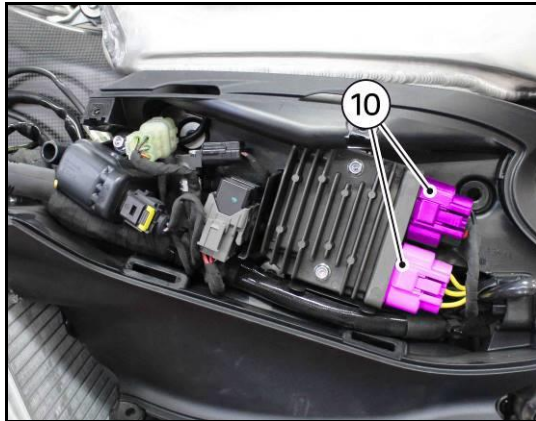
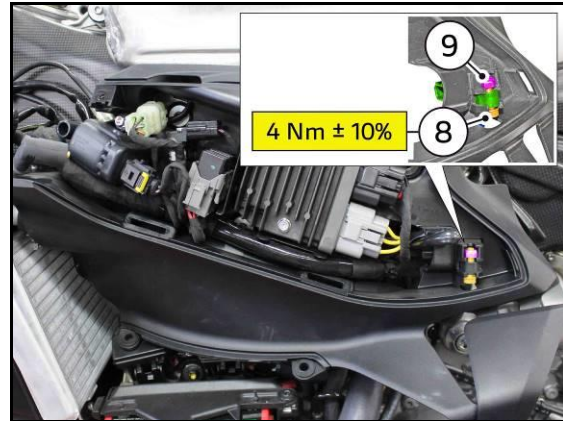
34. Fit the **2 connectors (10)** of the voltage regulator

35. Fasten the pressure sensor to the electrical components support by fitting **nut (9)** and tightening **M6x22 fastening screw (8)** to **4 Nm \pm 10%**

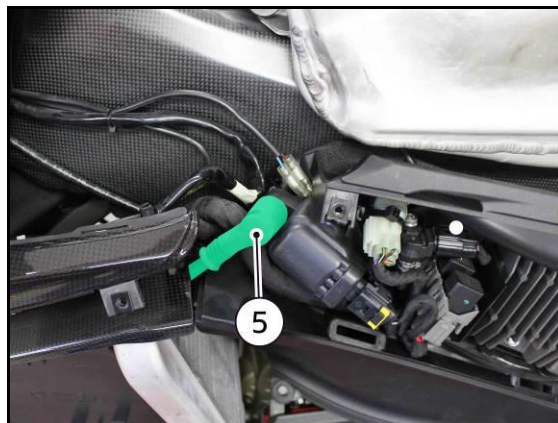
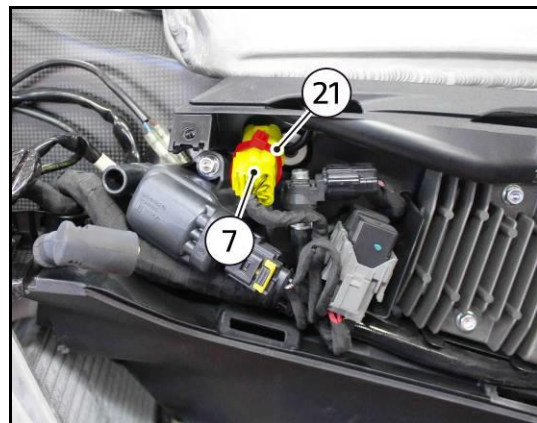
36. Connect the **spark plug cable (5)** of the horizontal cylinder coil

37. Connect ignition switch **connector (7)** and fasten it to the electrical components support using a new **self-locking tie (21)** and aim it as shown in the figure

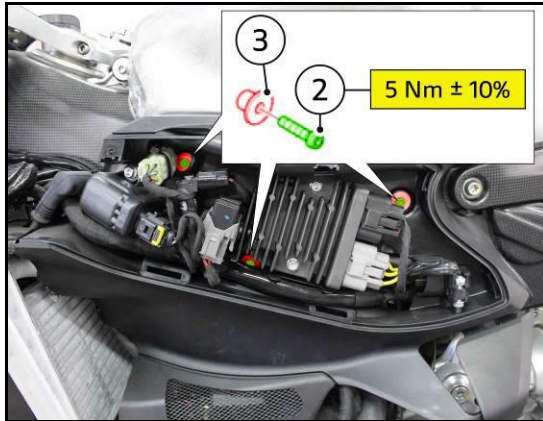
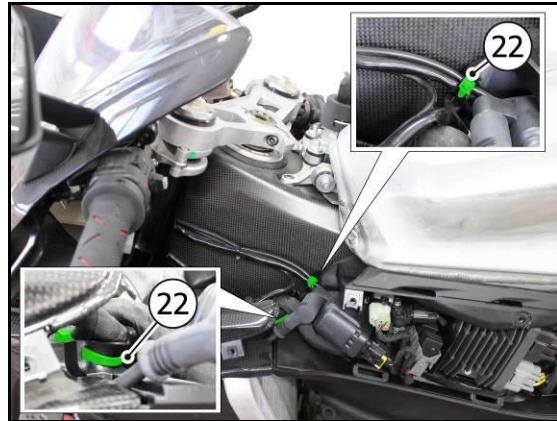
38. Install the electrical components support by starting the **3 M5x22 screws (2)** with the relevant **spacers (3)**. Tighten the **3 M5x22 screws (2)** to **5 Nm \pm 10%**

39. Install the 2 new big self-locking **ties (22)** as shown in the figure

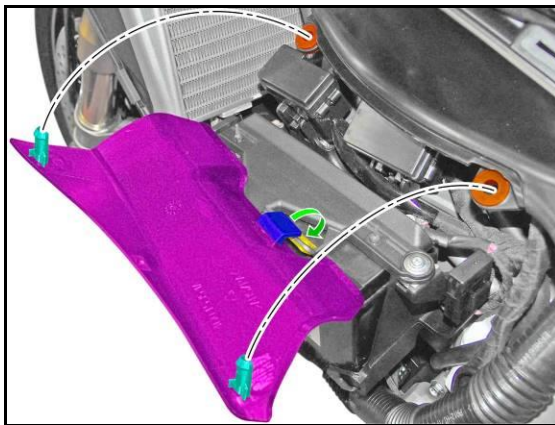
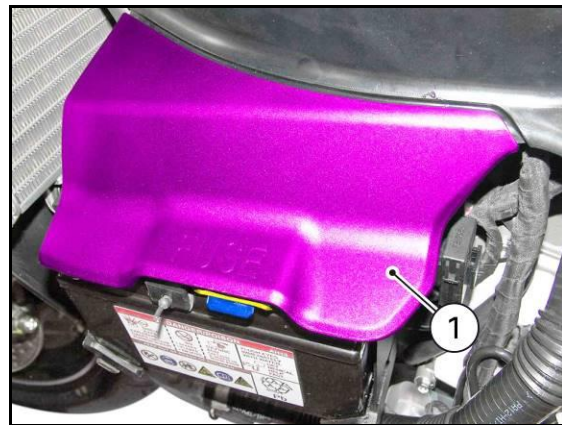
40. Install the battery **cover (1)** as shown in the figure
