Mercedes-Benz

Campaign No. 2019100001, October 2019

SUBJECT: **Model A-Class (177 platform), CLA-Class (118 platform), and GLC-Class (253 platform) vehicles**
Model Years 2019 and 2020
Check Driver Airbag Module Locknut

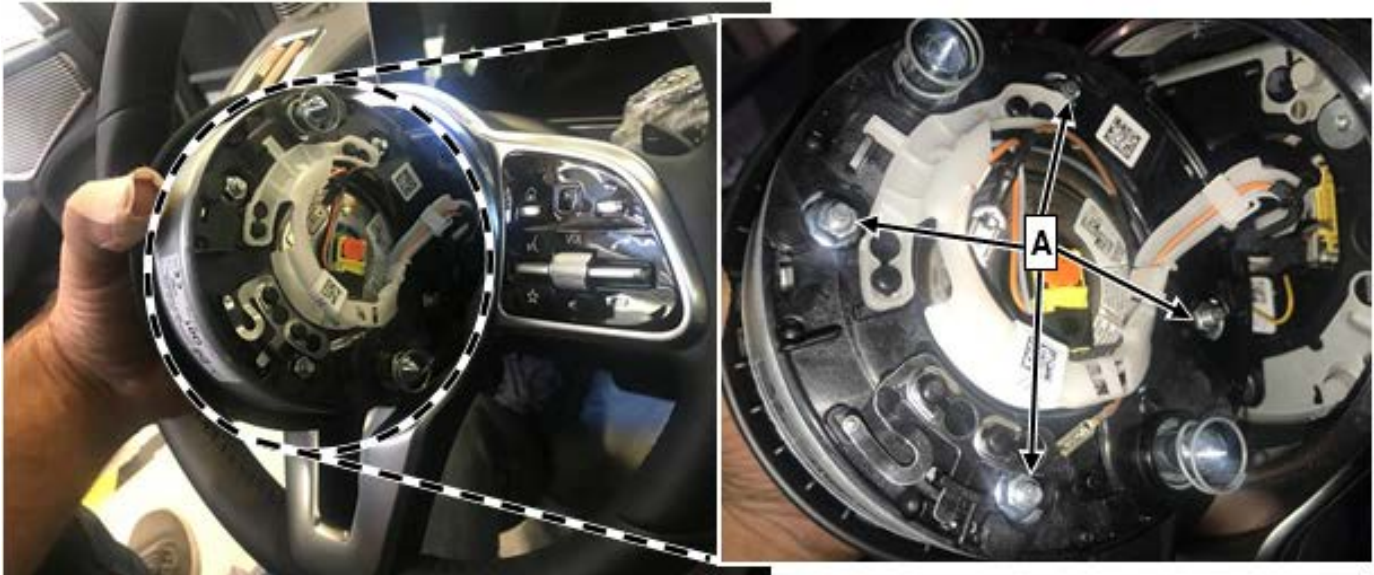
Figure 1

3. Check the 4 threaded connections (**A**) (**Fig. 1**).

i The 4 nuts (**A, Fig. 1**) **must** be present.

- a. If the nuts on the driver airbag unit **are not** present: perform **Work procedure**.
- b. If the nuts on the driver airbag unit are present: **end task**.

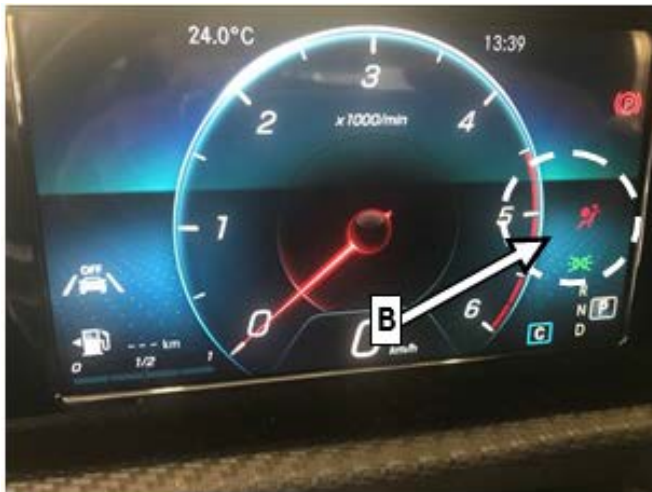
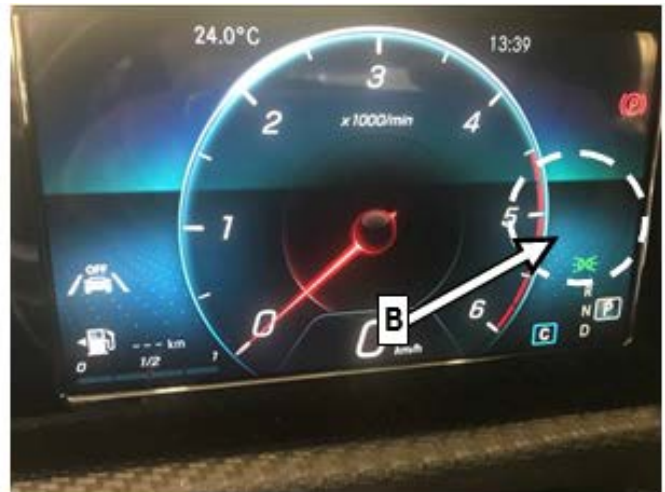
Figure 2

3. Turn the transmitter key in the electronic ignition lock to **position 1** **or** press the start button once without touching the brake pedal (ignition position 1) and check whether the airbag indicator lamp (B, Fig. 2 **or** 3) in the instrument cluster goes out permanently after a few seconds.

i The SRS indicator lamp check after airbag check or airbag replacement guarantees functionality.
